# Building Inspection Report

FANGS BUILDING INSPECTIONS

**Lotxx Evesham Drive, Point Cook, VIC, 3030**

Inspection Date:        01 Mar 2019

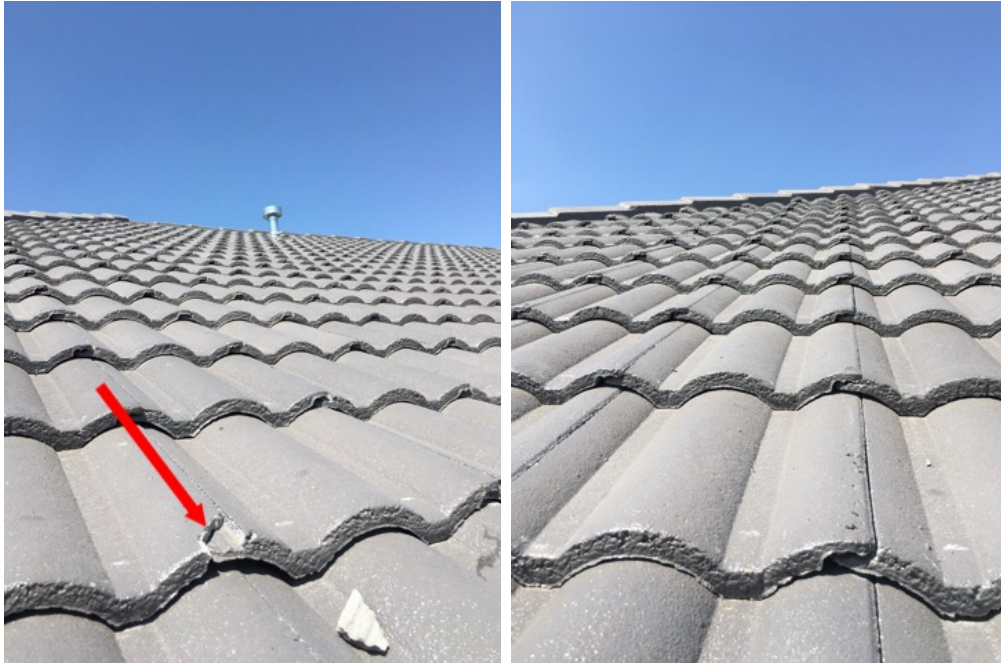
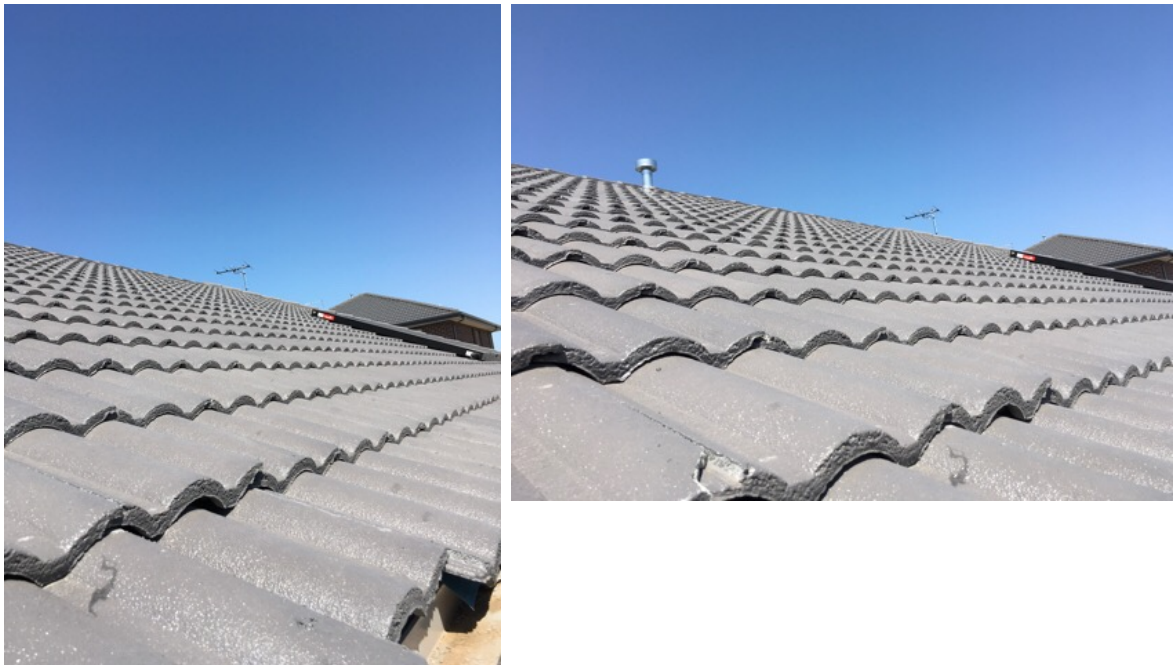
### Roof System

There are minor tiles cracking and damage to the referred area, please rectify this issue ASAP to avoid leaking.

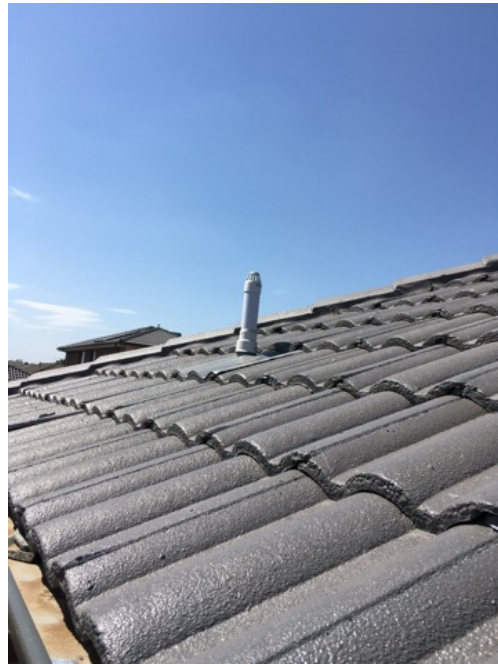
### Flashing

Flashing has been correctly installed

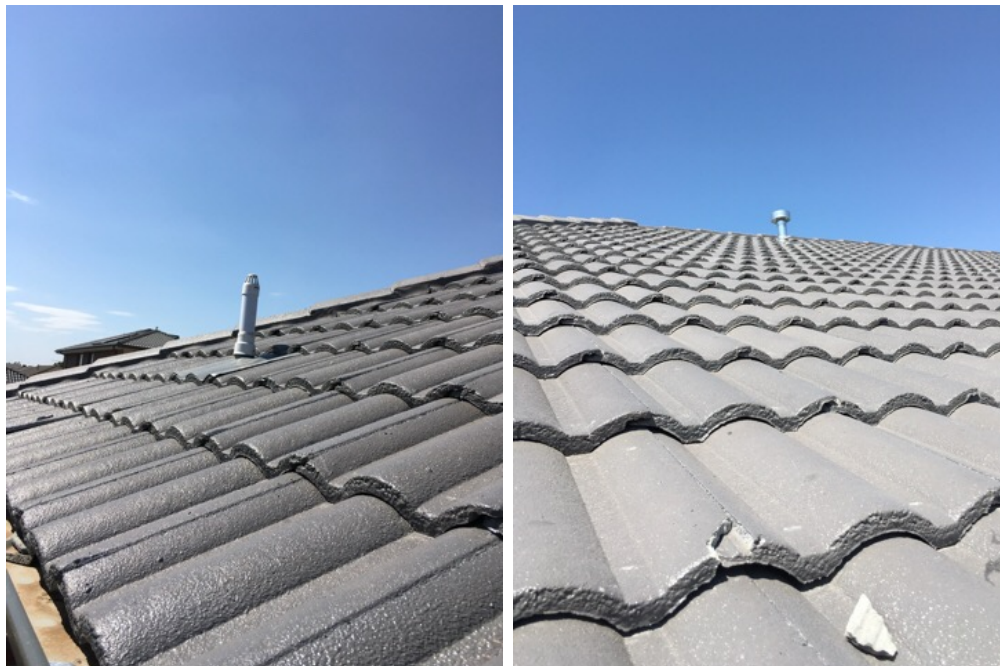
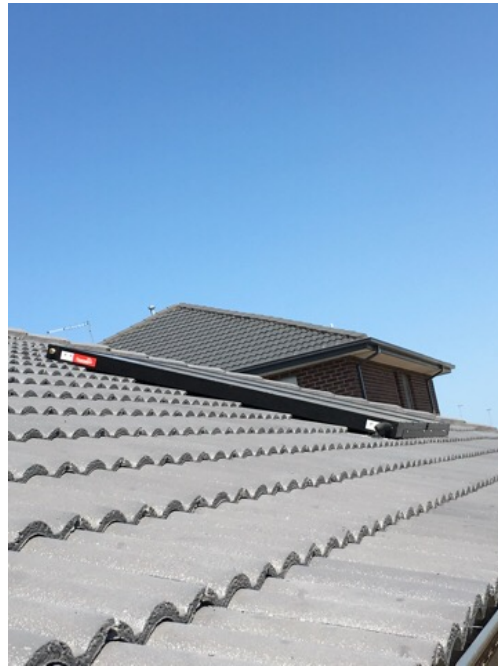
### Solar Panel and Sewage Venting Pipes

Solar Panel and sewage venting pipe has been installed as per drawings

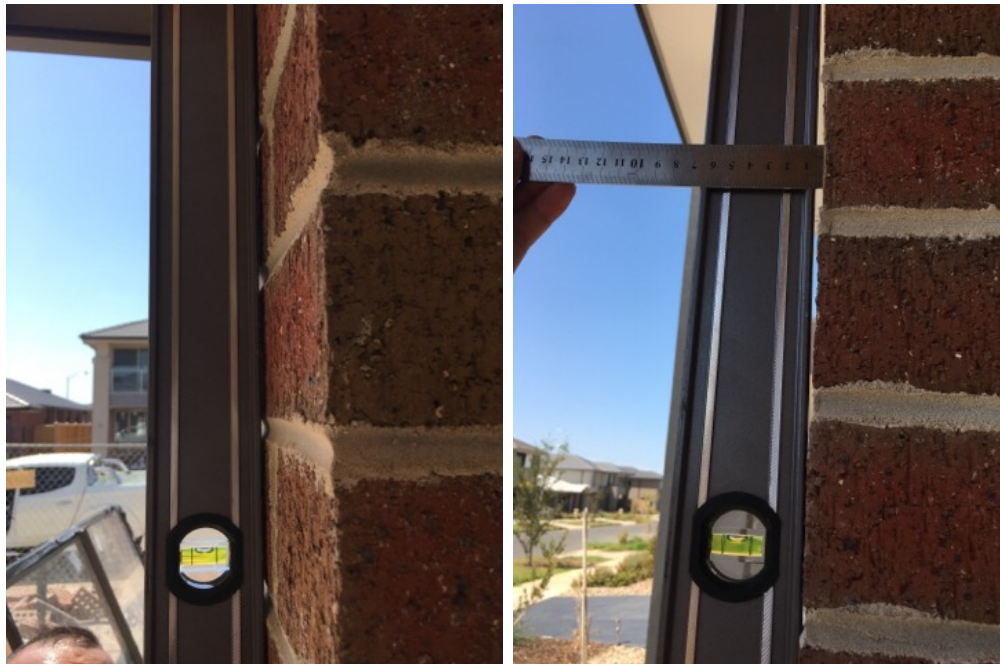
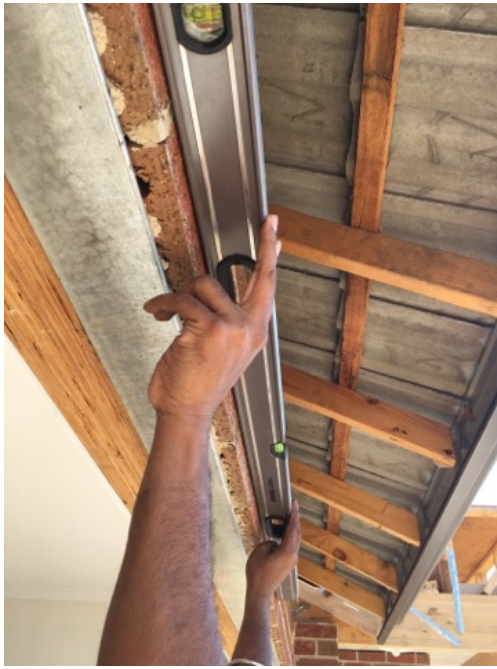
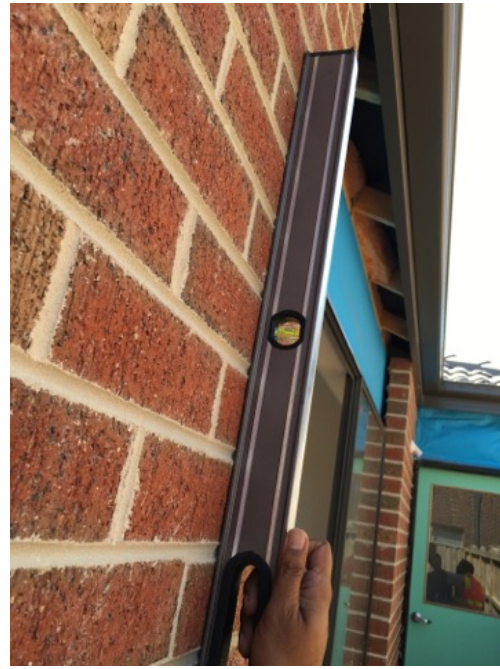
**External Wall Deviation Exceeded 10mm within 3 meters**

Defect is not applicable

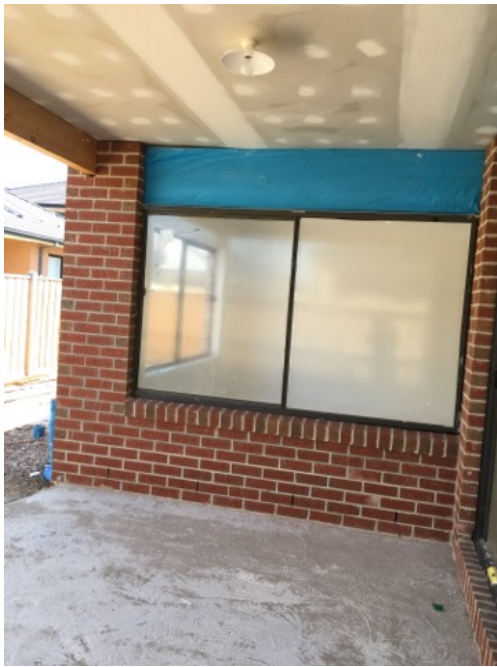
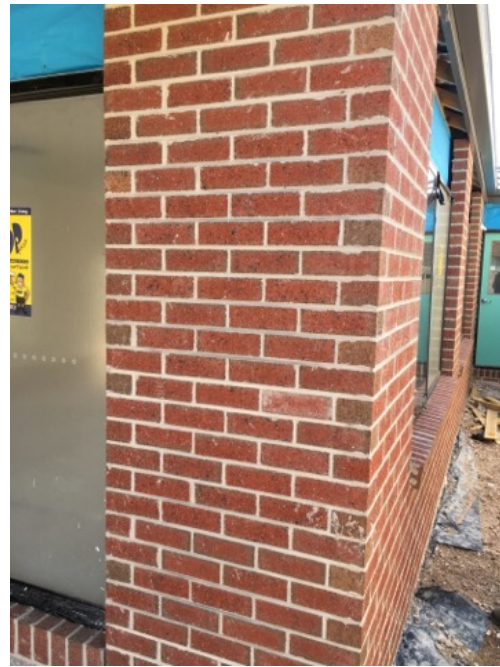
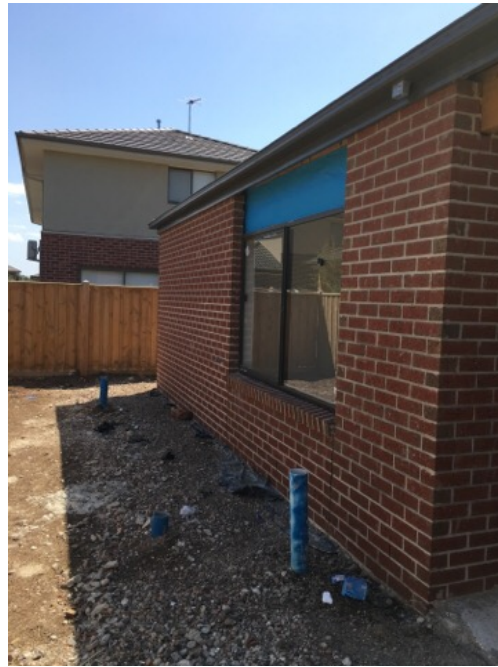
### External Wall Damaged and Chipped

External wall and cladding appears in good condition without any chips

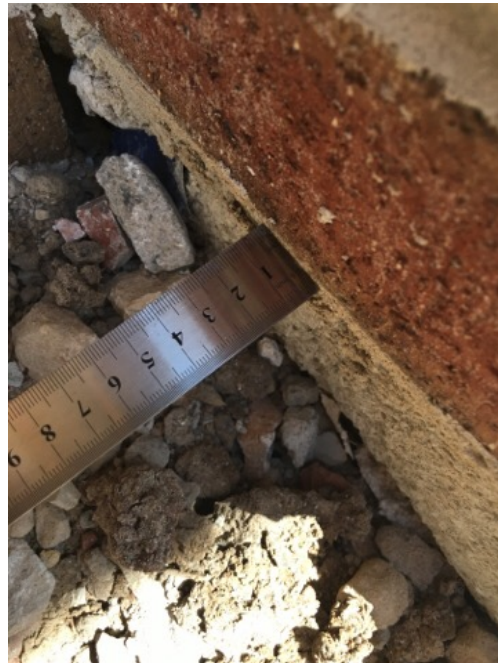
**Brick Overhang  $\geq 15\text{mm}$**

No brick overhang

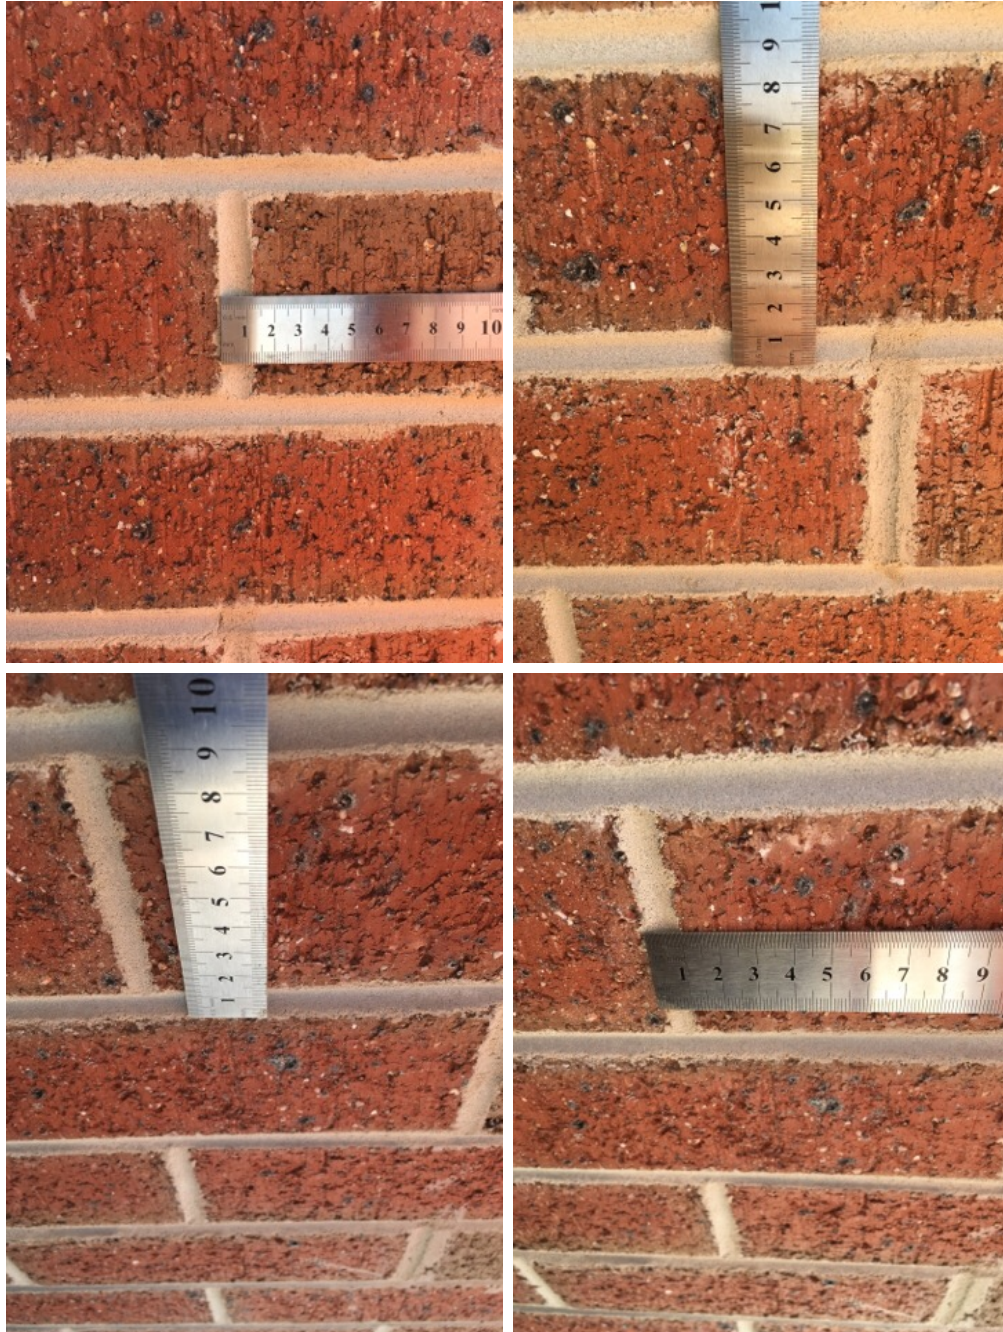
**Brick Mortar Thickness Horizontal  $\geq 3\text{mm}$  / Vertical  $\geq 5\text{mm}$**

Horizontal and vertical Mortar thickness appears adequate and reflects good workmanship

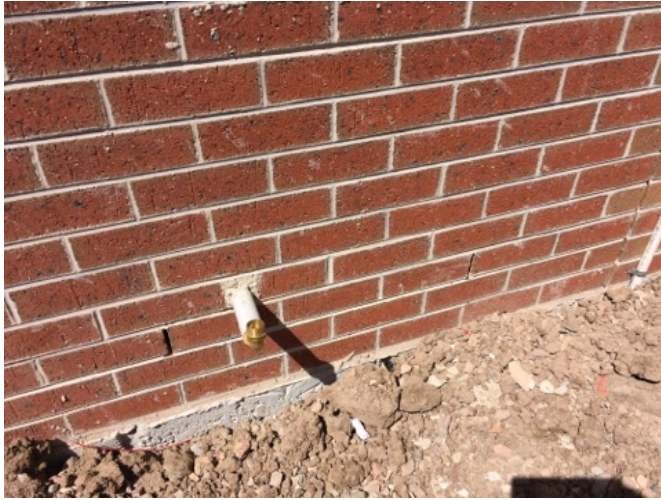
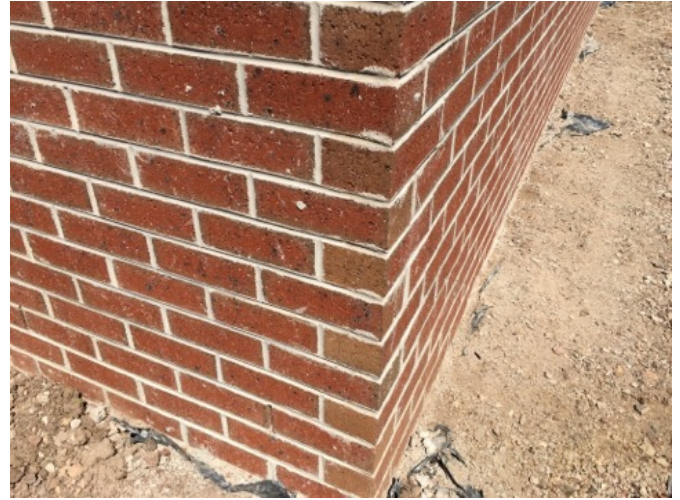
## Weep Holes

Weep holes have been correctly placed and reserved

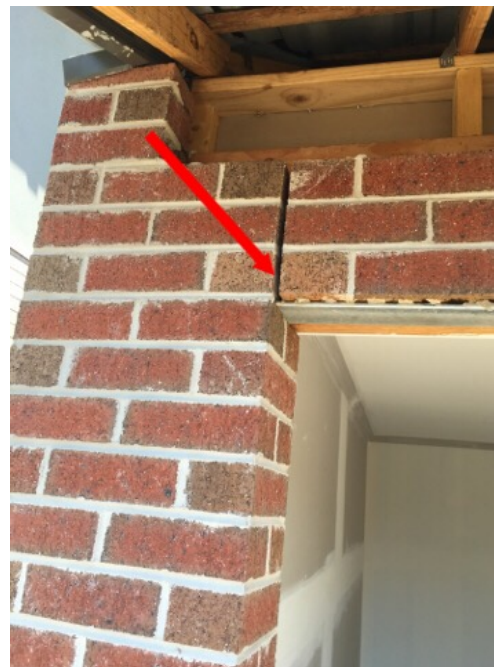
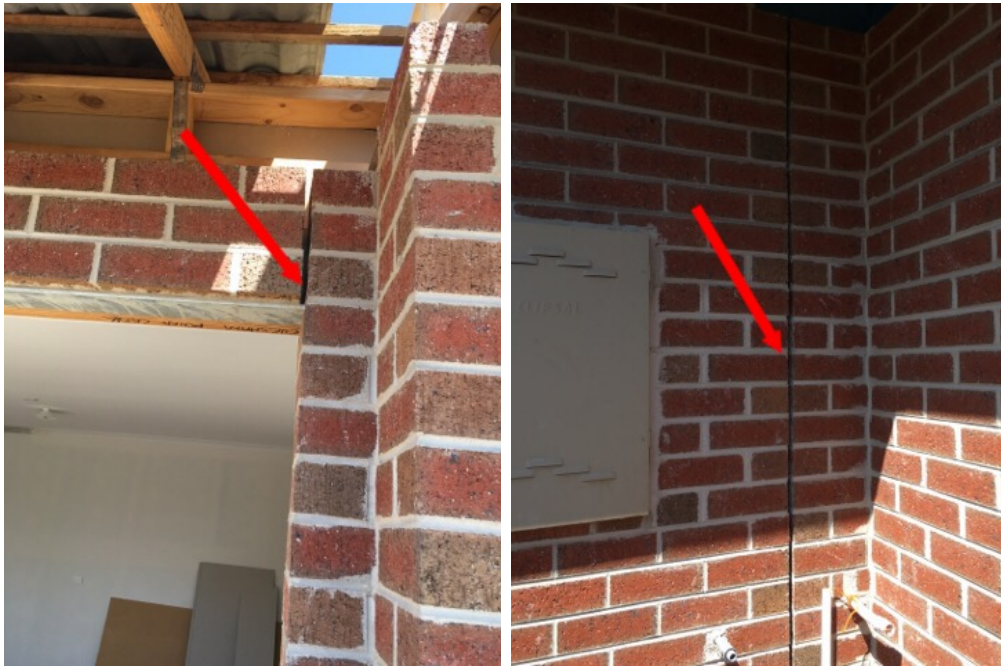
## Articulation Joints

Construction joints are not sealed and abflex must be inserted before caulking

Please refer to AS 4773.2, page 32, section 7.1, and the BCA for further details

All hard and incompressible substances (e.g., mortar dags) shall be removed from the gap in articulation and expansion joints.

All of the AJ's must be stripped, cleaned of all non-compressive material and then presented for inspection and only then sealed.

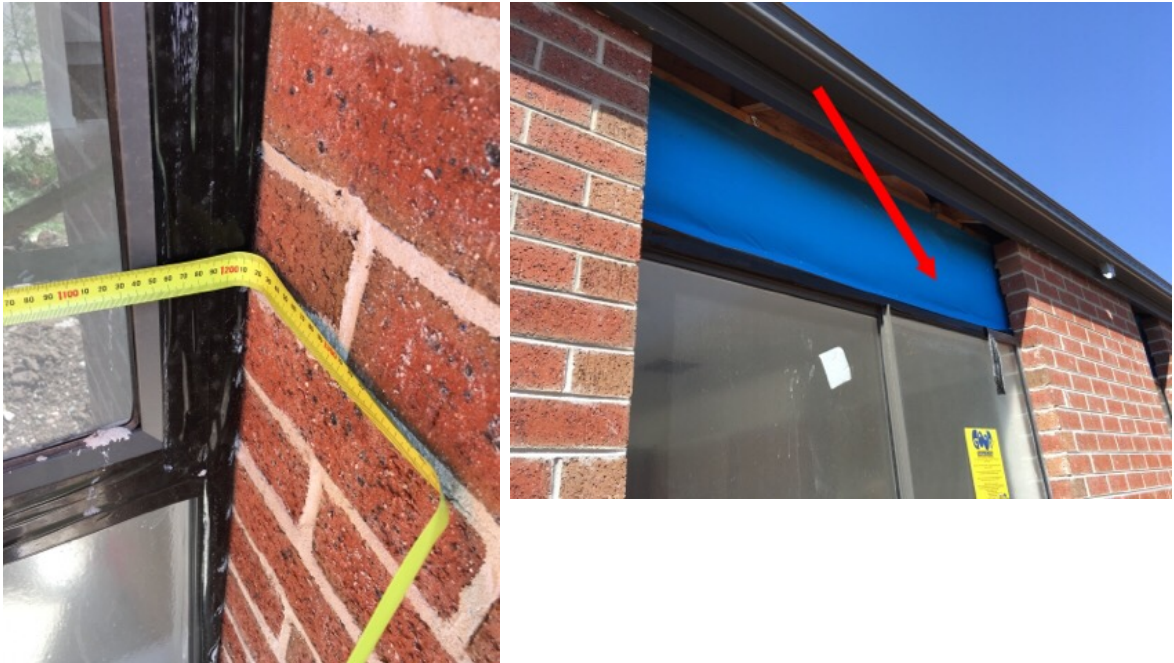
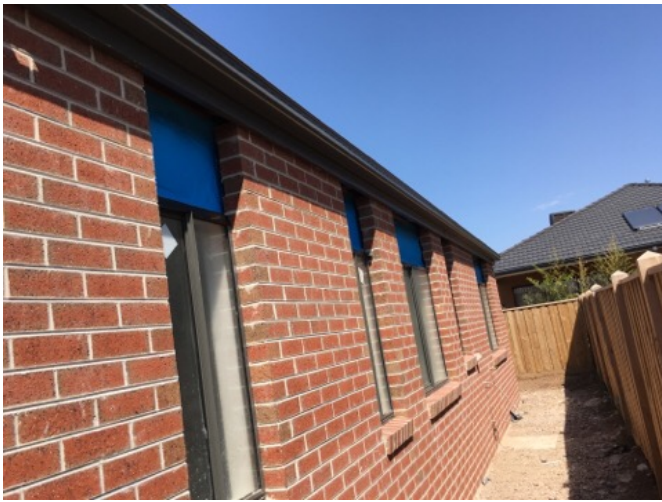
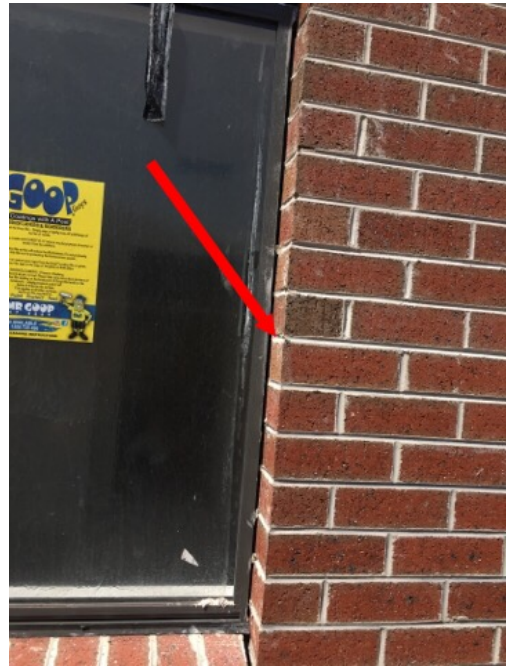
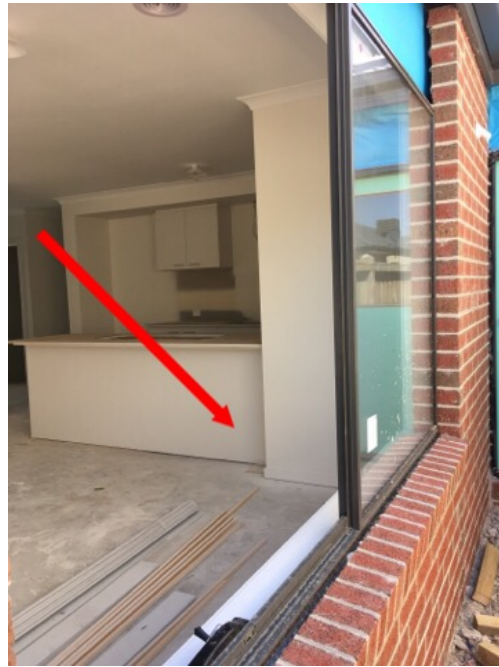
### Windows Installation

The window trimmer is missing and all the gap around window must be sealed  
Window glass is missing

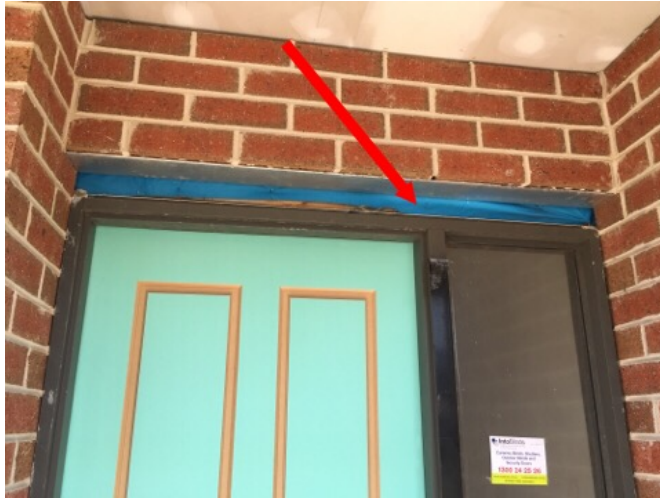
## Door Installation

The door trimmer is missing and all the gap around door must be sealed

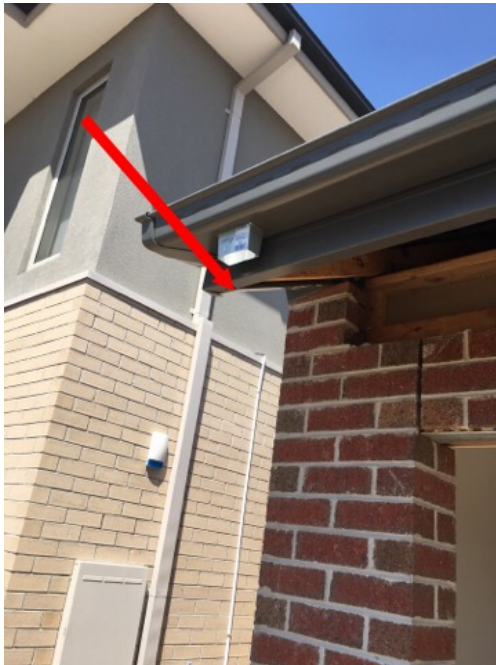
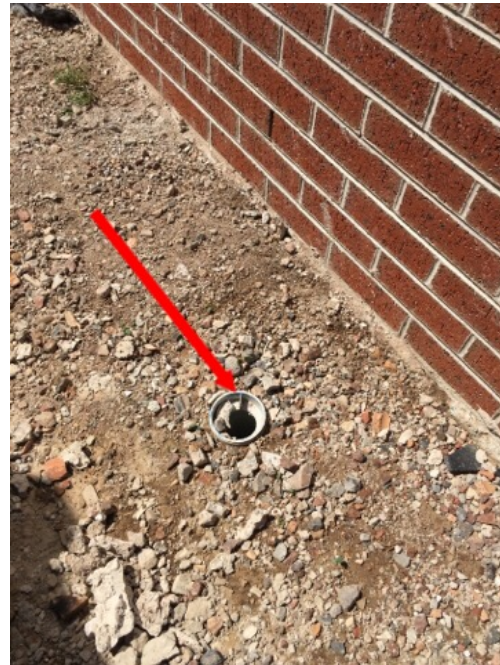
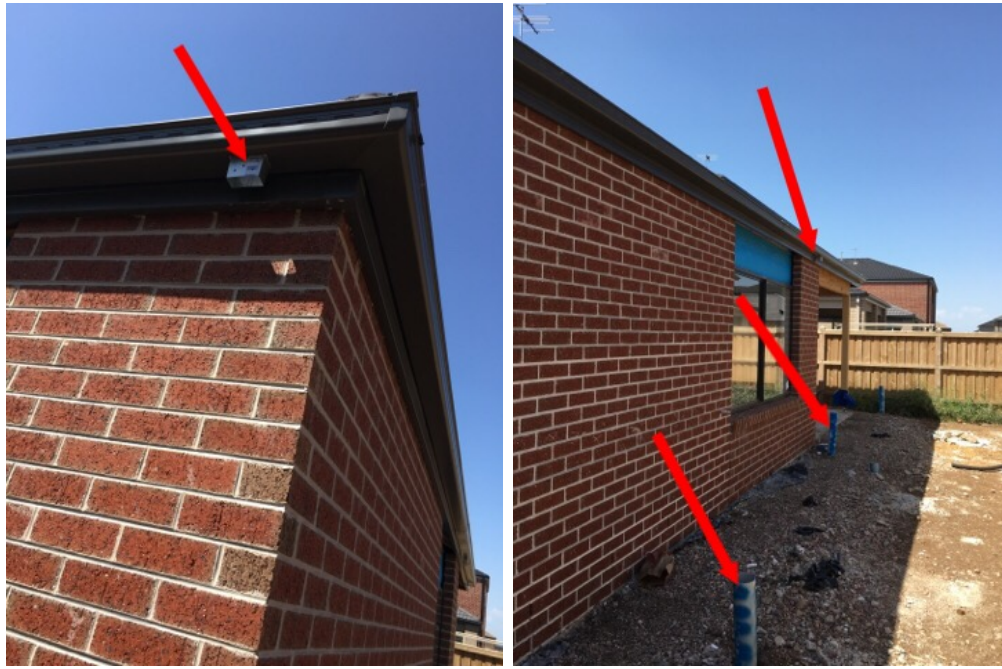
### Drainage and Sewer

BUILDING DEFECTS	Building Defects	Drainage and Sewer	No capping to the drainage pipes

Downpipe appears to be not connected during the inspection  
No capping to the drainage pipes

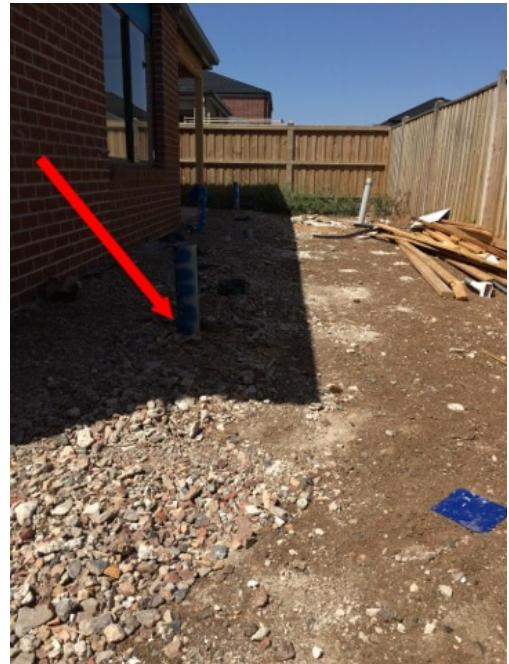
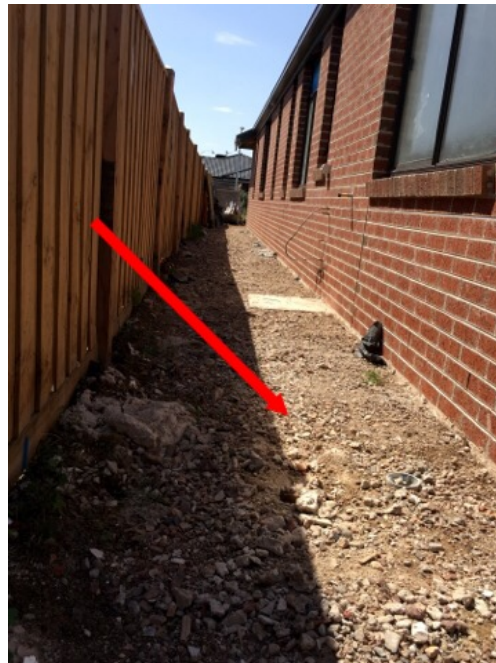
## Surface Water Drainage

The dwellings slab footings have the opportunity to pool with water due to the way the block has been cut and the lack of back filling.

Water management on site is paramount to ensuring that the foundations are not damaged. Water, when seeping down beside the slab, between the slab and the dirt softens the dirt. The soils capacity to withstand the downward pressure of the forces of the weight in the slab is greatly reduced. Hence slab failure occurs. It may not happen today or tomorrow, however poorly managed site water during construction is known to cause damage at a later date.

The BCA is very clear in its requirements to have the soil graded from the start away from the dwelling as a minimum of 50 mm over 1 m. This has not been done. Please refer to all of BCA, part 3.1.2.3.

Surface water drainage needs to be managed as soon as the roof is installed to stop the possibility of slab movement from the earliest stages of construction.
