Building Inspection Report

FANGS BUILDING INSPECTIONS

Lotxx Hutchence Drive, Point Cook, VIC, 3030

Inspection Date: 28 Feb 2019

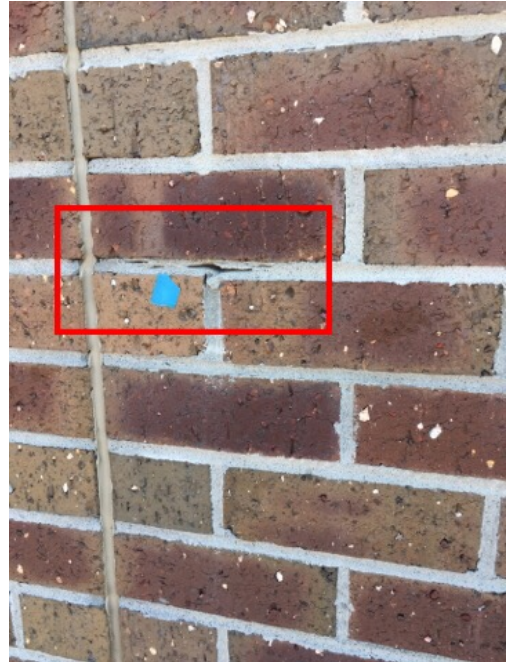
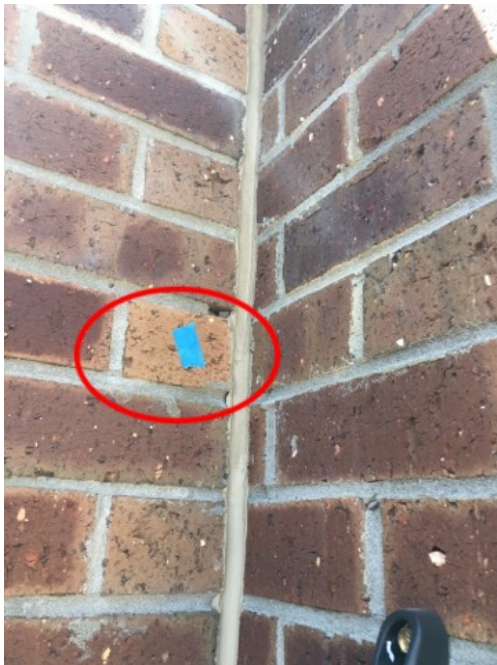
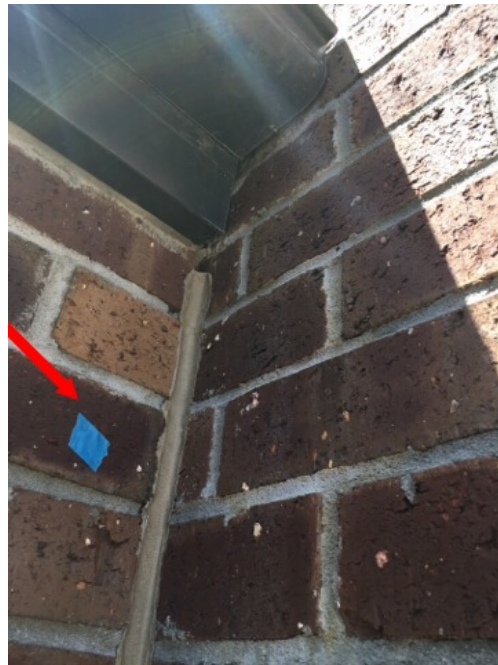
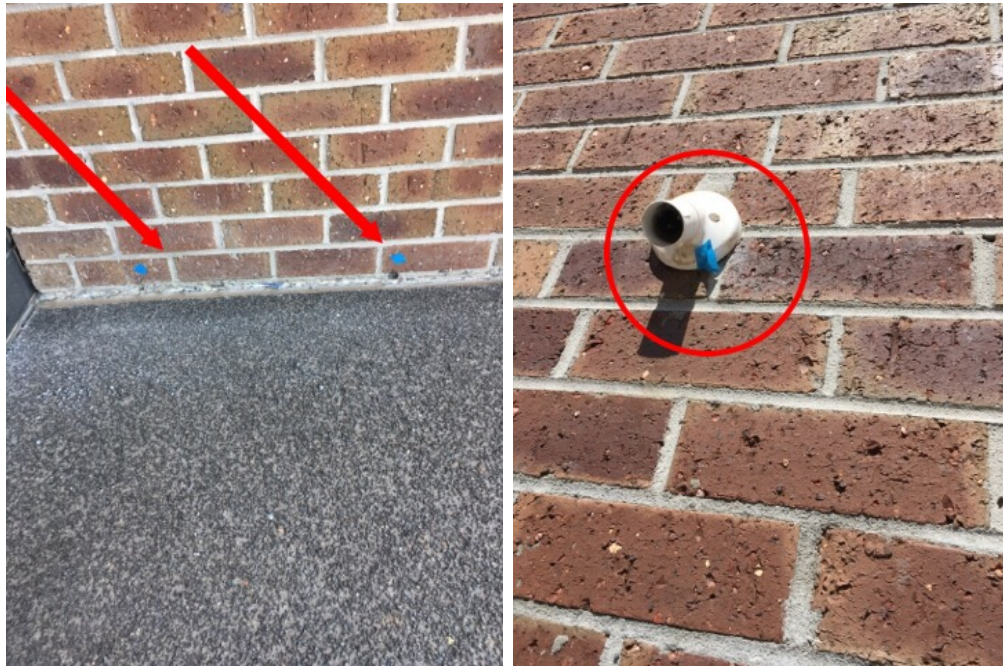
Condition

Poor laying or repair of brick work noted. We recommend you engage a brick layer for repairs.
Light glove missing

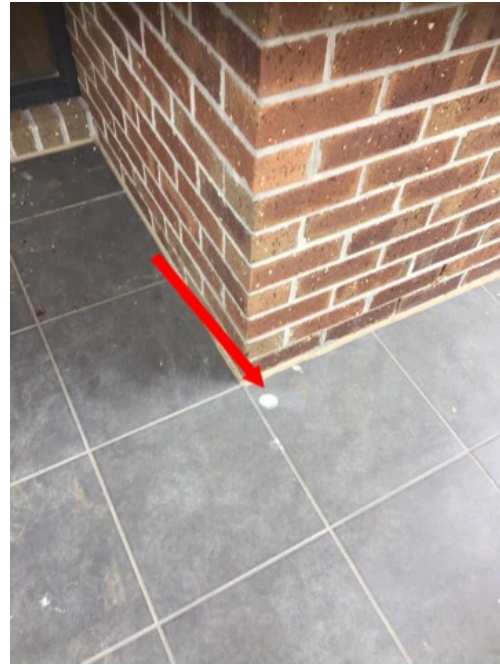
Base or Flooring Condition

Overpainted

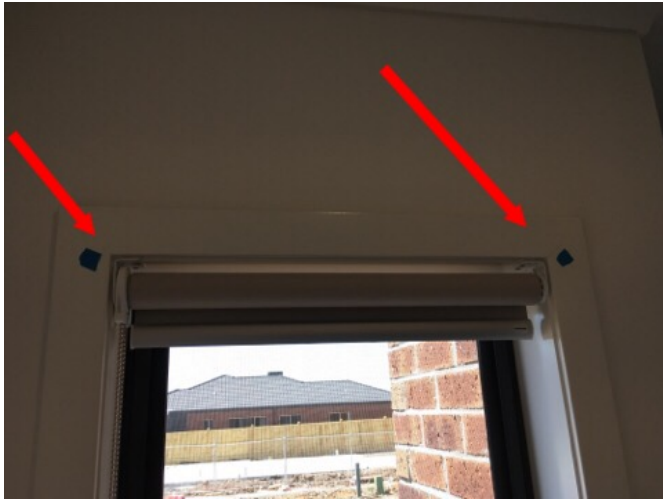
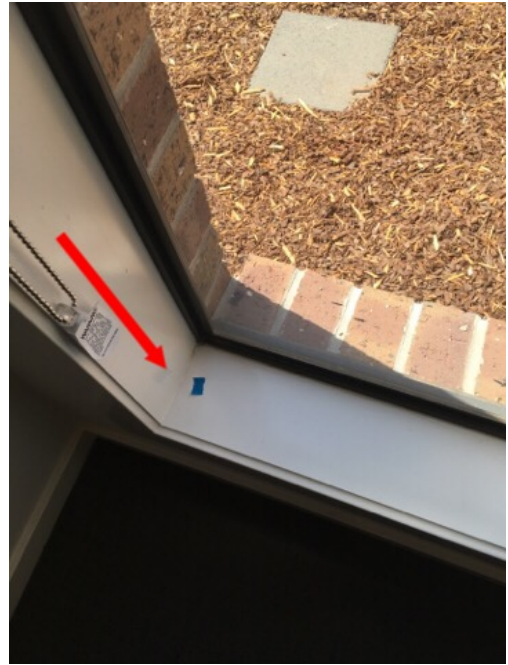
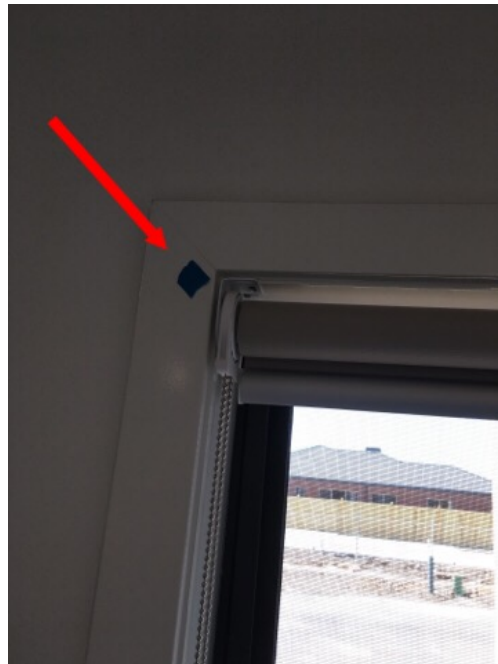
Paint Mark and Cracking Noted - Touch Up Will Satisfy

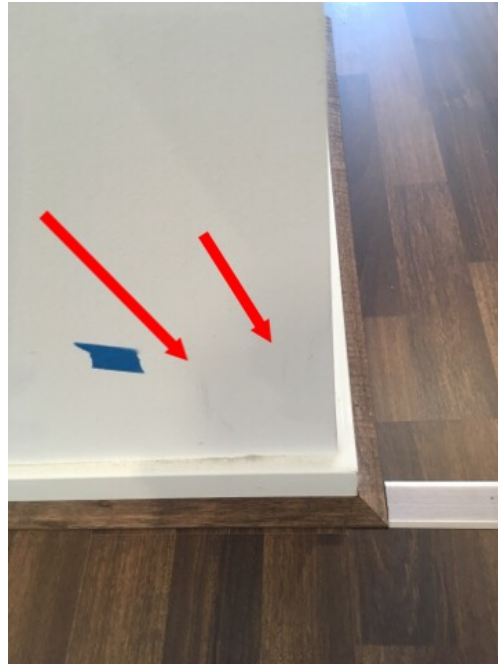
Minor Dent, Chips and Scratches Noted - Touch Up Will Satisfy

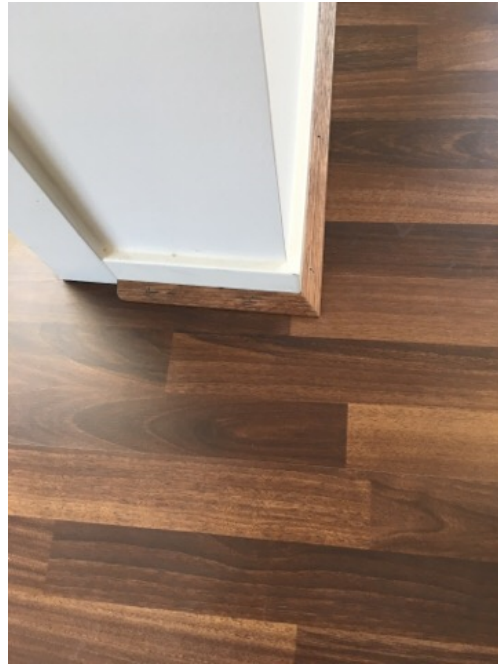
Paint Mark and Cracking Noted - Touch Up Will Satisfy

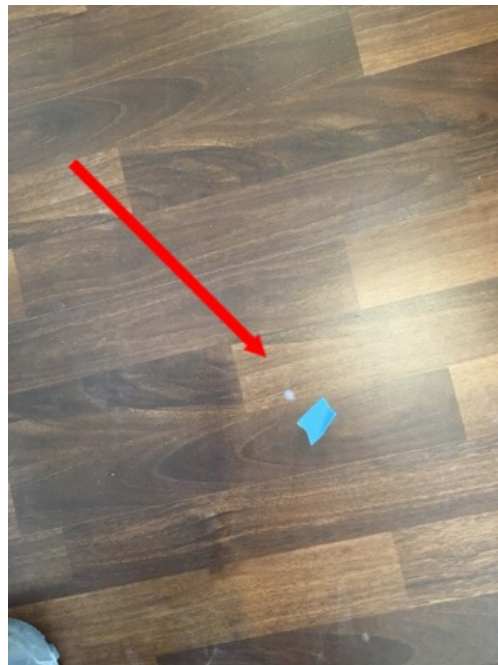
Paint Mark and Cracking Noted (Include Skirting) - Touch Up Will Satisfy

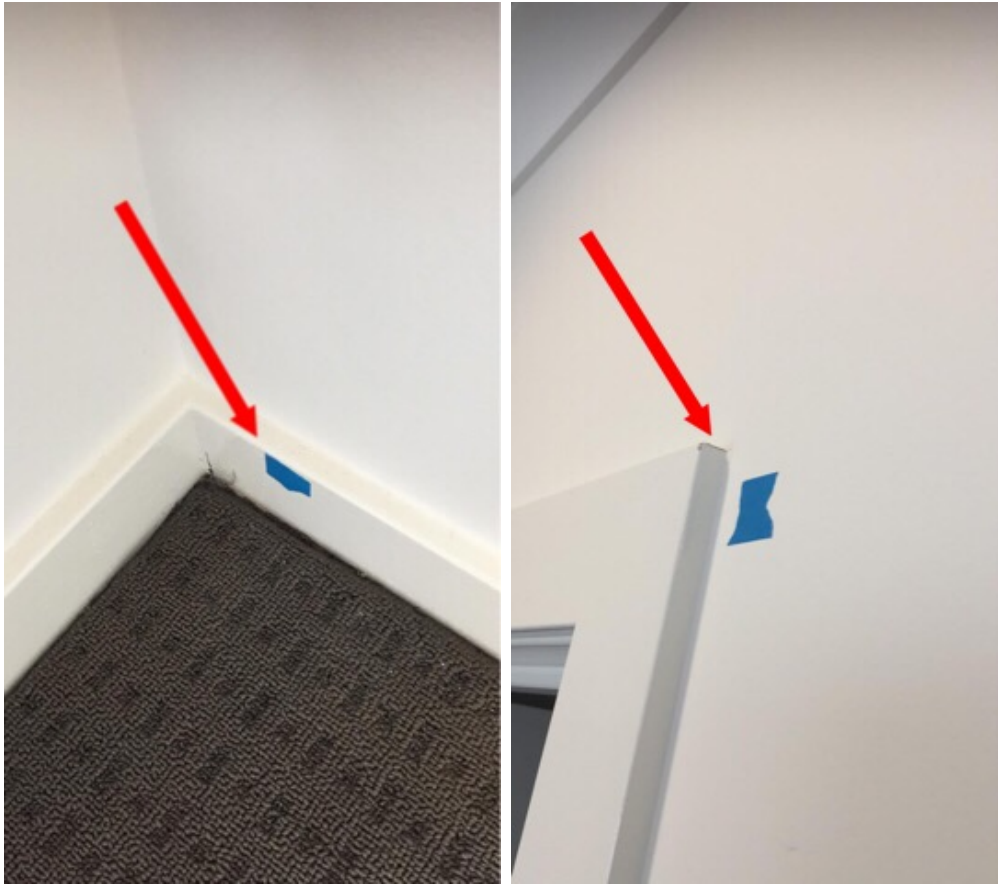
Minor Dent, Chips and Scratches Noted - Touch Up Will Satisfy

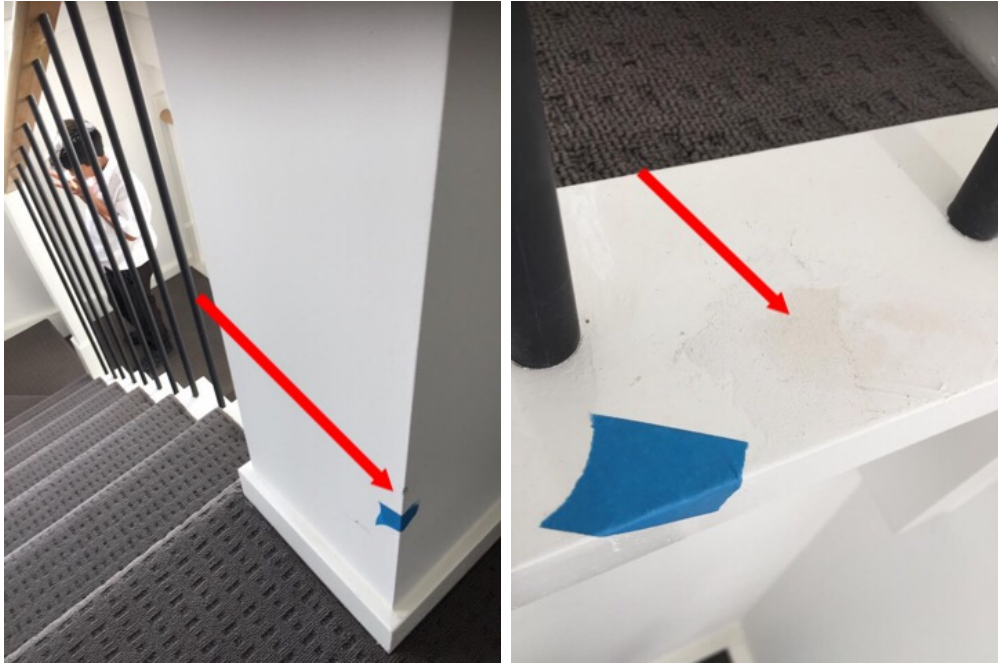
Internal Stair Case

Impact damage to wall noted. Patch and paint will generally suffice, however see a qualified plasterer for further advice

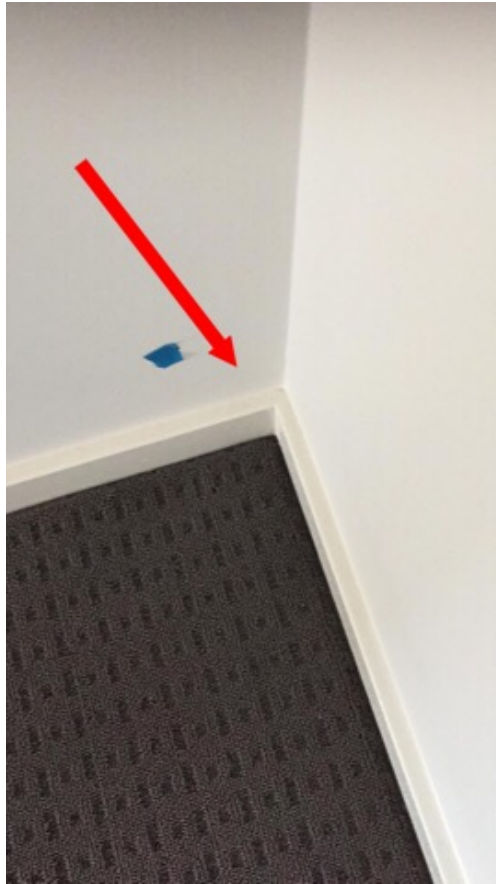
Minor Dent, Chips and Scratches Noted - Touch Up Will Satisfy

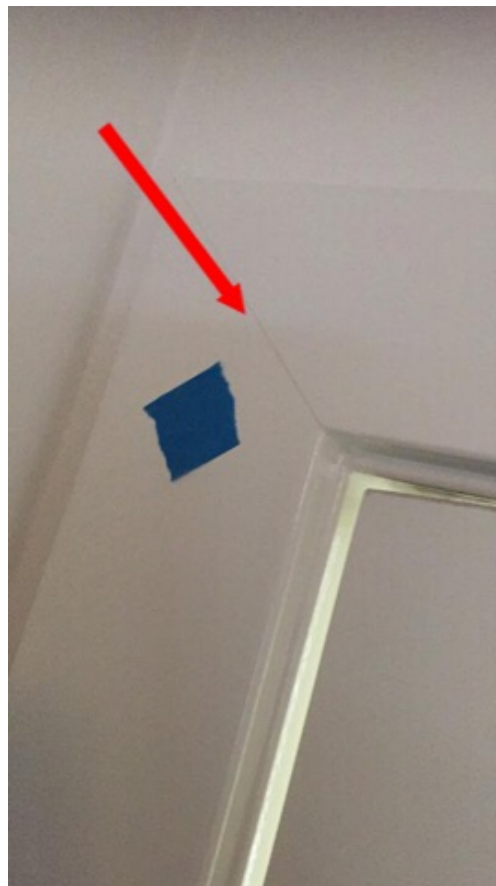
Minor Dent, Chips and Scratches Noted - Touch Up Will Satisfy

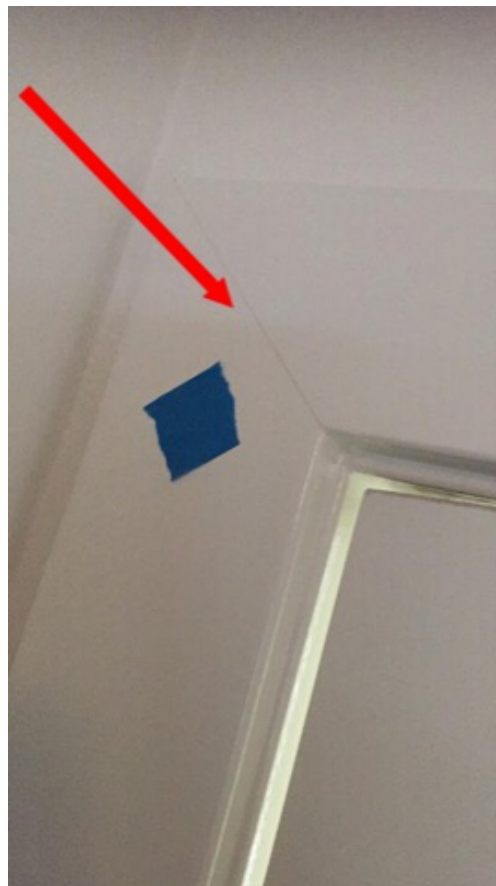
Paint Mark and Cracking Noted - Touch Up Will Satisfy

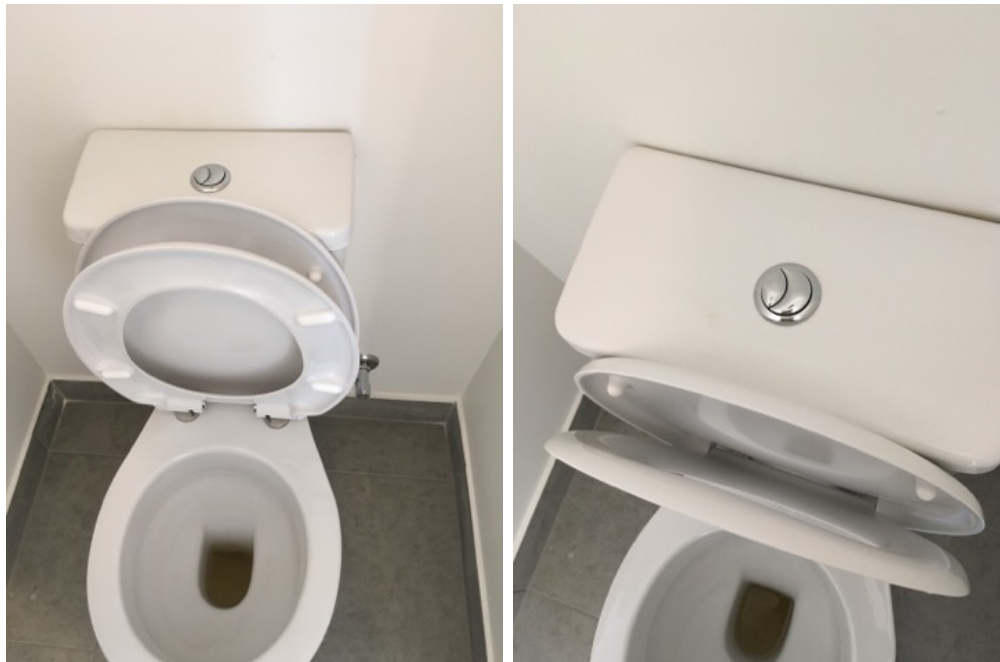
Pan is loose at the base. Contact a licensed plumber for repairs.
Toilet seat needs to be fixed

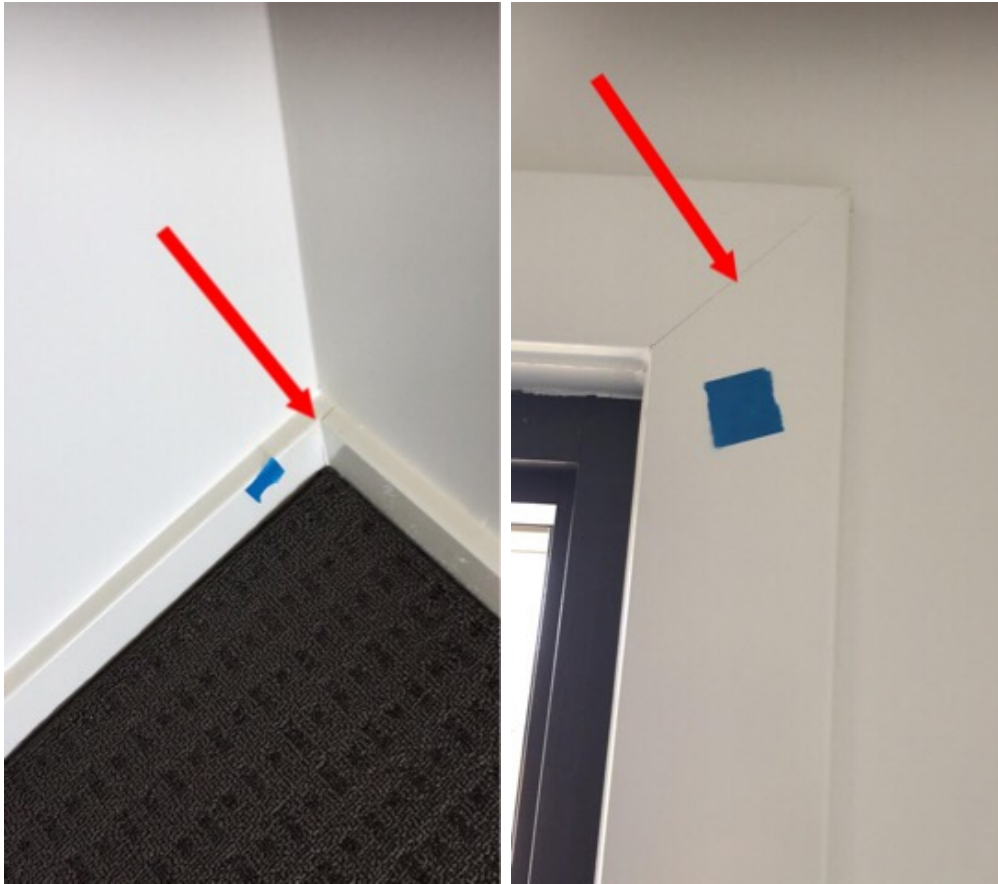
Minor Dent, Chips and Scratches Noted - Touch Up Will Satisfy

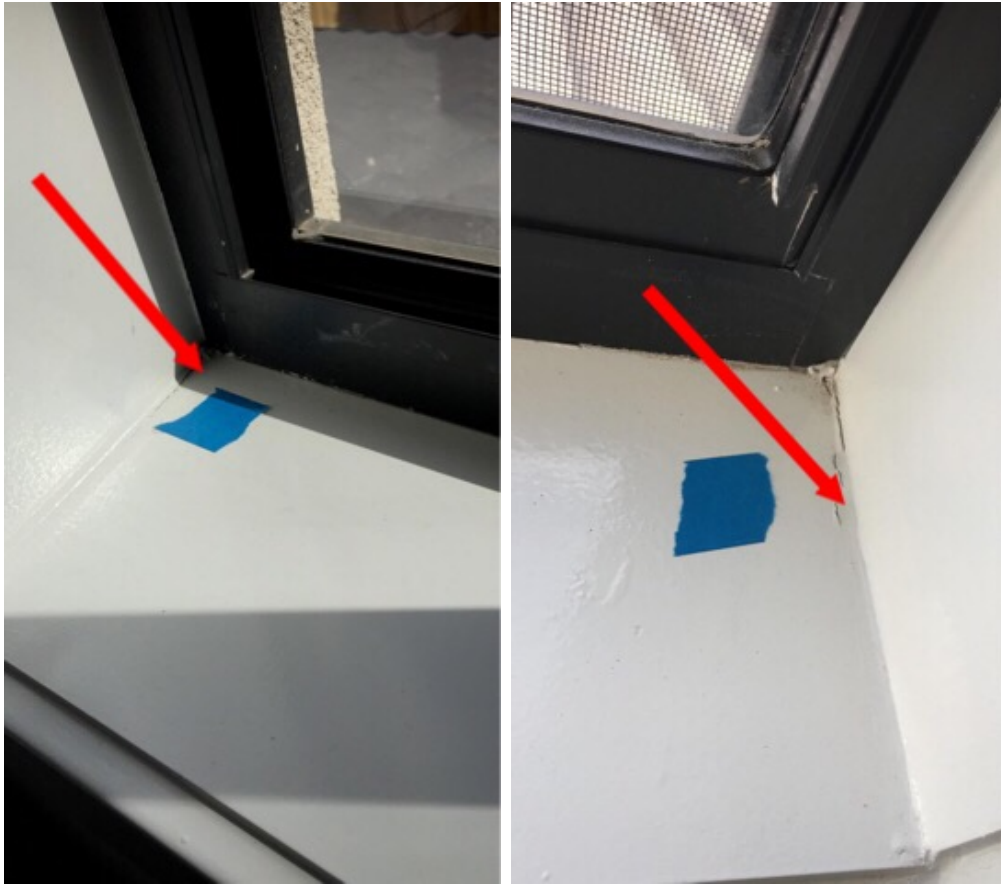
Paint Mark and Cracking Noted (Include Skirting) - Touch Up Will Satisfy

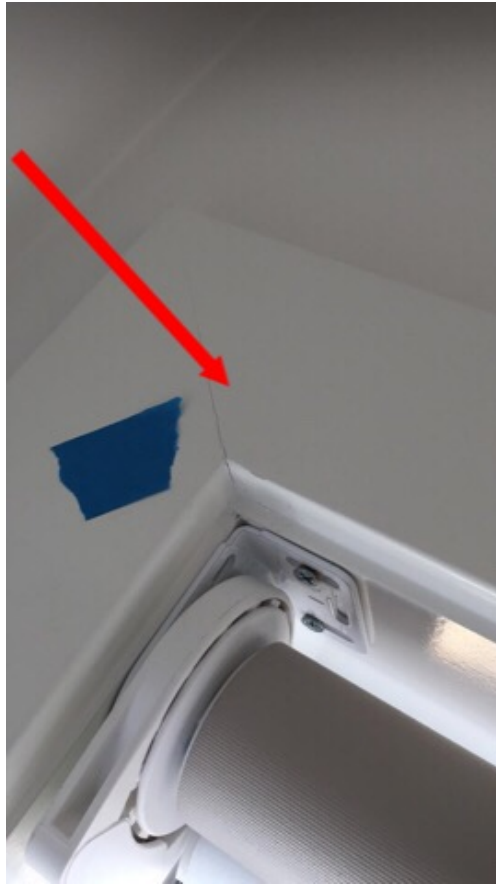
Paint Mark and Cracking Noted (Include Skirting) - Touch Up Will Satisfy

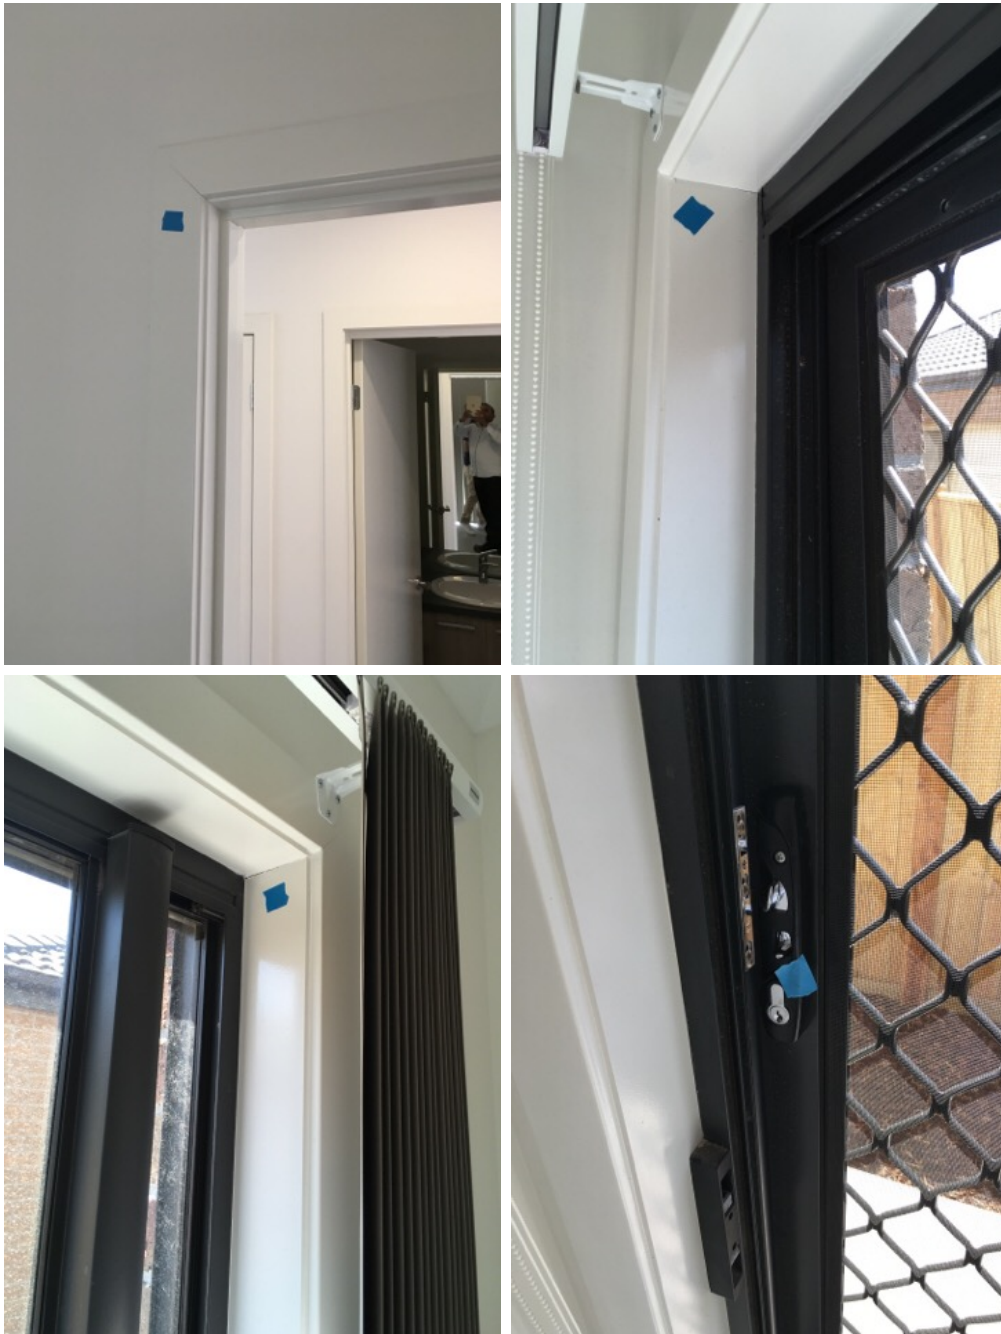
Paint Mark and Cracking Noted - Touch Up Will Satisfy

The laundry door lock is damaged - Recommendations: A locksmith should be engaged for repairs
