# Building Inspection Report

FANGS BUILDING INSPECTIONS

**Lotxx Fogarty Street Williams Landing , VIC**

Report/Agreement #    270219031831

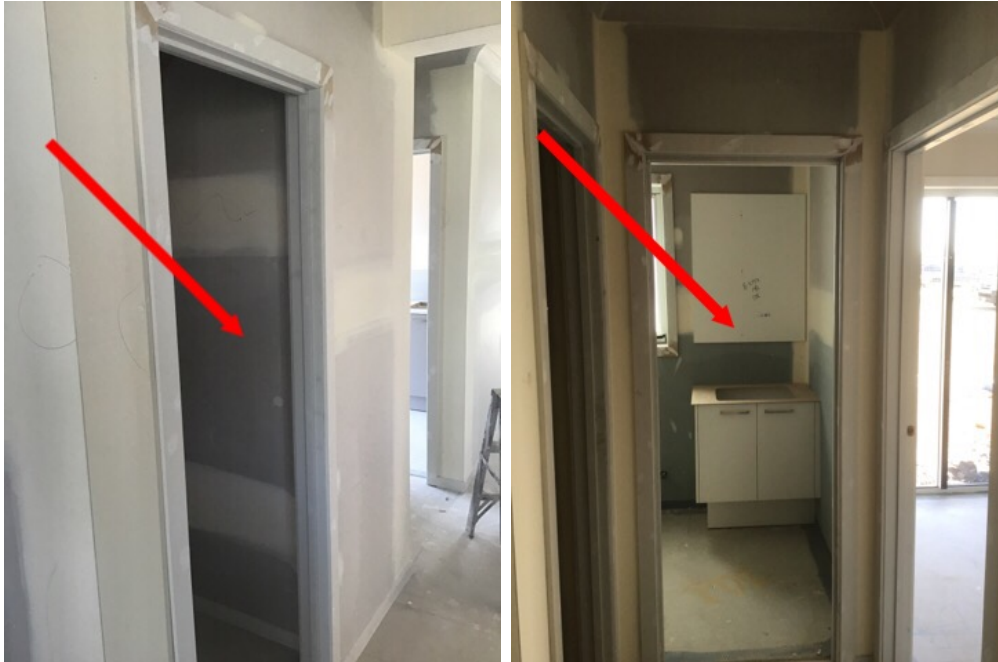
#### **Internal Door Clearance (To Frame Between 2-5mm, To Floor $\leq$ 20mm, Clearance Uniform)**

Door has not been installed during inspection

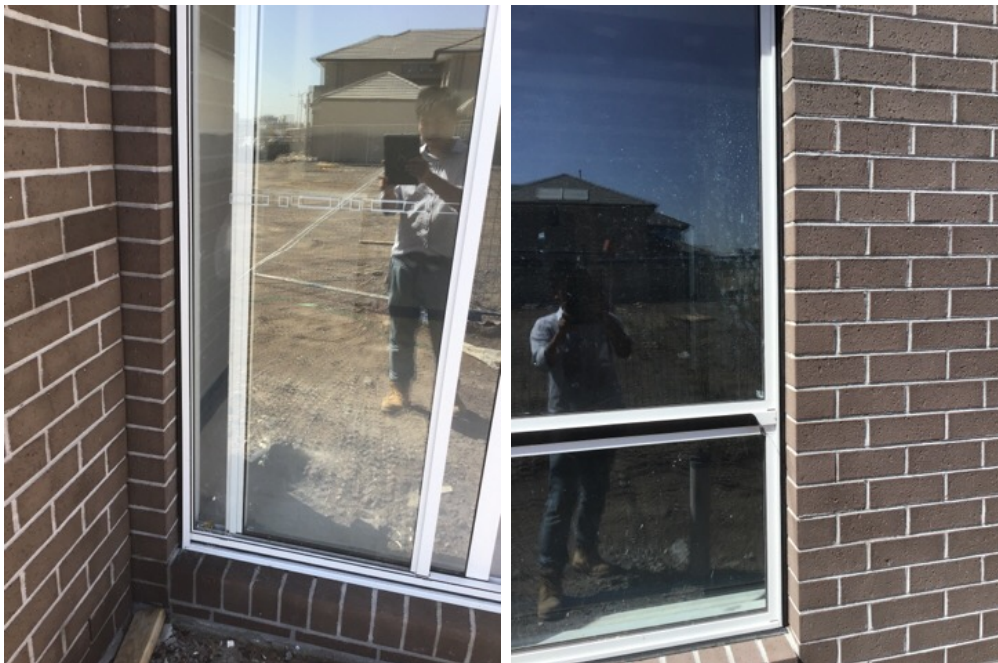
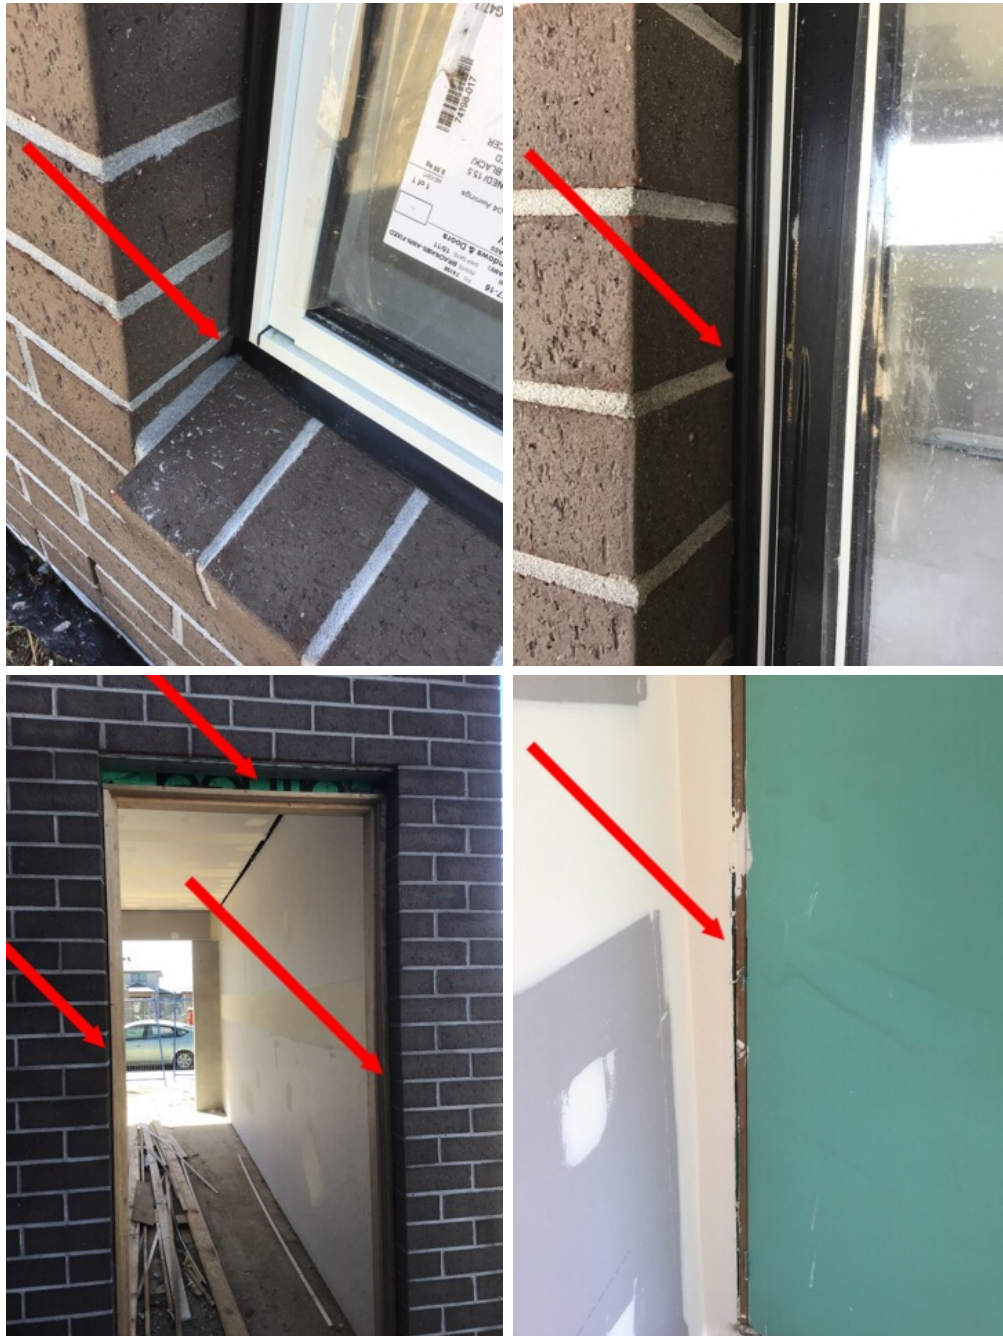
#### **Sealing of Door and Window Edges**

Gap noted

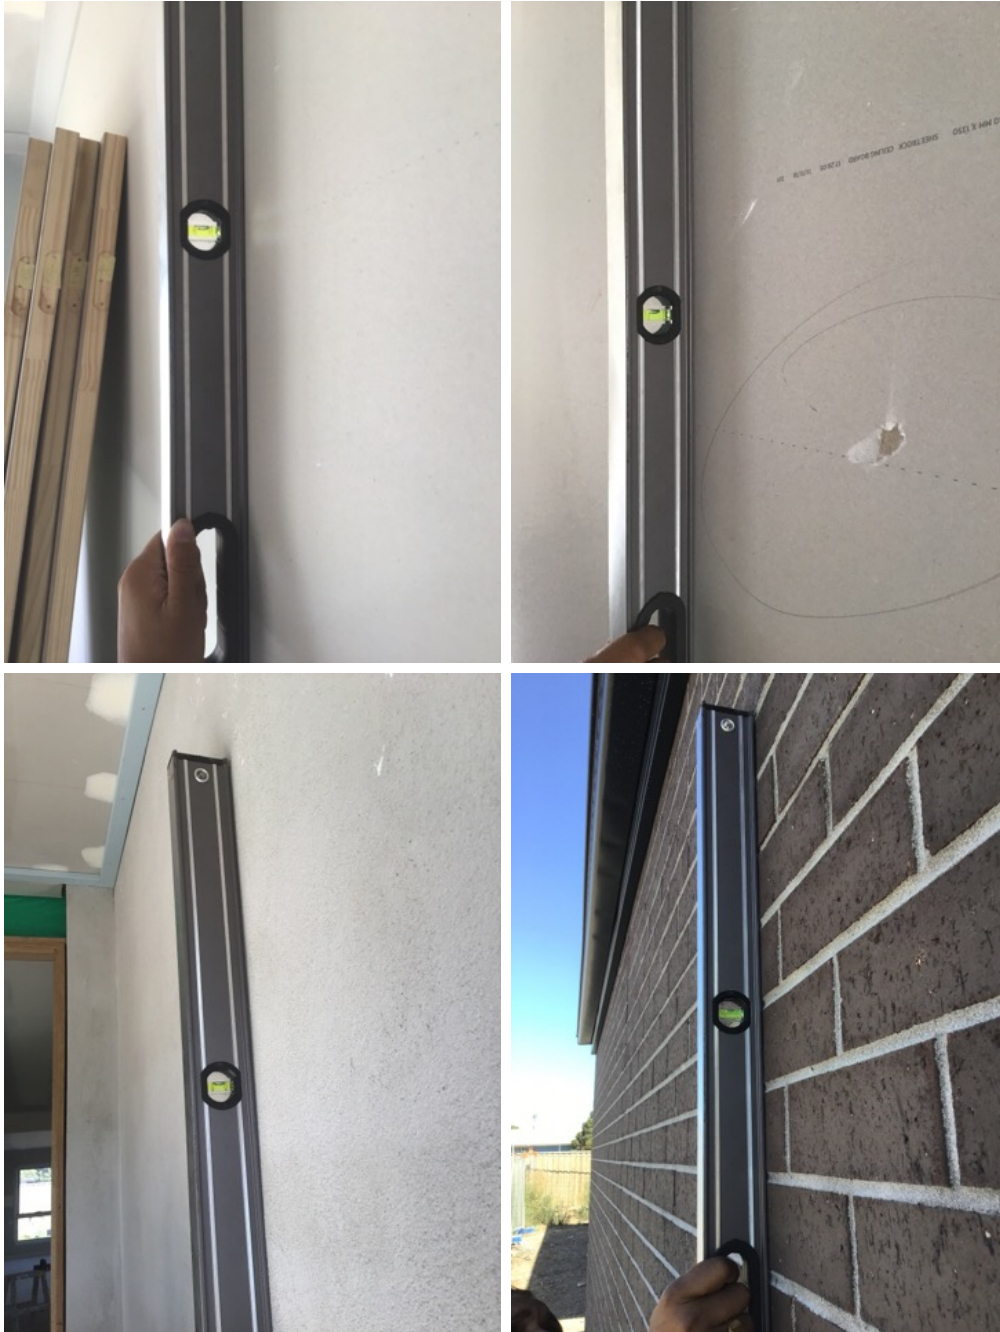
**Internal or External Walls Deviates > 5 mm Over Every 1.8 m**

Vertical-ness or plumbness of internal and external wall surfaces are no more than 5mm within 1.8m as per Standards and tolerance 2015 9.01

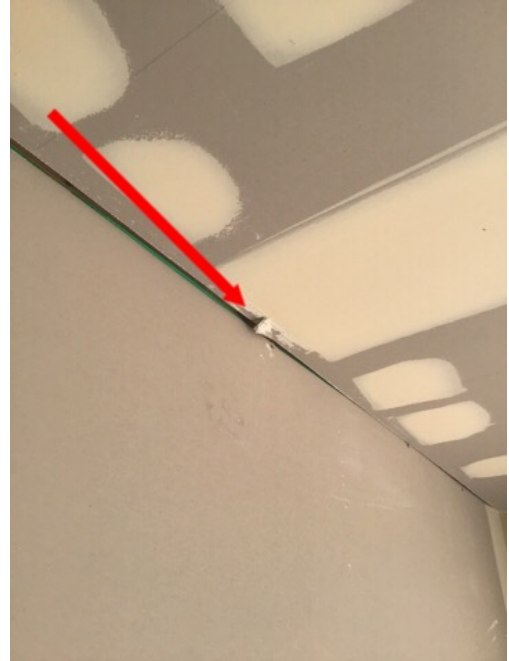
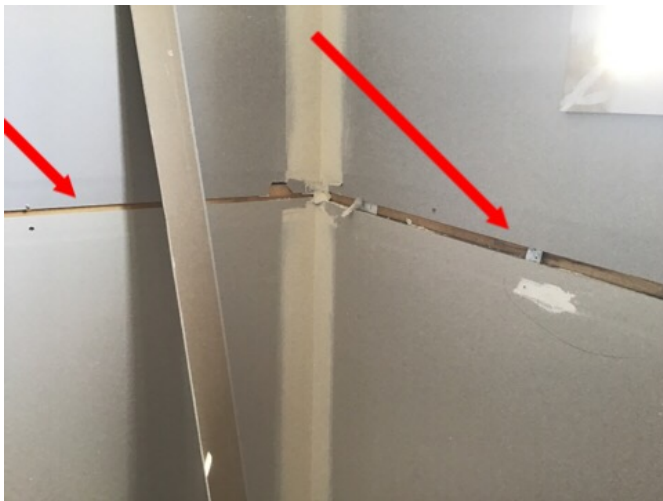
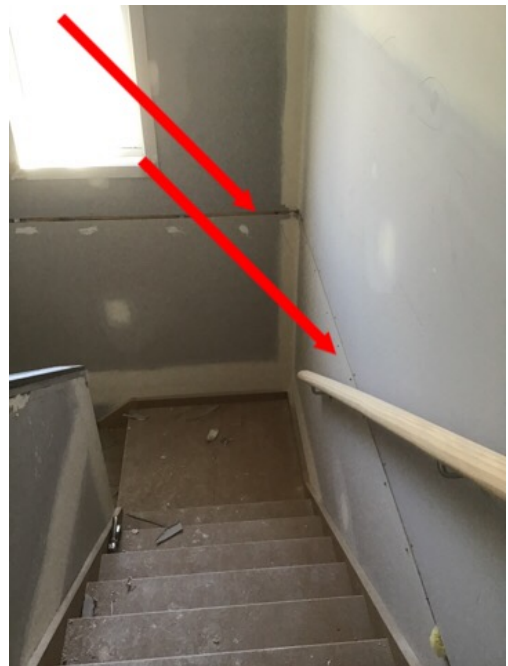
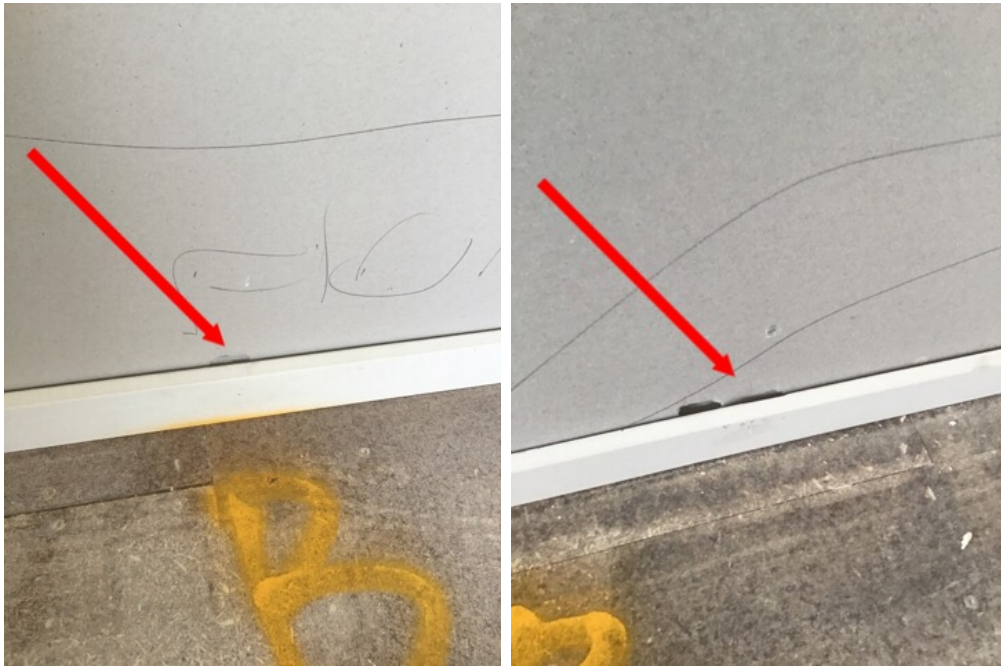
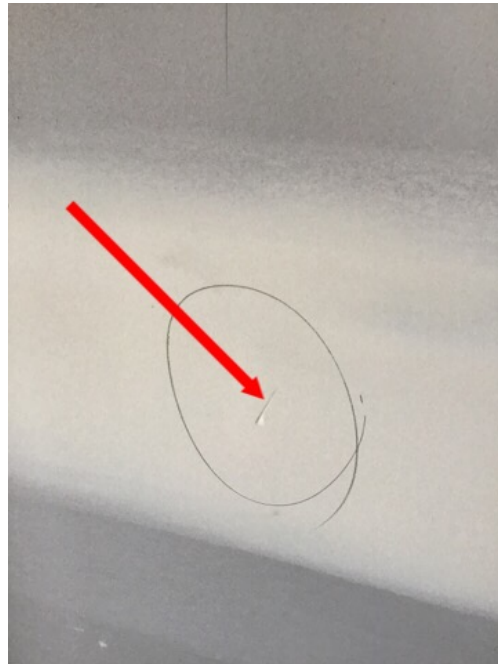
### **Cracking in Plaster Observed Width > 1mm**

Minor crackings observed from the referred area exceed 1mm over the tolerance. Default finish level as level 4. Cracking in walls, ceilings and bulkheads is defective if it exists at handover or exceeds 1 mm in width within the first 24 months of completion and can be seen from a normal viewing position As per Standards and tolerance 2015 9.14

Cracking in recessed and butt joints is defective if it exists at handover or exceeds

1 mm in width within the first 24 months of completion and can be seen from a normal viewing position.

Incomplete noted

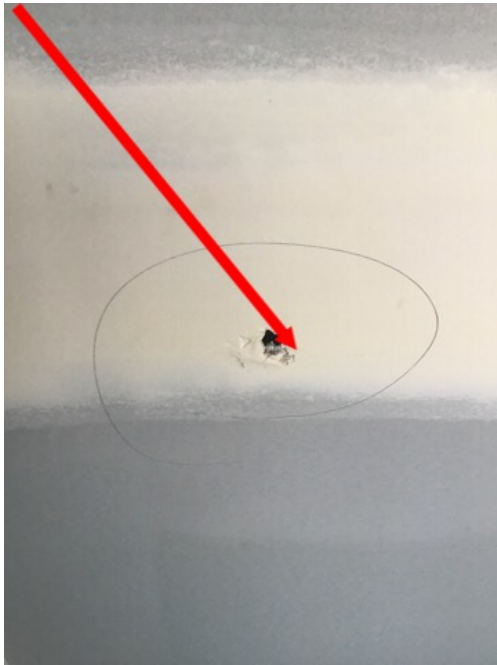
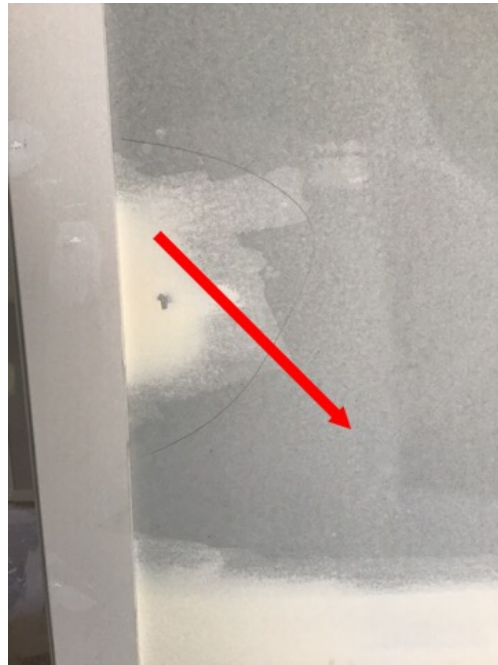
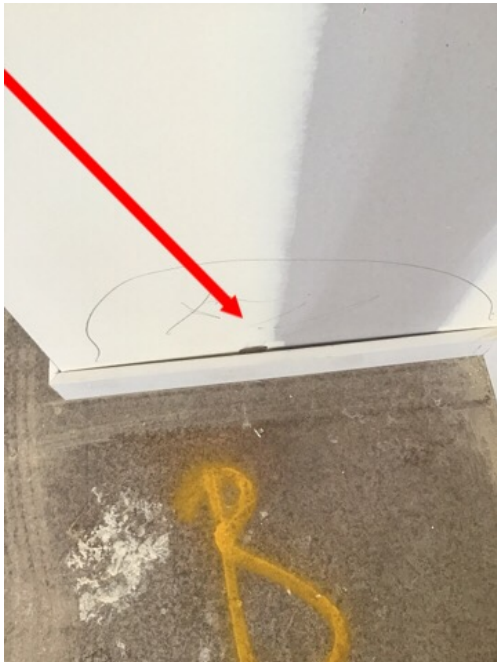
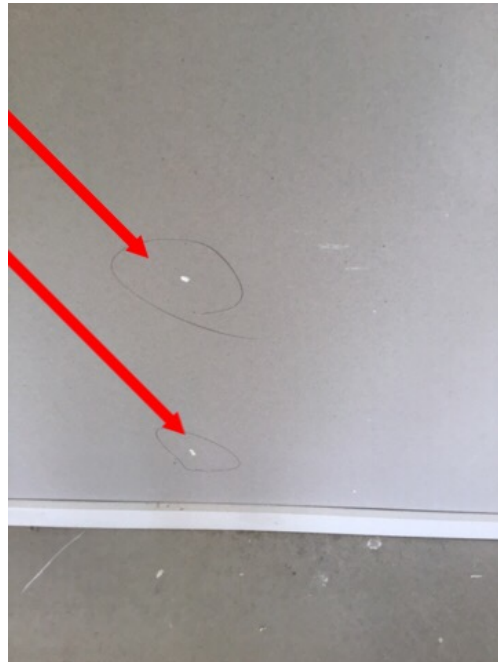
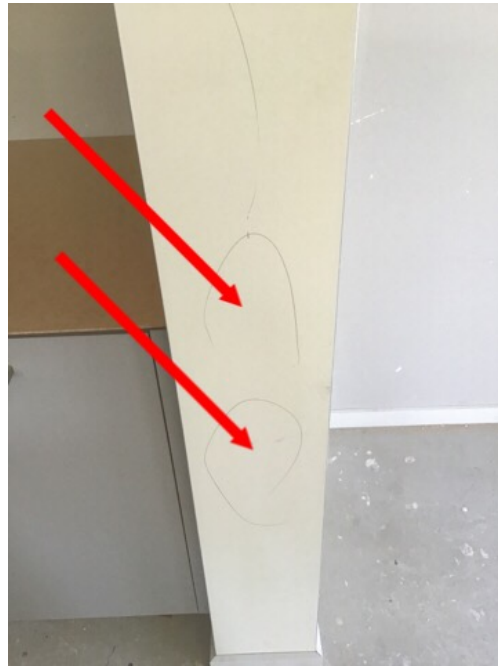
**Cracking in Plaster Observed**

Dent on plaster wall noted

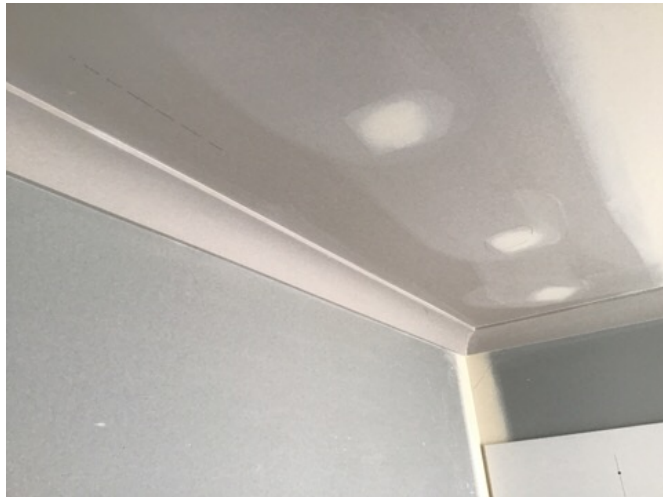
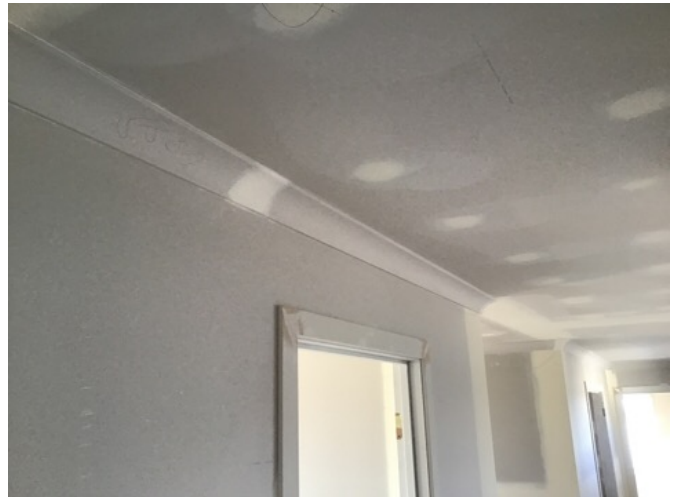
### **Straightness and Alignment of Plaster Cornices > 4mm for a 2m Distance**

Straightness and alignment of plaster cornices are no more than 4mm within 2m as per Standards and tolerance 2015 9.17

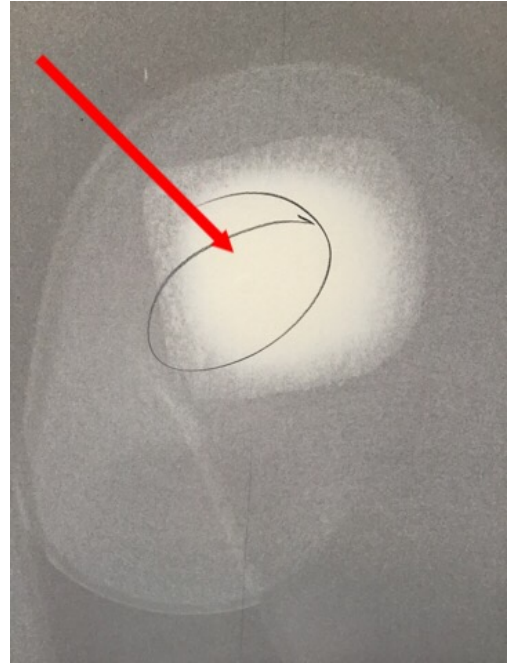
### **Nails Popping on Surface**

The referred area has nail popping issue.

Nail popping in sheeting is defective if it exists at handover or occurs within the first 24 months of completion and can be seen from a normal viewing position as per Standards and tolerance 2015 9.19

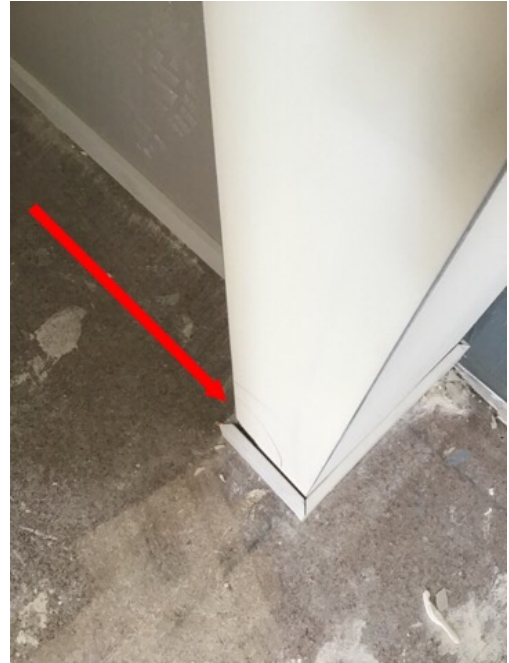
**Gaps > 2mm wide Among Internal Fixing Work**

It is noted that there are gaps associated with internal fixing over 2mm during the time of inspection. It is defective as per Standards and tolerance 2015 10.01

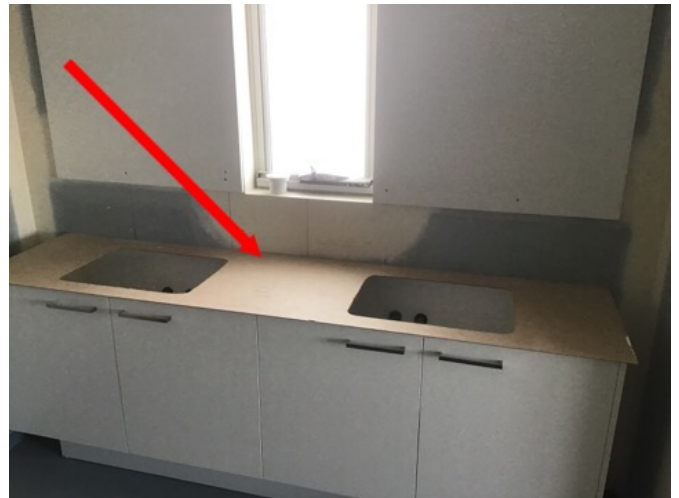
**Bench Sealing**

The referred area must be sealed.

Incomplete noted

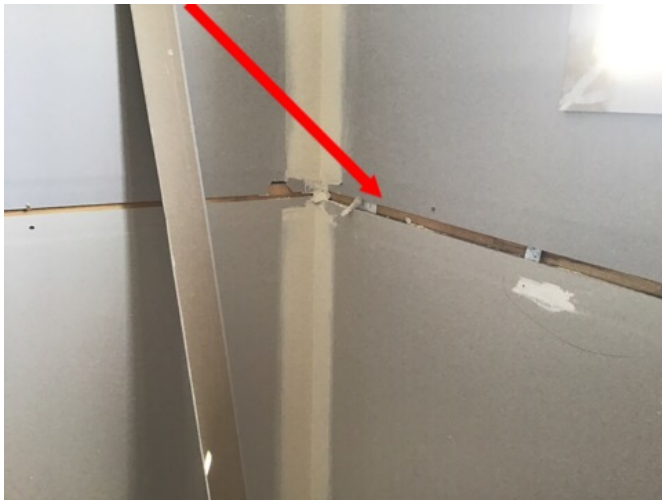
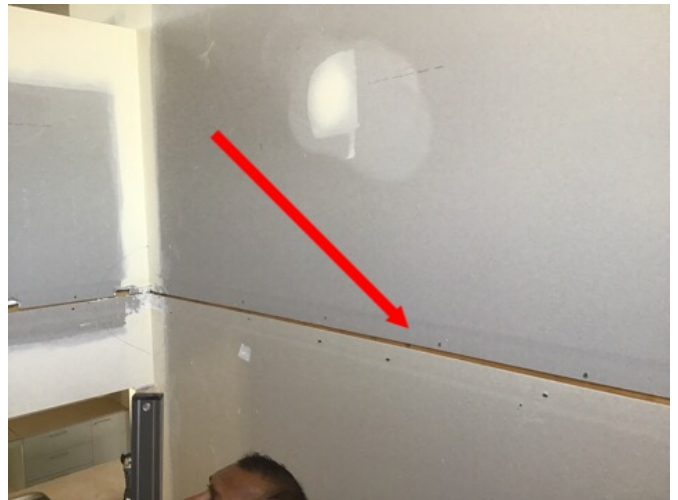
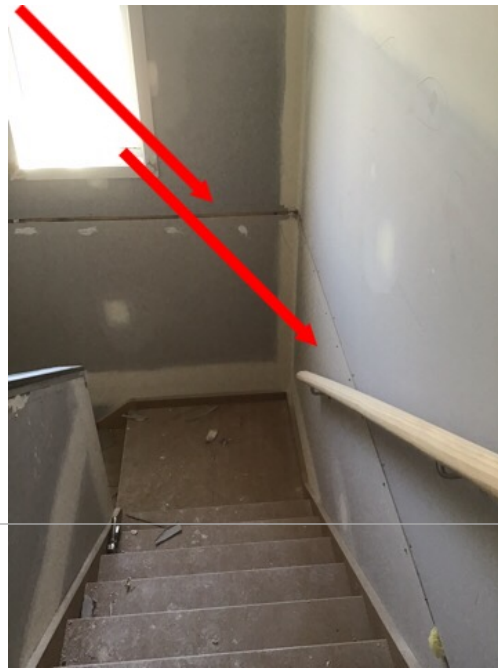
### Staircase

Plaster work incomplete noted

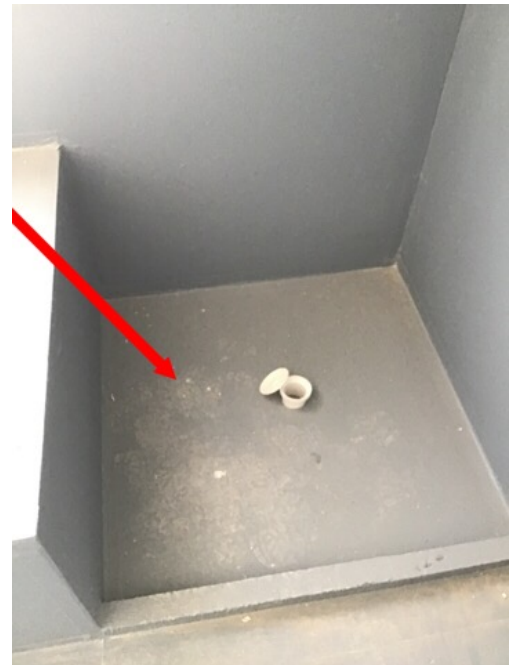
## Fall in Floor Finish Shower Space Requirement 1:80 Minimum

Fall in floor finish does not meet 1:100 in shower space requirement as per AS3740, for the shower space without hob or water stop must meet 1:80 minimum

As a minimum for other shower areas, the fall shall be a minimum of 1:80.

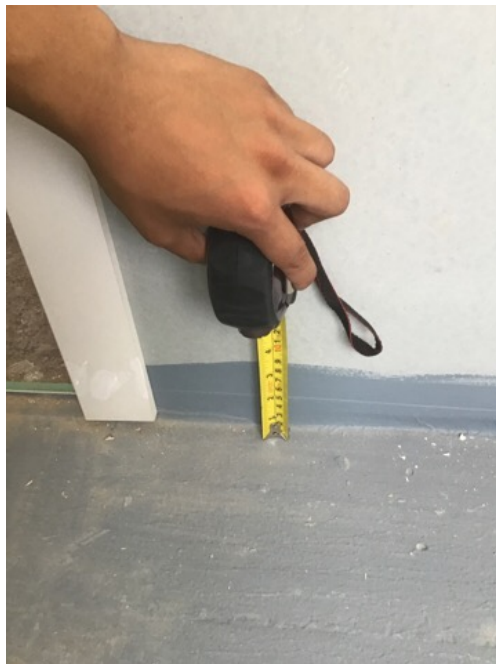
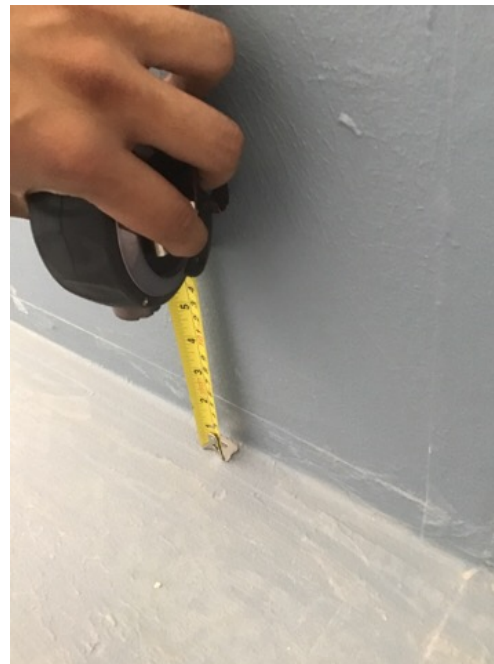
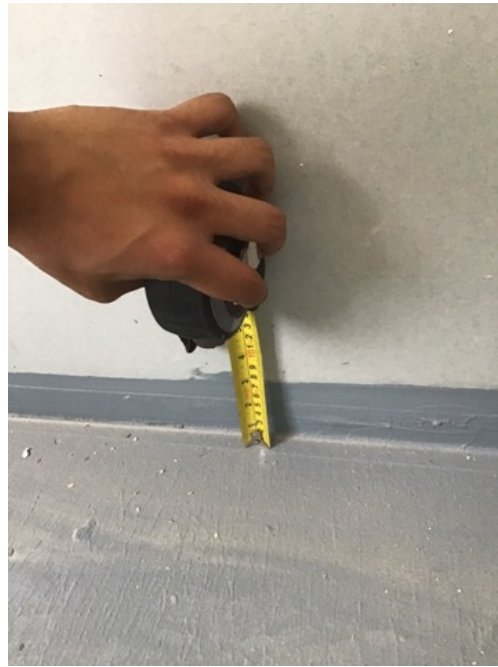
## Perimeter Flashing Installation NOT Correct - Minimum 25mm Vertically Above Floor or 50mm Across Doorway

Perimeter flashing to wall/floor surfaces continuously sealed to the horizontal surface and have a vertical leg of a minimum of 25 mm above the finished floor level and the horizontal leg meet minimum width of 50 mm

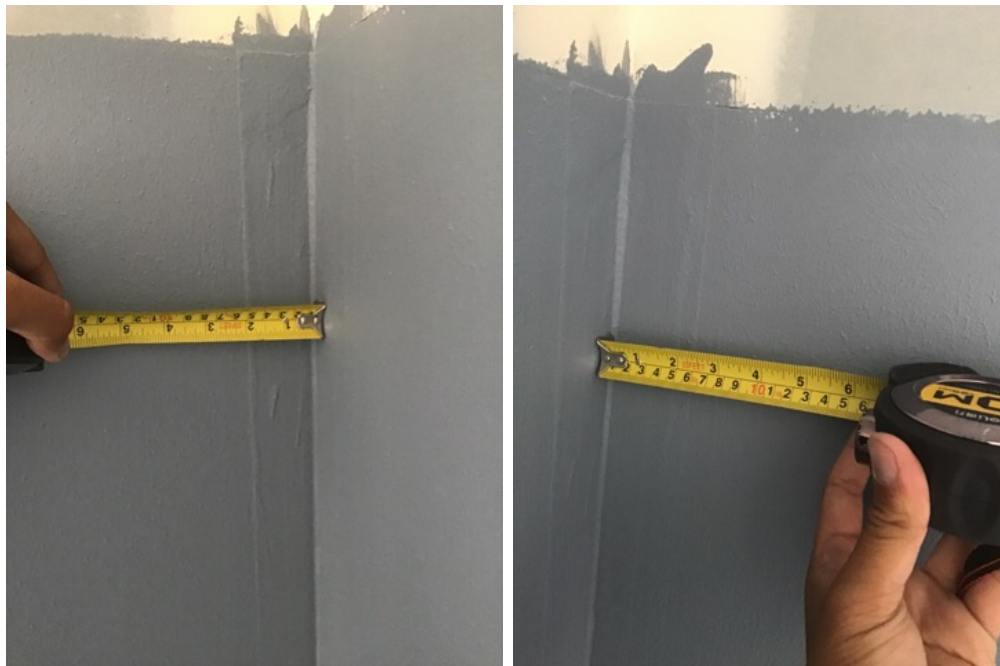
**Vertical Flashing Installation NOT Correct - Minimum 40mm Overlap to Wall Sheeting or Render**

Internal vertical flashing each leg meet the minimum overlap of 40 mm to the wall sheeting or render

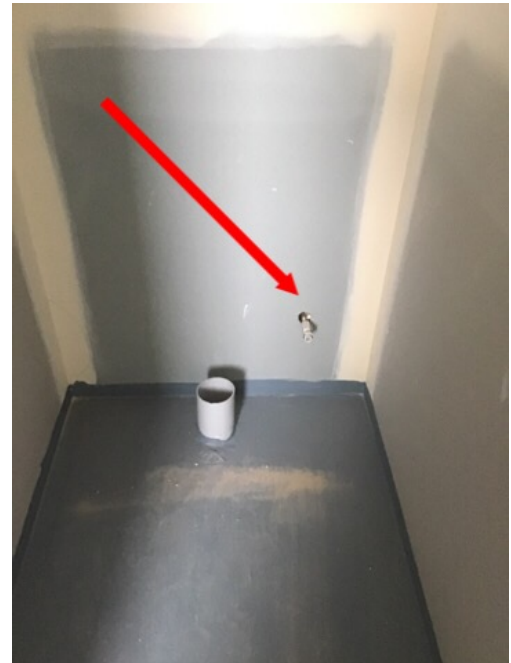
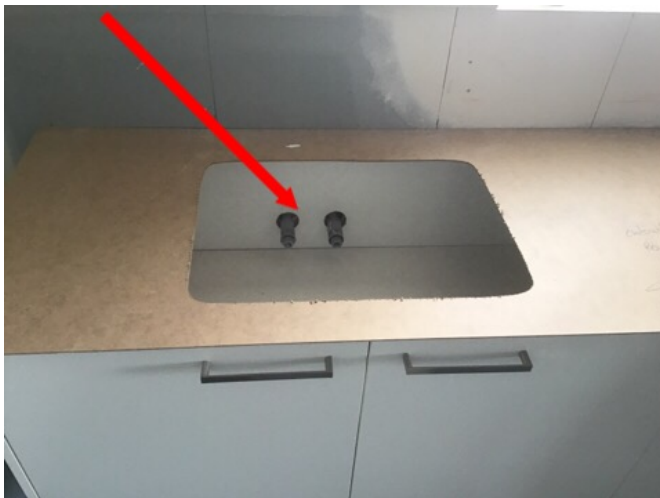
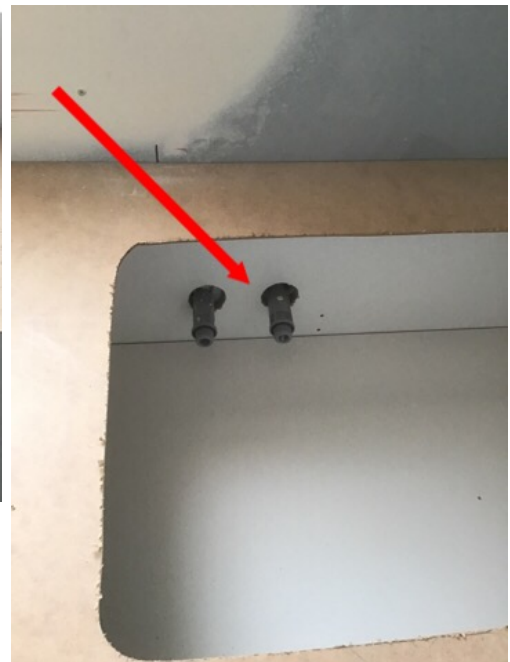
**Waterproofing of Penetrations for Taps and Fixtures**

Penetrations for taps, shower nozzles, recessed soap holders and similar fixtures has not been waterproofed well by sealing with proprietary flange systems or a sealant. When sealing the tap body to the wall, allowance shall be made for the servicing of tap washers or ceramic disks without damaging the seal.

As per AS3740 3.10.1 Any penetrations of mechanical fixings or fastenings through surface materials shall be waterproofed.

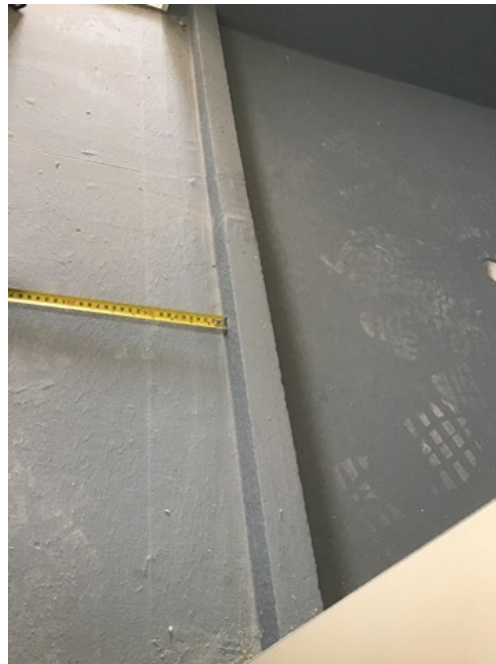
### **Hob Waterproofing > 50mm Extend to the Floor**

Hob waterproofing must be 50mm extend to the floor

The membrane brought up over the top of the hob, down the outside face and terminate a minimum 50 mm onto the floor meet AS3740 3.15.1.2
