# Building Inspection Report

FANGS BUILDING INSPECTIONS

**John St , Mernda, VIC, 3754**

### Building Inspection

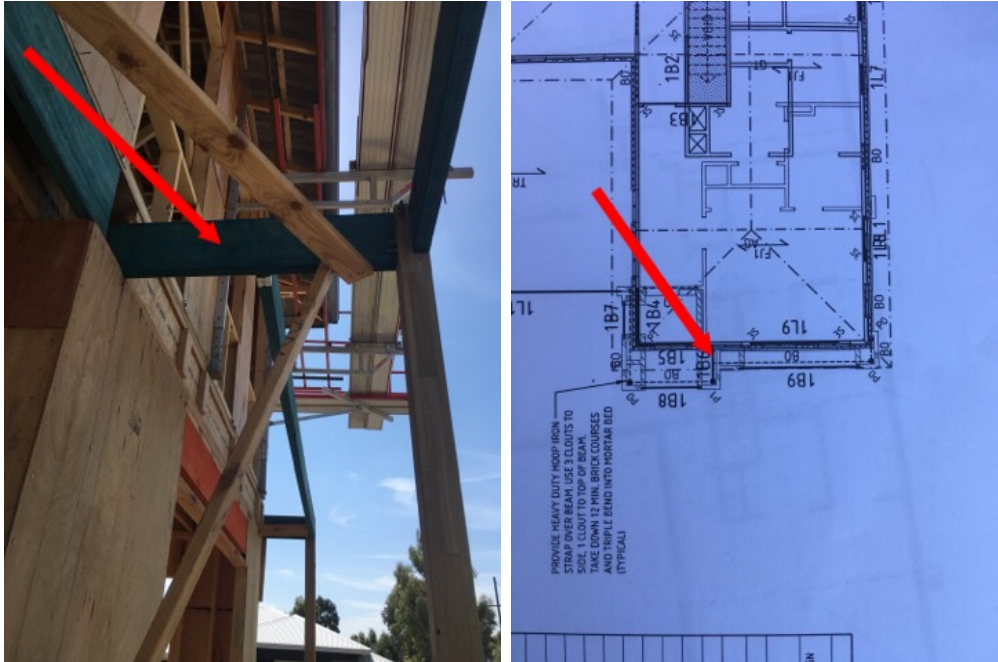
### Installation NOT fully consistent with drawings

Wrong-sized / grade beam(s) installed, please refer to below location(s) and rectify as per AS1684.2 and engineering drawings before plastering

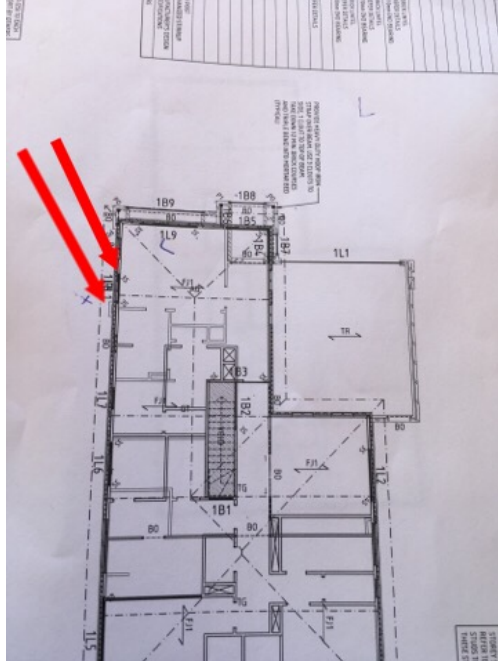
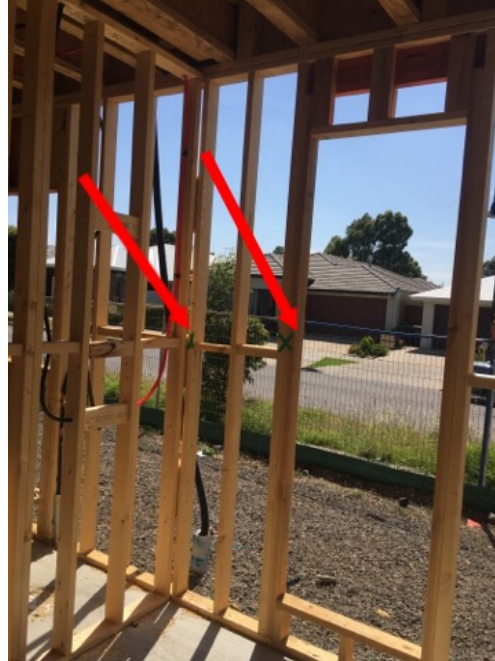
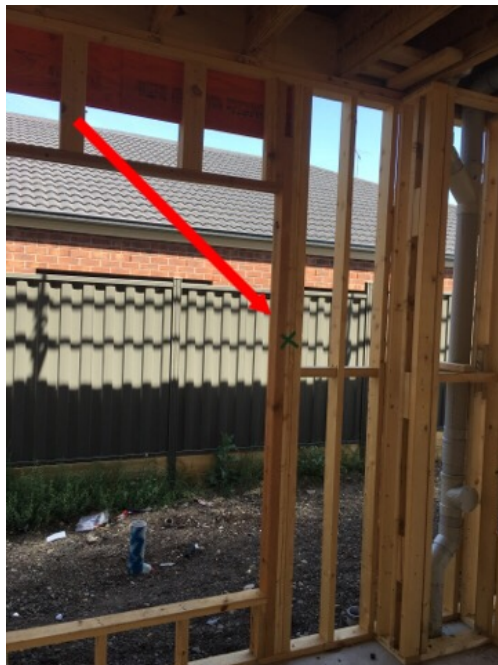
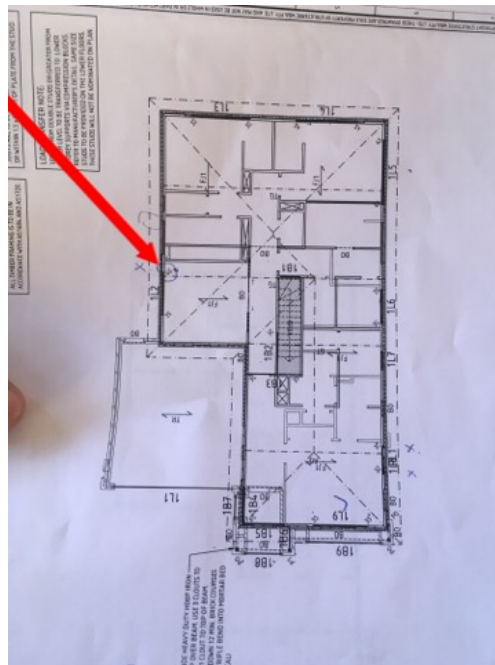
### Installation NOT fully consistent with drawings

3S showing on the drawings not installed, please check whether drawing is correct or studs should have been installed

One stud missing noted

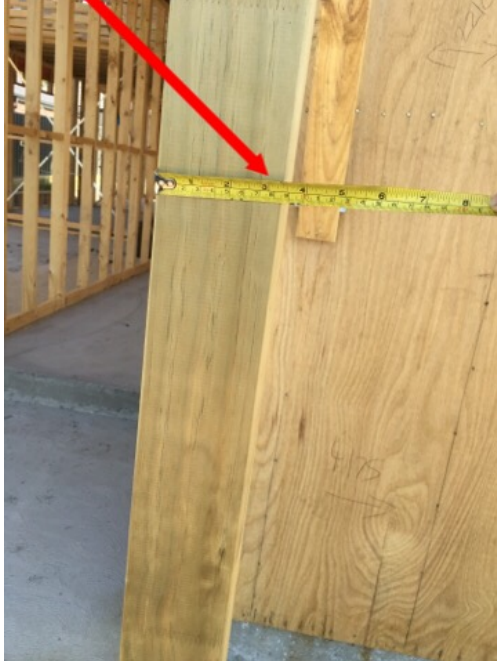
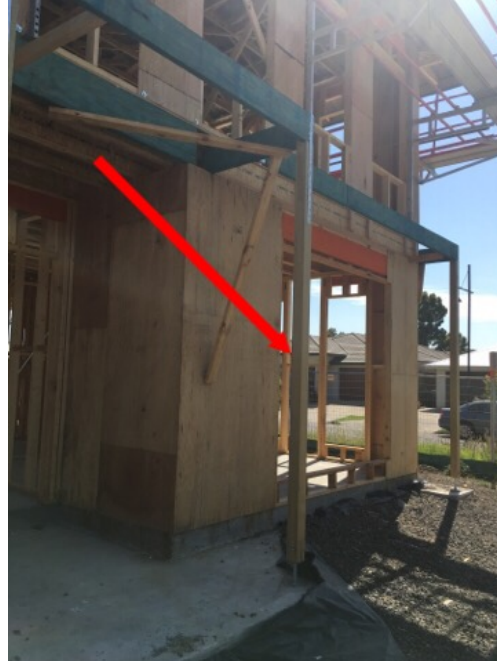
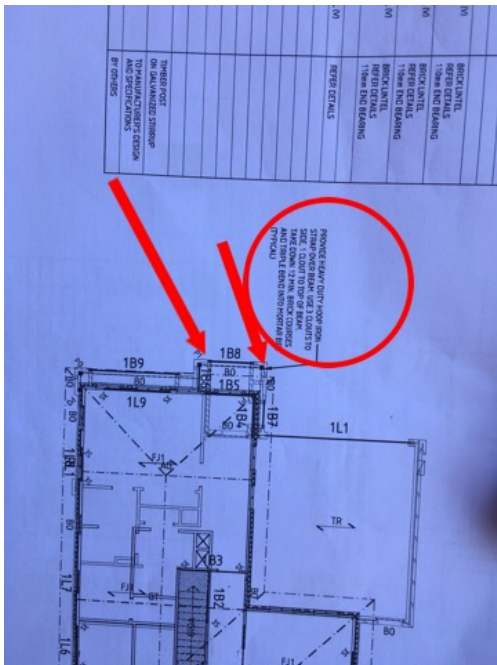
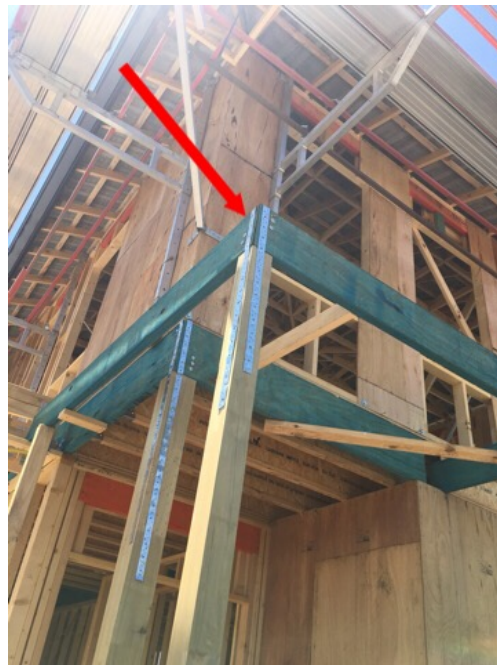
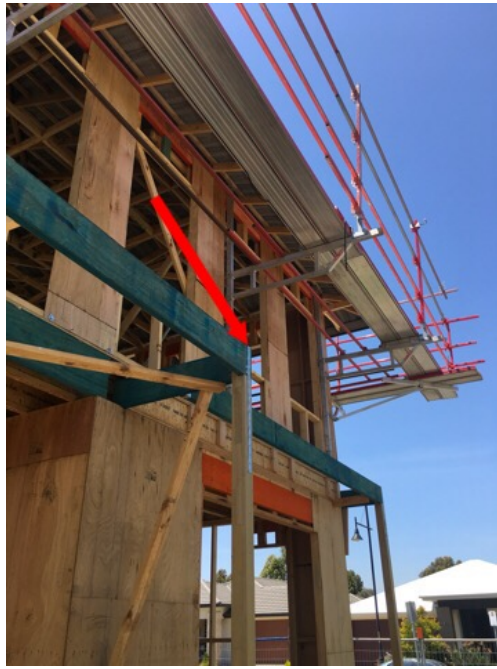
### Installation NOT fully consistent with drawings

Wrong-sized / grade post(s) installed, please refer to below location(s) and rectify as per AS1684.2 and engineering drawings before plastering

Extend hoop iron, make sure take down 12min brick course

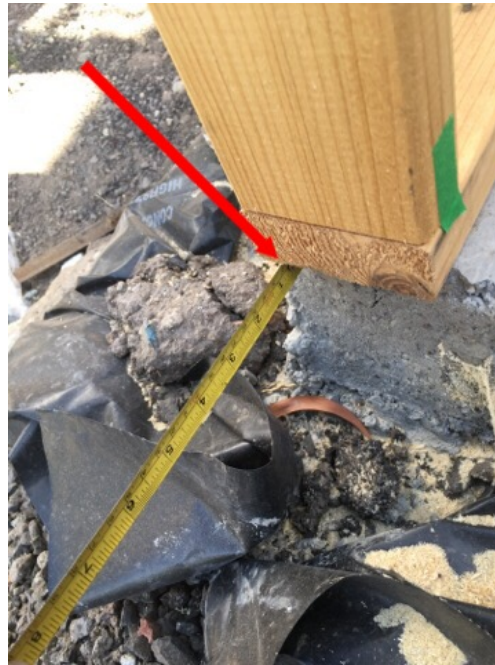
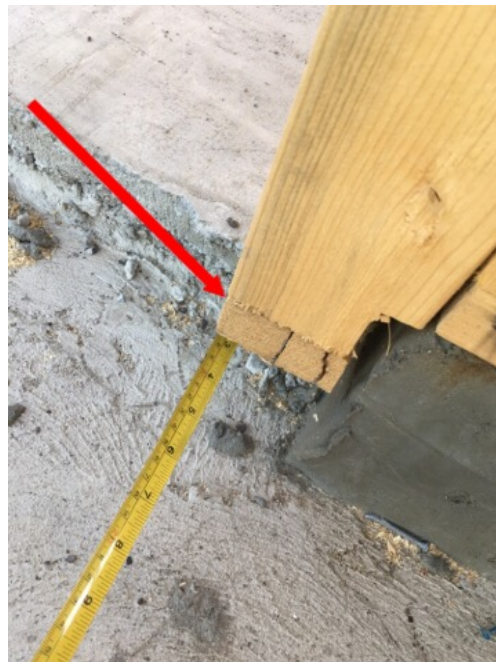
### Wall Bottom Plate Overhang Exceeded 10mm

Wall bottom plate overhang exceeded 10mm, the floor slab has been boxed and poured short at the referred area which has left the bottom plate overhanging the edge of the floor slab more than the allowable tolerance.

- 4.08** Bottom plates that overhang concrete slabs  
 Bottom plates that are less than 90 mm wide and overhang concrete slabs are defective.  
 Bottom plates that are 90 mm wide or greater and overhang concrete slabs by more than 10 mm are defective.  
 Minimum cavity widths as required by the Building Code of Australia shall be maintained.

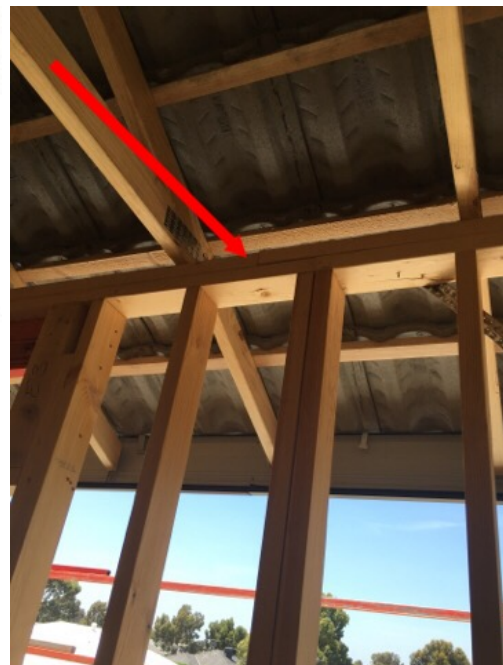
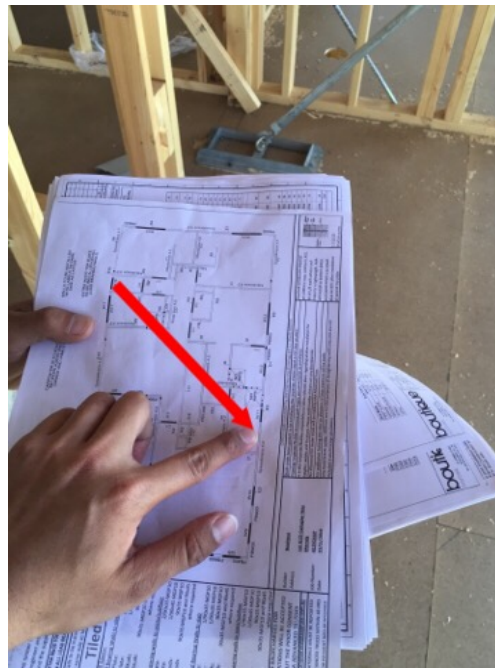
### Unsupported Joint

It is a requirement of Australian Standard, A.S 1684 Residential Timber-Framed Construction, clause 2.4 Stud/Plate Lamination, that 'where joints occur in either top plate between studs, and where rafters or trusses bears onto top plates, additional blocking shall be provided.'

Please refer to below location(s) and rectify the issue as per AS1684.2 Figure 2.9 and engineering drawings before plastering

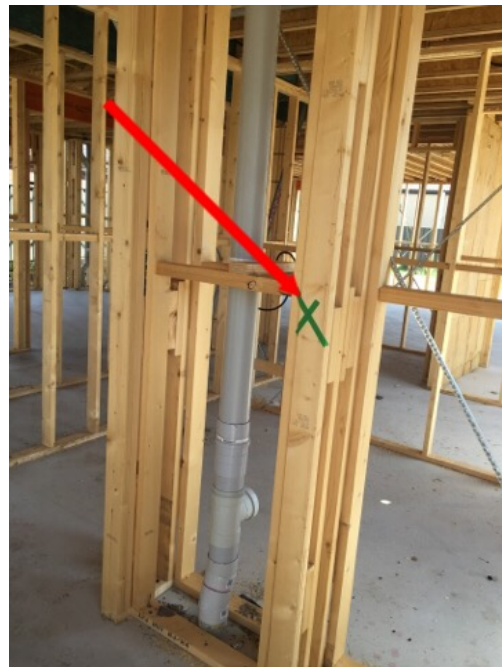
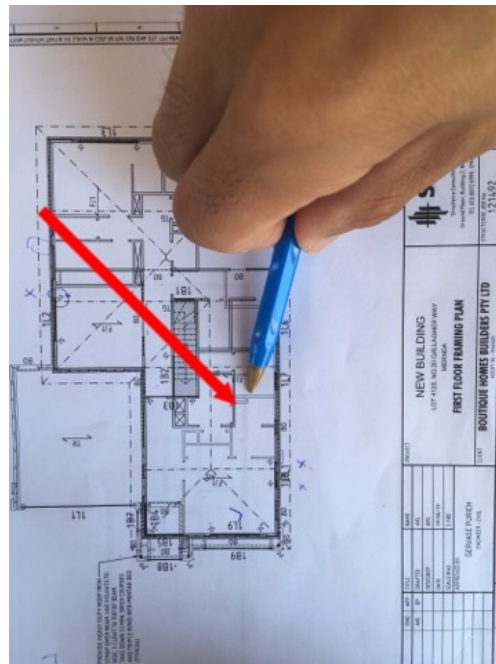
### Out of Plumbing Exceeded 5 mm over a 1.8 m height

Posts and wall frames are defective if they deviate from vertical by more than 5 mm over a 1.8 m height.

Please refer to below location(s) and rectify the issue(s) as per Standards and Tolerance 2015 and engineering drawings before plastering.

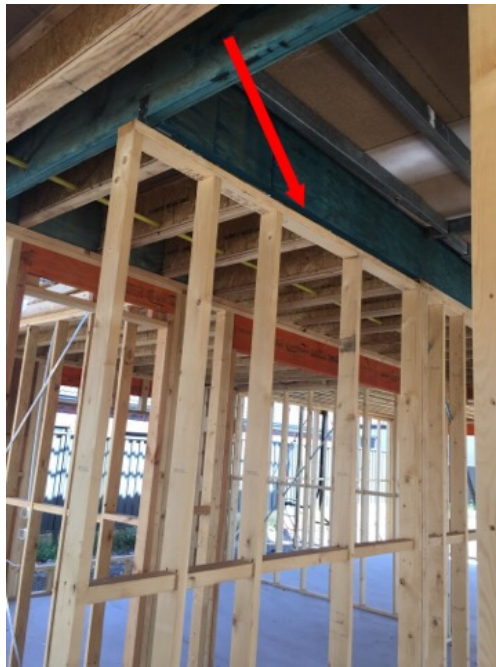
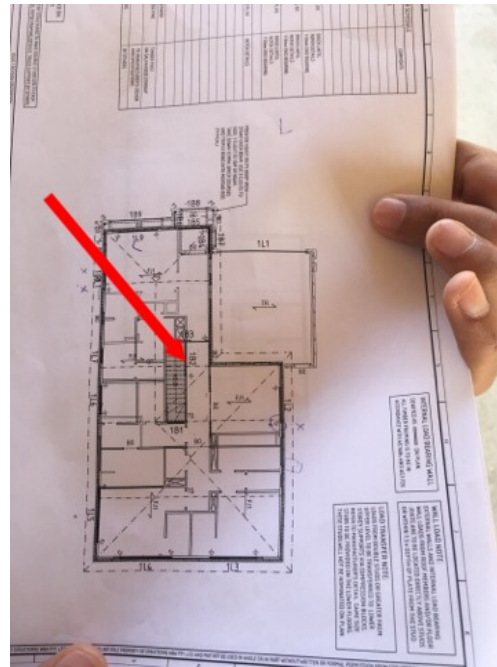
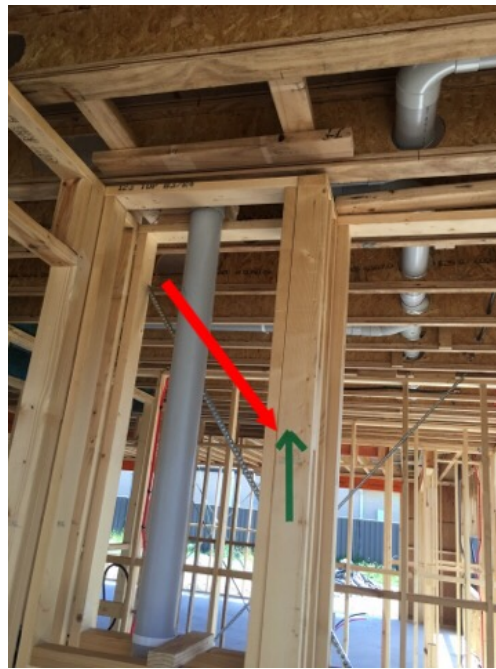
## Shear Block to Non-Load Bearing Braced Wall Not Installed

Install Shear Block to Non-Load Bearing Braced Wall

Please refer to below location(s) and rectify the issue(s) as per AS4440 2.2.3 and AS1684.2 6.2.5.2 and engineering drawings before plastering.

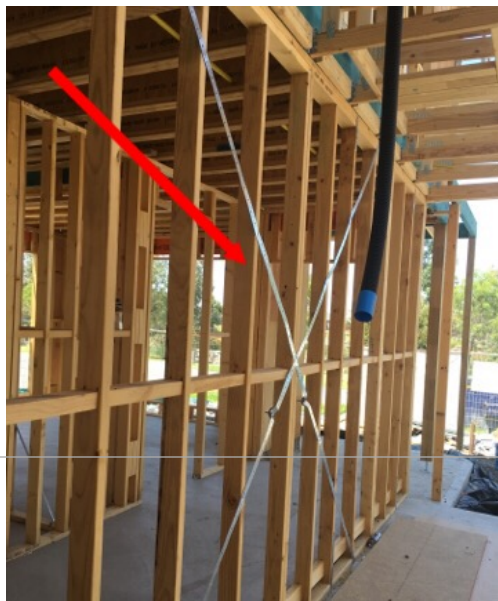
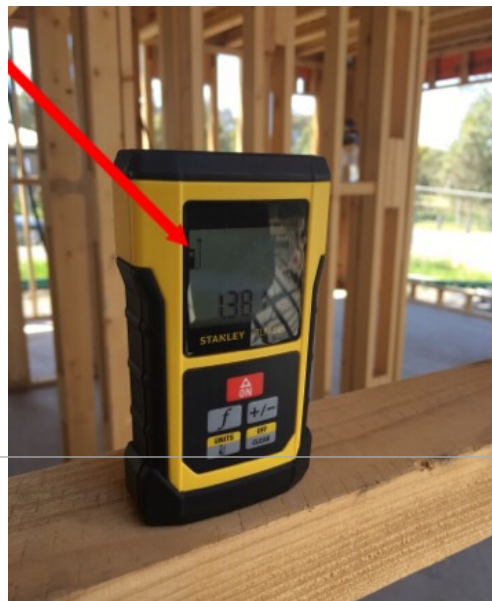
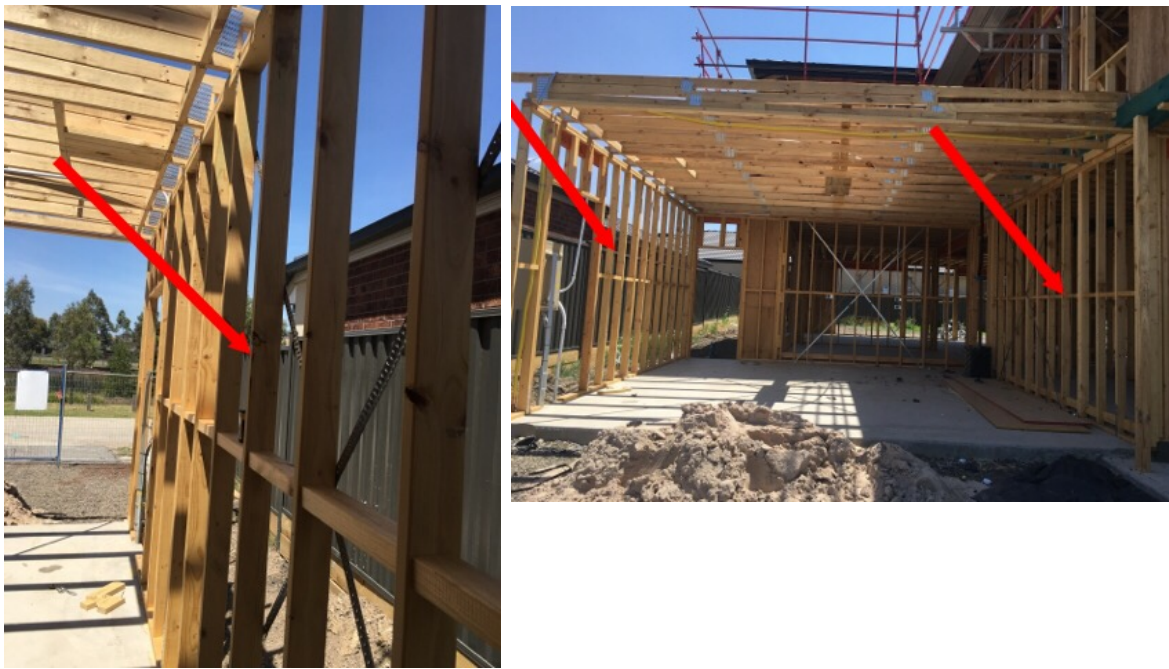
### Nogging(s) Missing - Distance In Between Exceeded 1350mm

Where required, wall studs shall have continuous rows of noggings, located on flat or on edge, at 1350 mm maximum centres.

Please refer to below location(s) and rectify the issue(s) as per AS1684.2 6.2.1.5 and engineering drawings before plastering.

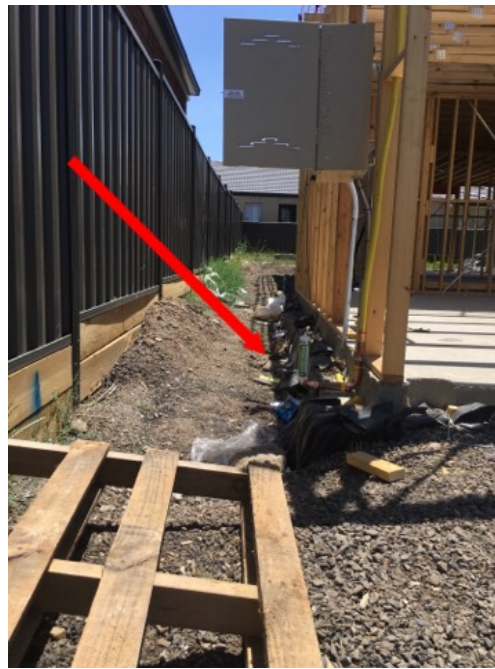
**Site Surface Drainage Inadequate - soil graded away for a min. of 50mm over 1m**

Site Surface Drainage Inadequate

The dwellings slab is currently exposed to ponding against the slab due to the lay of the land and the builder’s lack of site soil fall control

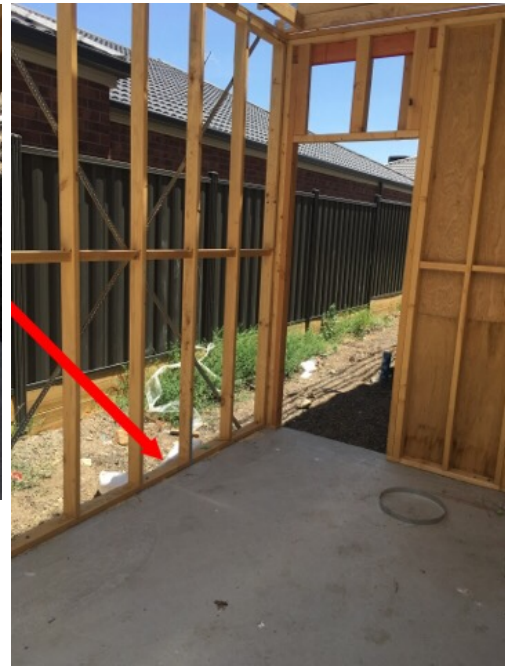
**Nail(s) missing on bottom plate to concrete (75mm nail, max 1200mm centres)**

Nail(s) missing or not affixed properly, please refer to below location(s) and rectify as per AS1684.2 and engineering drawings before plastering

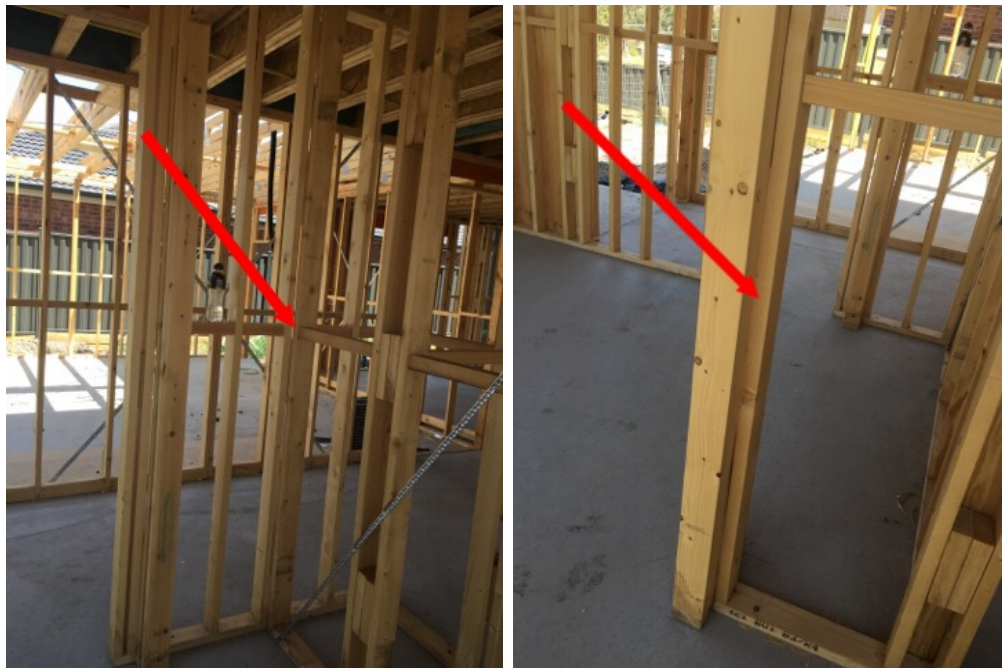
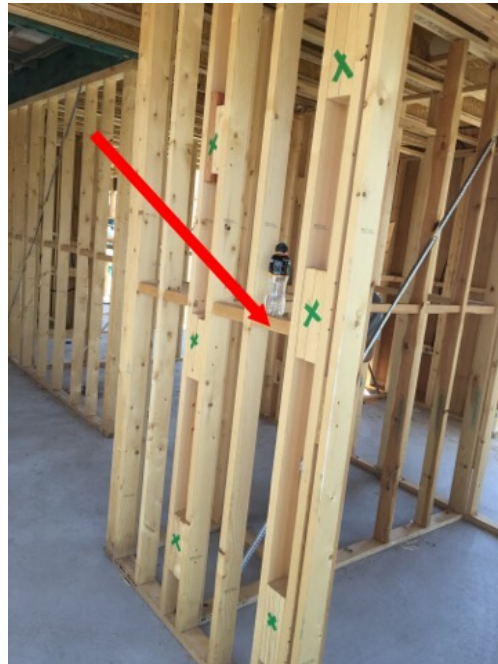
**Nail(s) missing on blocks to studs (2/75x3.05mm nail)**

Nail(s) missing or not affixed properly although the property, please rectify as per AS1684.2 and engineering drawings before plastering

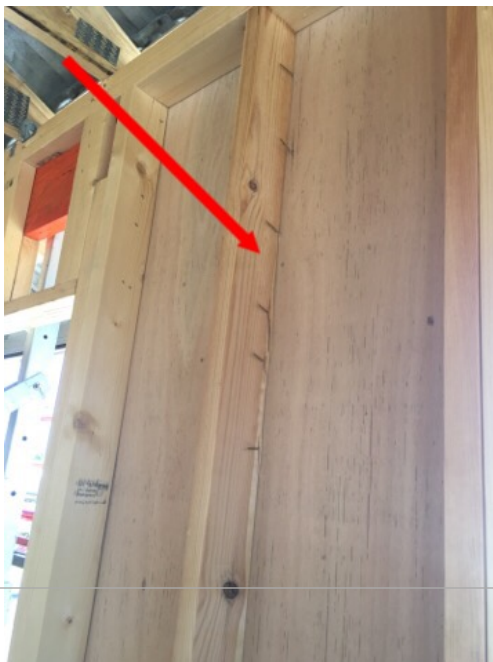
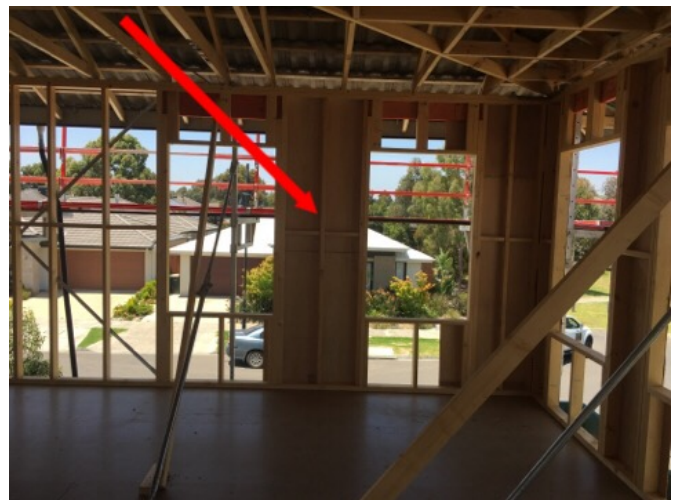
**Nail(s) missing on timber braces to studs or plates / ring beams (2/50x2.8mm nail each joint)**

Nail(s) missing or not affixed properly, please refer to below location(s) and rectify as per AS1684.2 and engineering drawings before plastering

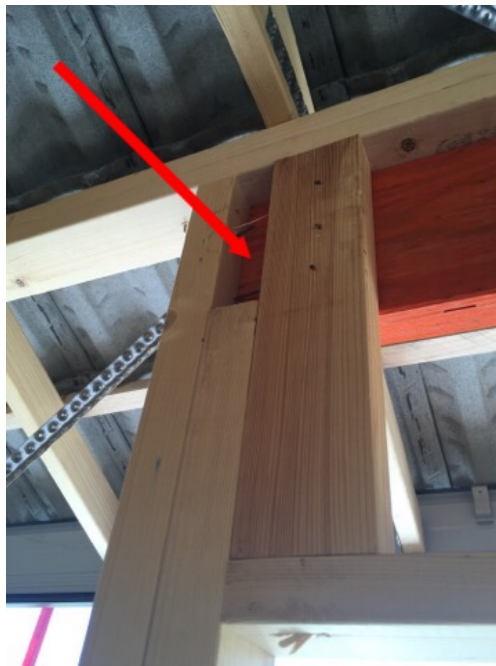
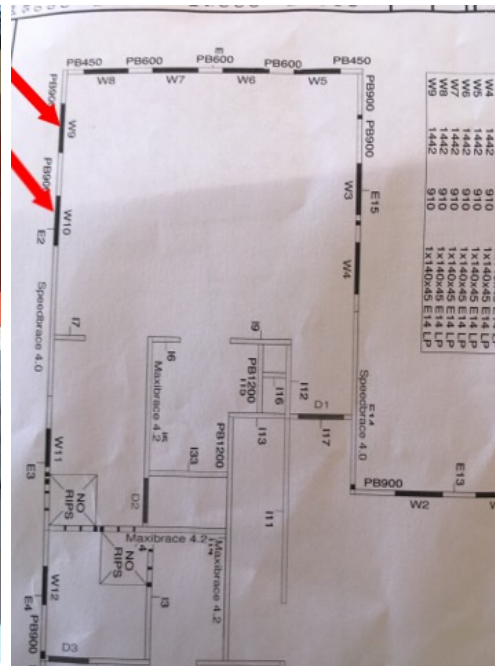
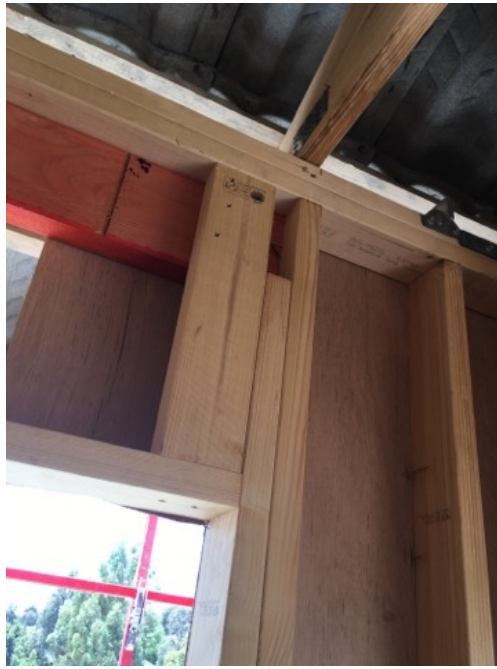
## Nail(s) missing on lintel to jamb studs (2/75x3.05mm nails each joint)

Nail(s) missing or not affixed properly, please refer to below location(s) and rectify as per AS1684.2 and engineering drawings before plastering
