Building Inspection Report

FANGS BUILDING INSPECTIONS

John St, Burwood East, VIC, 3151

Inspection Date: 26 Oct 2019

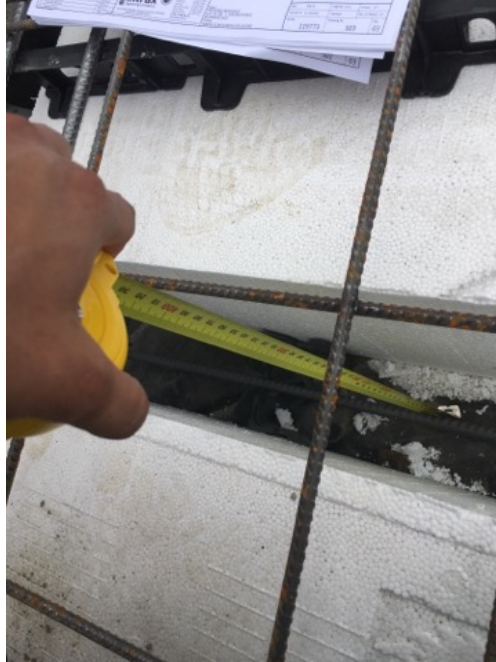
Void Form Height

300mm

Void form height appears 300mm as per engineering drawings

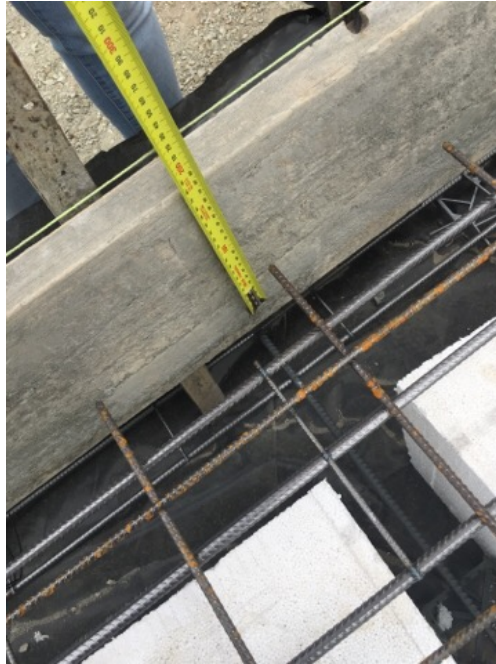
Slab Thickness

85mm

Slab thickness appears 85mm as per engineering drawings

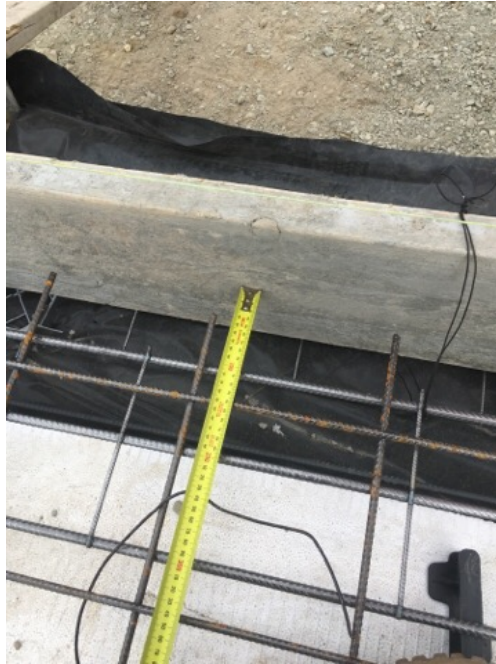
Stem Width

Overall Slab Depth

385mm

Overall slab depth appears 385mm as per engineering drawings

150mm

Stem width appears 150mm as per engineering drawings

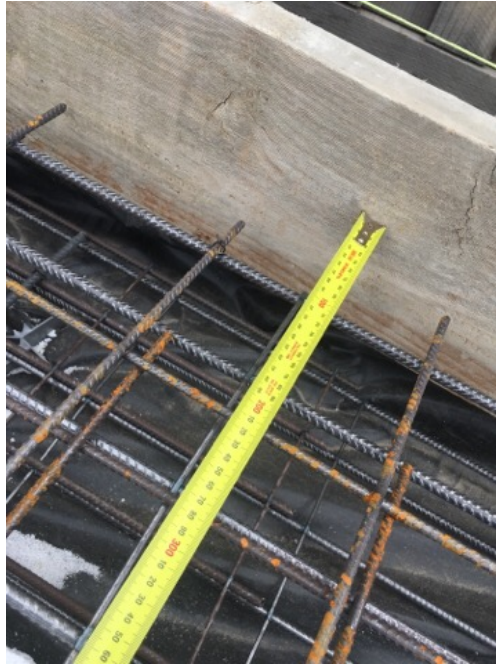
External Rib Width

300mm

External rib width appears 300mm as per engineering drawings

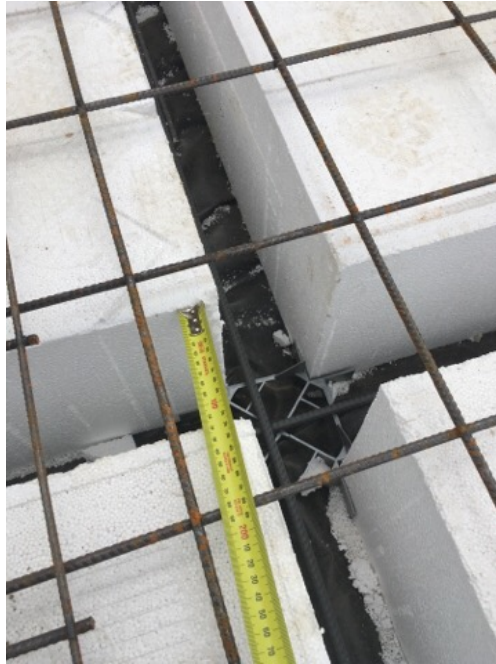
Internal Rib Width

110mm

Internal rib width appears 110mm as per engineering drawings

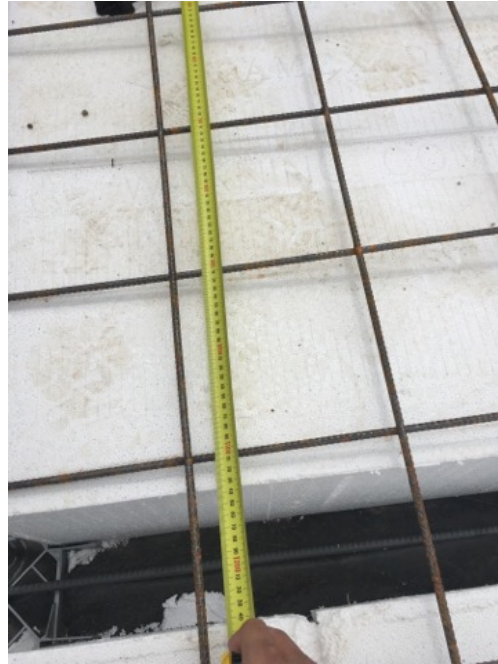
Rib Spacing

1200mm

Rib spacing appears 1200mm as per engineering drawings

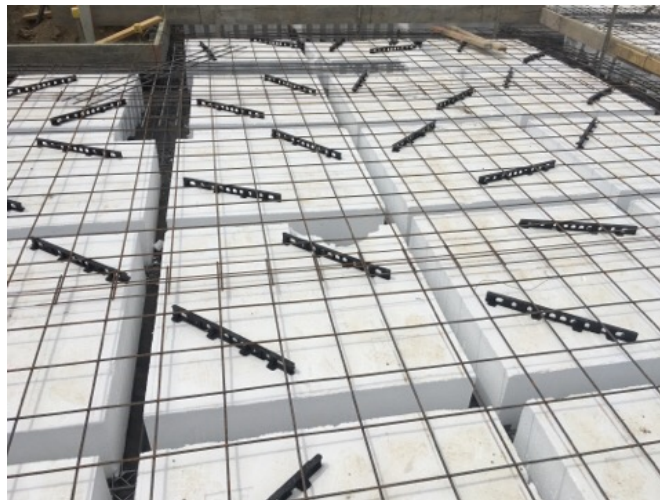
Slab Fabric

SL92

SL92 slab mesh has been placed

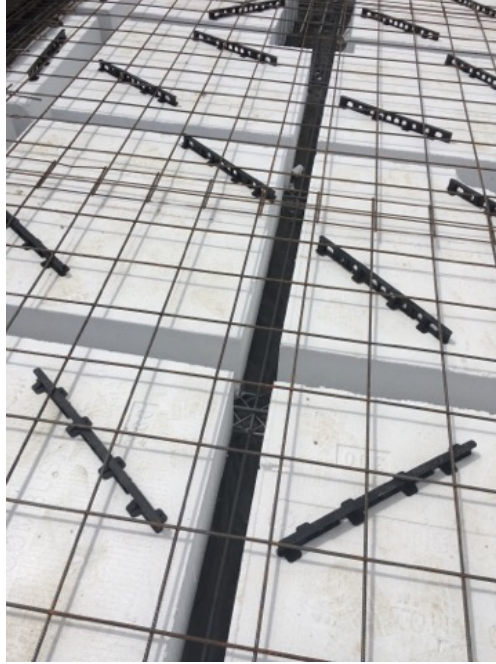
Internal Rib Reinforcement

1-N16 bar placed at the bottom as per engineering drawings

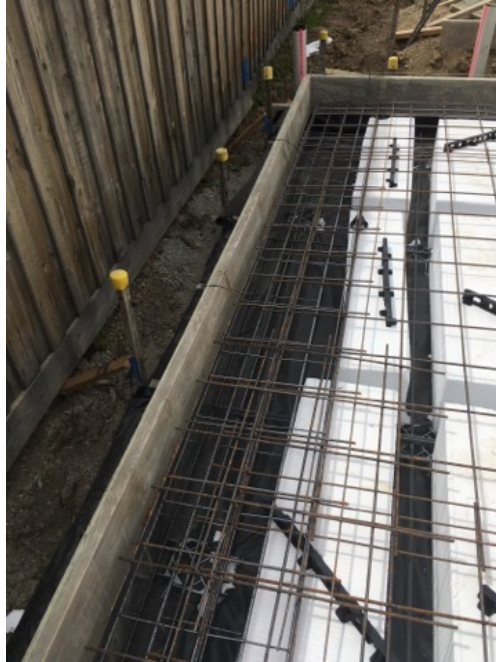
External Rib Reinforcement

3-L11TM has been placed at top as per engineering drawings

3-L11TM has been placed at the bottom as per engineering drawings

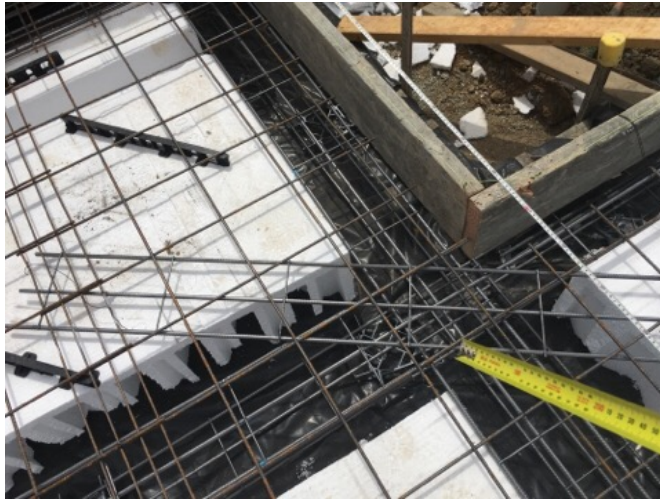
Crack Control Bars

2000mm Long 3-L11TM control bars has been placed as per engineering drawings

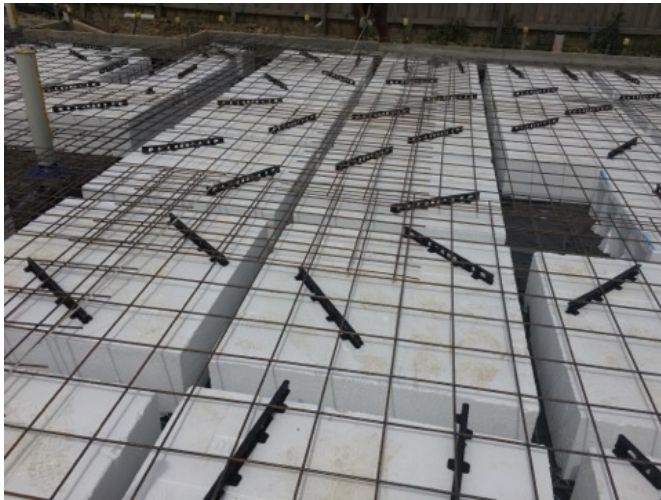
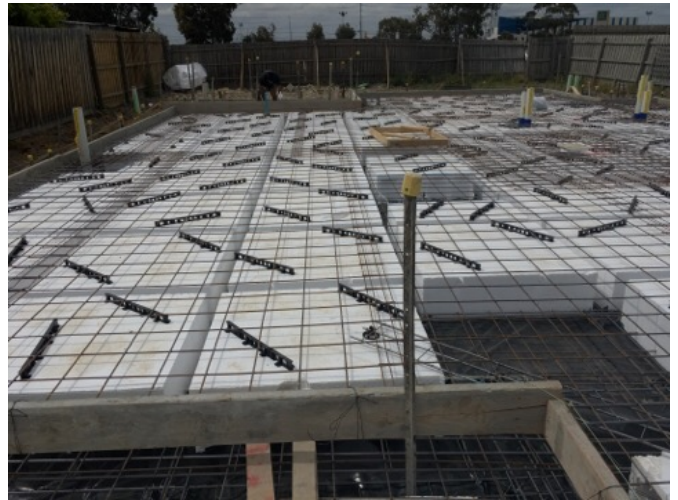
Bar Chair Spacing

Bar chairs are placed maximum 800mm centers for steel fabric and appears in right order

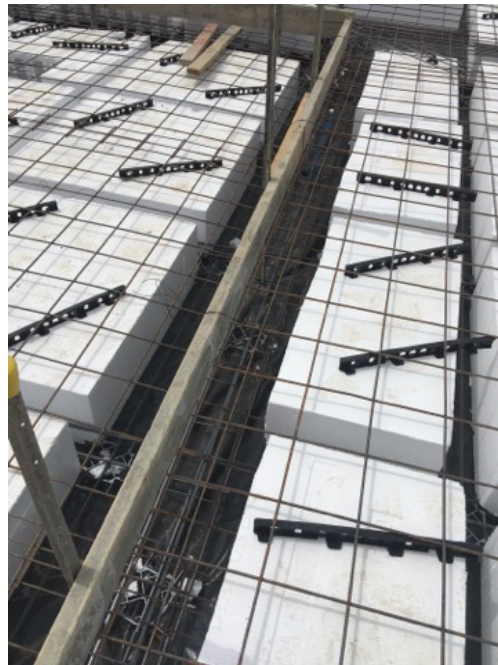
Concrete Cover

Edge of the reinforcement to the timber form has 40mm minimum clearance satisfy

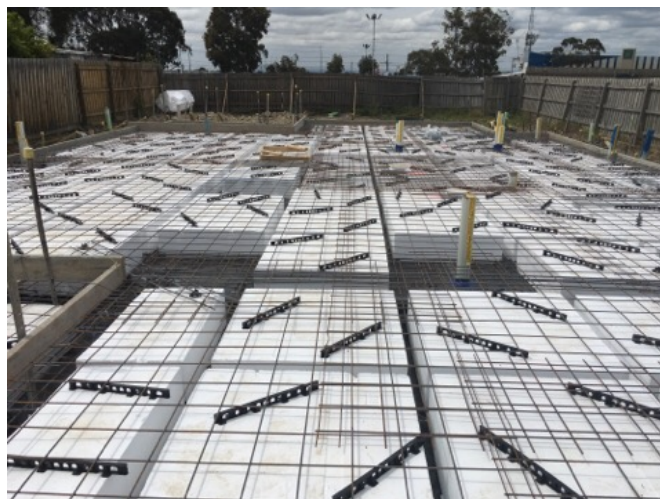
Boxing Levelling

Box Levelling appears in satisfy condition

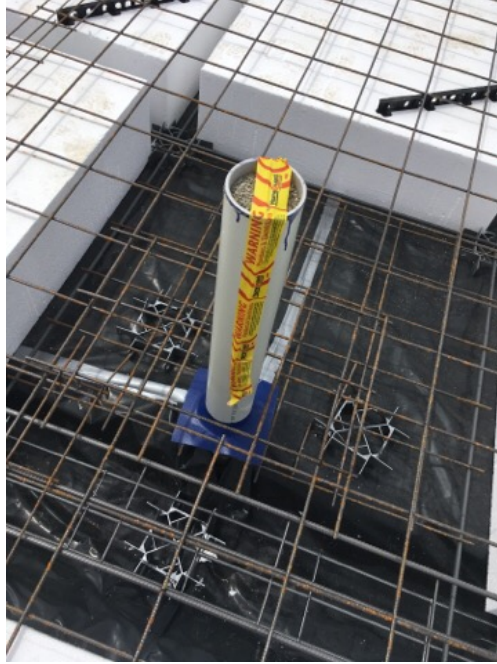
Termite Barrier Part A

Termite barriers part A are installed in accordance with AS 3660.1

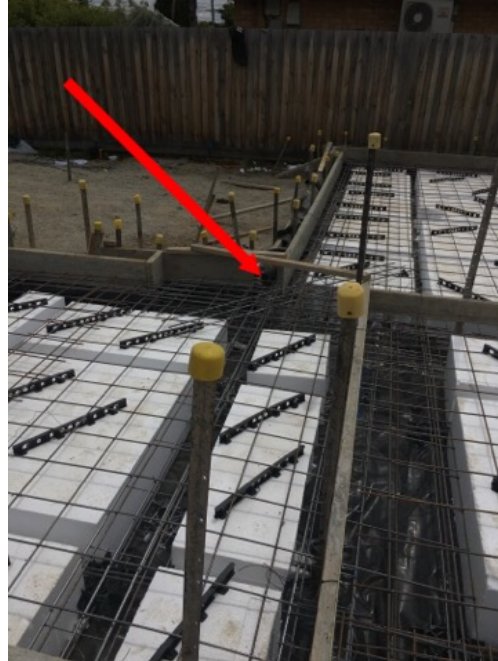
| Section | Location | Name | Comment |
|---|---|---|---|
| BUILDING DEFECTS | Building Defects | Section(s) of Timber Form Missing | Section(s) of form work timber is missing Some areas of boxing still need to be completed, prior to any concrete pour, to avoid any blow-out and widening |

Section(s) of form work timber is missing

Some areas of boxing still need to be completed, prior to any concrete pour, to avoid any blow-out and widening

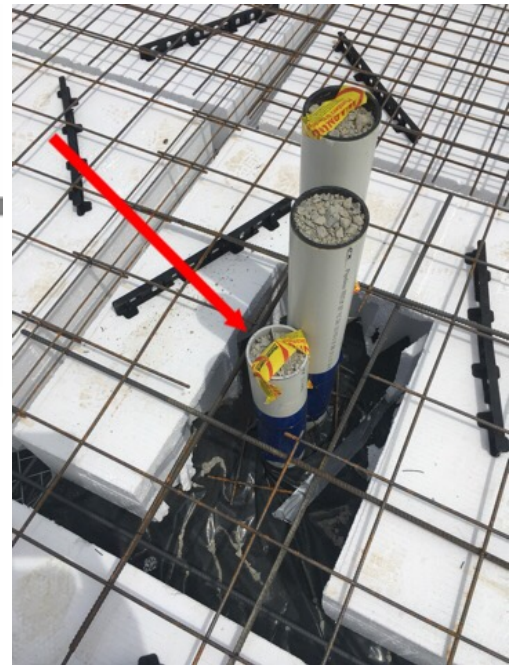
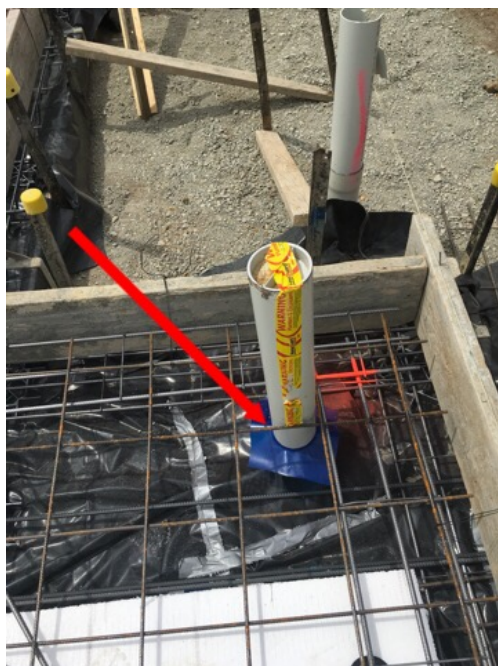
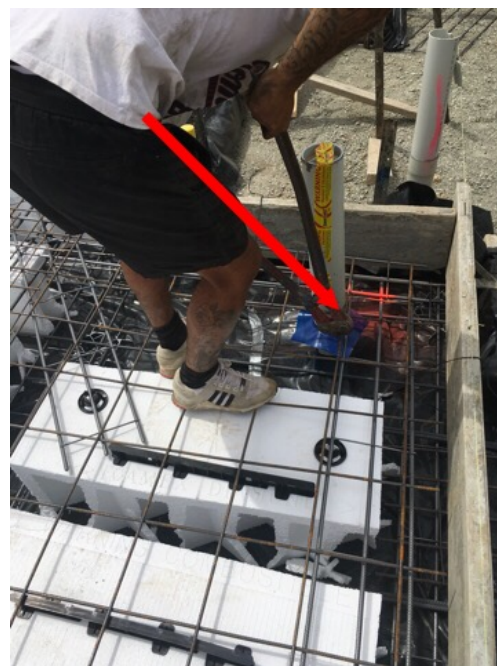
| BUILDING DEFECTS | Building Defects | 20mm Clearance Around Pipe Not Achieved | 20mm clearance around pipe is not achieved as per BCA 3.2.3.2 "(d) Footings and slabs-on-ground must have concrete cover between the outermost edge of the reinforcement (including ligatures, tie wire etc.) and the surface of the concrete of not less than: (i) 40 mm to unprotected ground. (ii) 30 mm to a membrane in contact with the ground. (iii) 20 mm to an internal surface" |

20mm clearance around pipe is not achieved as per BCA 3.2.3.2

"(d) Footings and slabs-on-ground must have concrete cover between the outermost edge of the reinforcement (including ligatures, tie wire etc.) and the surface of the concrete of not less than:

- (i) 40 mm to unprotected ground.
- (ii) 30 mm to a membrane in contact with the ground.
- (iii) 20 mm to an internal surface"

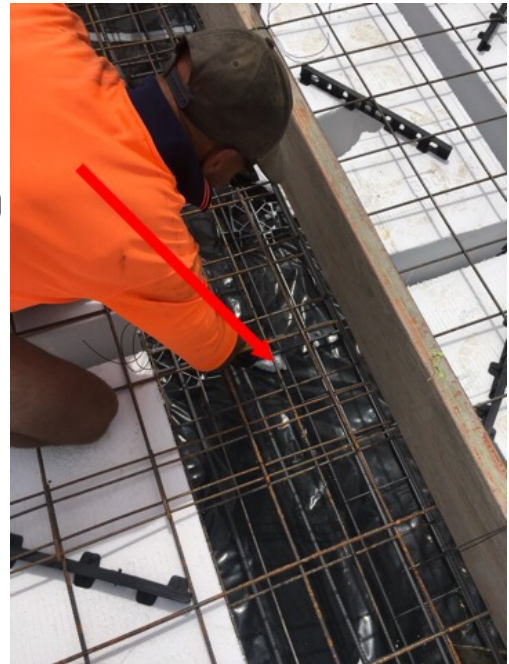
| BUILDING DEFECTS | Building Defects | Bar Chairs 30mm Clearance Not Achieved | Bar chairs are not placed in right order, 30mm clearance must be provided as per BCA Section 3 3.2.3.2 (d) "Footings and slabs-on-ground must have concrete cover between the outermost edge of the reinforcement (including ligatures, tie wire etc.) and the surface of the concrete of not less than: (ii)30 mm to a membrane in contact with the ground." |

Bar chairs are not placed in right order, 30mm clearance must be provided as per BCA Section 3 3.2.3.2 (d)

"Footings and slabs-on-ground must have concrete cover between the outermost edge of the reinforcement (including ligatures, tie wire etc.) and the surface of the concrete of not less than:

(ii)30 mm to a membrane in contact with the ground."

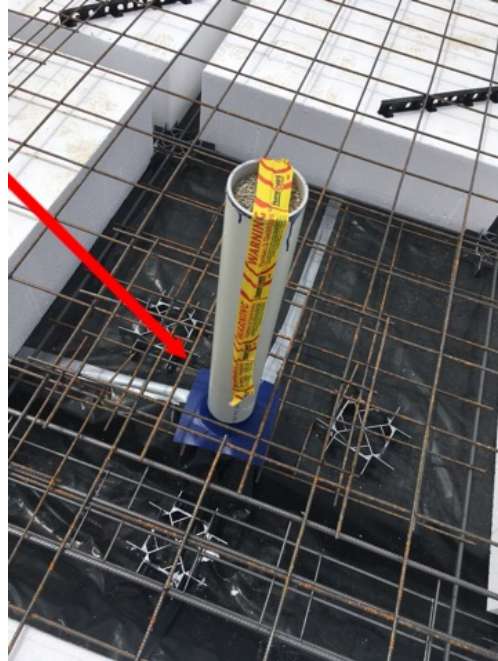
| BUILDING DEFECTS | Building Defects | Extra Support Not Provided Around Pipes | Additional reinforcing bars are required to be installed around pipe. |

Additional reinforcing bars are required to be installed around pipe.

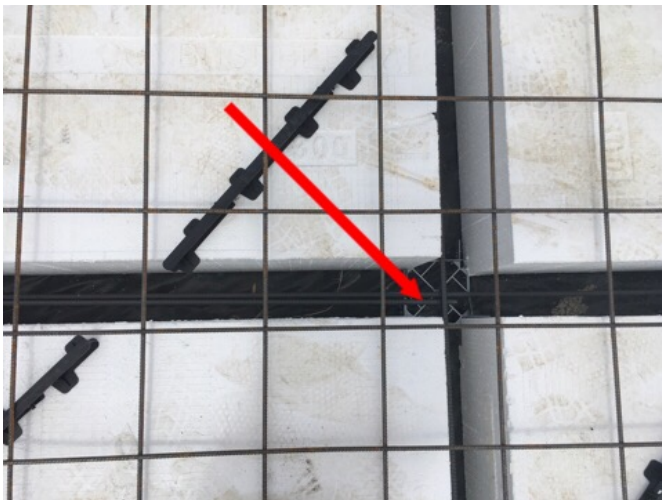
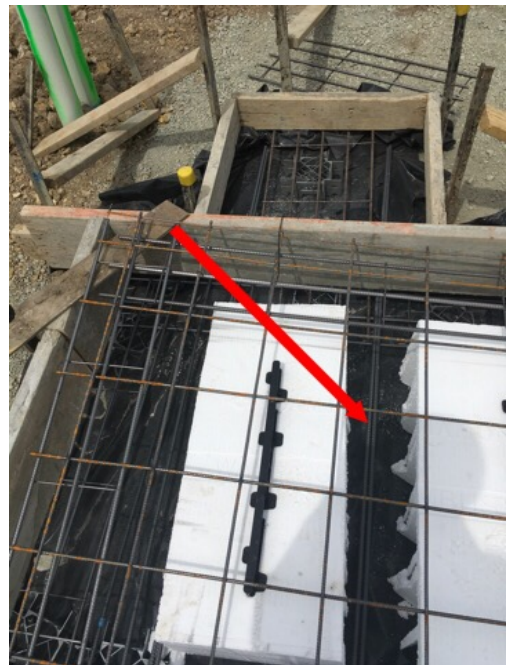
| BUILDING DEFECTS | Building Defects | Steel Members Not Tied / Secured to Each Other | It is a requirement of Part 3.2.3.2 Steel Reinforcement of the BCA that 'All reinforcement must be firmly fixed in place to prevent it moving during concreting operations' |

It is a requirement of Part 3.2.3.2 Steel Reinforcement of the BCA that 'All reinforcement must be firmly fixed in place to prevent it moving during concreting operations'

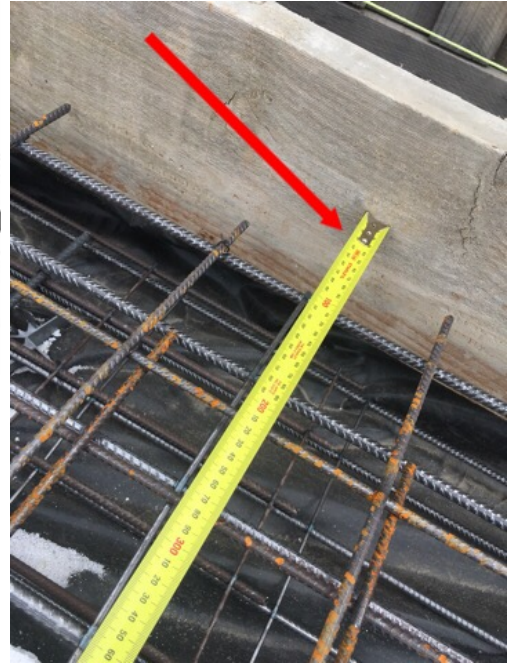
| BUILDING DEFECTS | Building Defects | Steel to Beam Clearance Not Satisfied | It is a requirement of Part 3.2.3.2 Steel Reinforcement of the BCA that 'Footings and slab- on-ground must have concrete cover between the outermost edge of the reinforcement (including ligatures, tie wire etc.) and the surface of the concrete of not less than 40mm to external exposure.' All of the reinforcement will need to be rectified and confirmed as having this minimum clearance, prior to any concrete being poured. |

It is a requirement of Part 3.2.3.2 Steel Reinforcement of the BCA that 'Footings and slab- on-ground must have concrete cover between the outermost edge of the reinforcement (including ligatures, tie wire etc.) and the surface of the concrete of not less than 40mm to external exposure.'

All of the reinforcement will need to be rectified and confirmed as having this minimum clearance, prior to any concrete being poured.

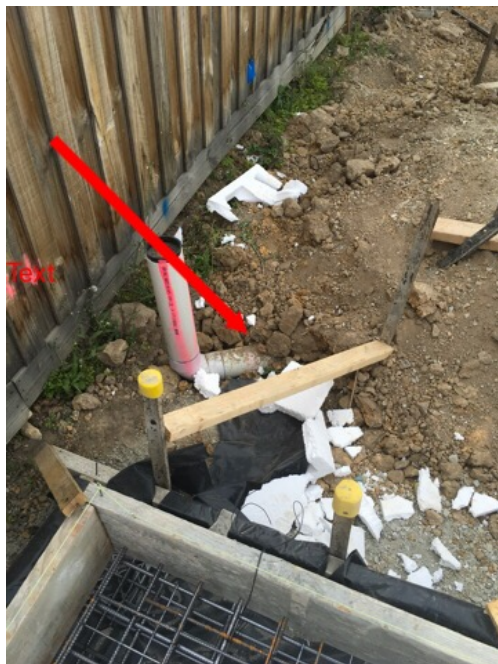
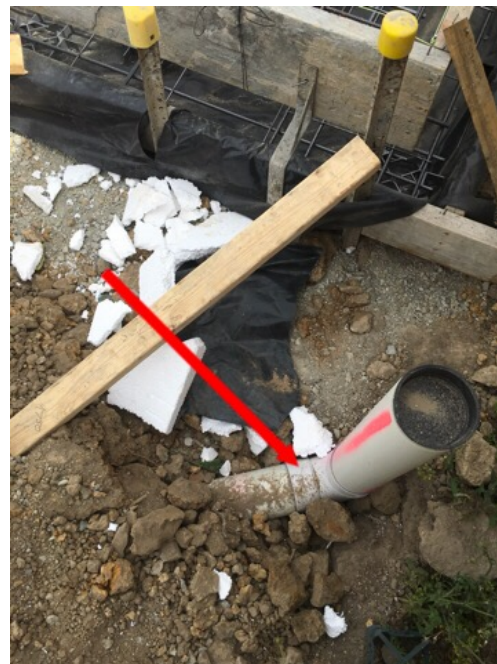
| BUILDING DEFECTS | Building Defects | Pipe Lagging Missing | Pipe laggings are missing and must be installed before concrete pouring |

Pipe laggings are missing and must be installed before concrete pouring

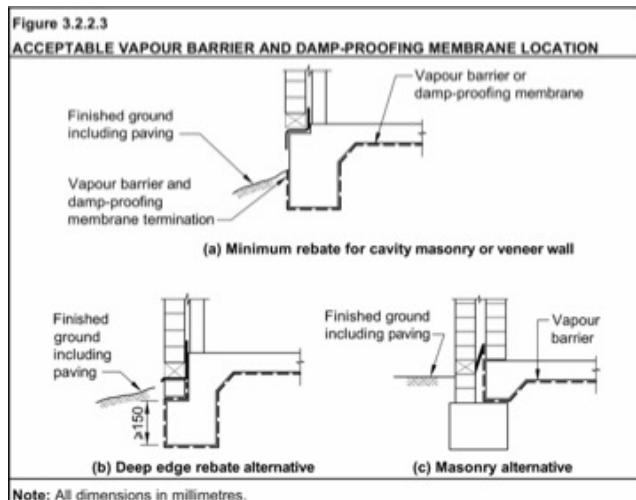
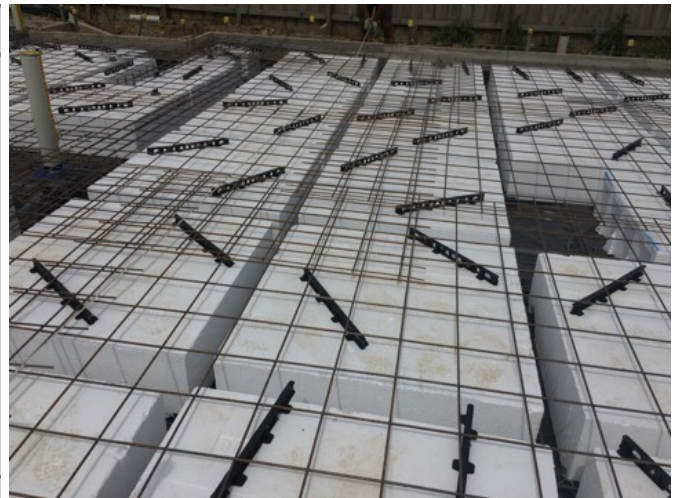
| BUILDING DEFECTS | Building Defects | Top Mesh Overlapping Not Satisfied | It is a requirement of Part 3.2.3.2 Steel Reinforcement of the BCA that Minimum laps for reinforcement as shown in Table 3.2.3.1 and Figure 3.2.3.1 must be provided where reinforcing is used. Two outermost wires lapping required. |

It is a requirement of Part 3.2.3.2 Steel Reinforcement of the BCA that Minimum laps for reinforcement as shown in Table 3.2.3.1 and Figure 3.2.3.1 must be provided where reinforcing is used. Two outermost wires lapping required.
