Building Inspection Report

FANGS BUILDING INSPECTIONS

Spencer St, West Melbourne, VIC, 3000

Inspection Date: 20 Nov 2019

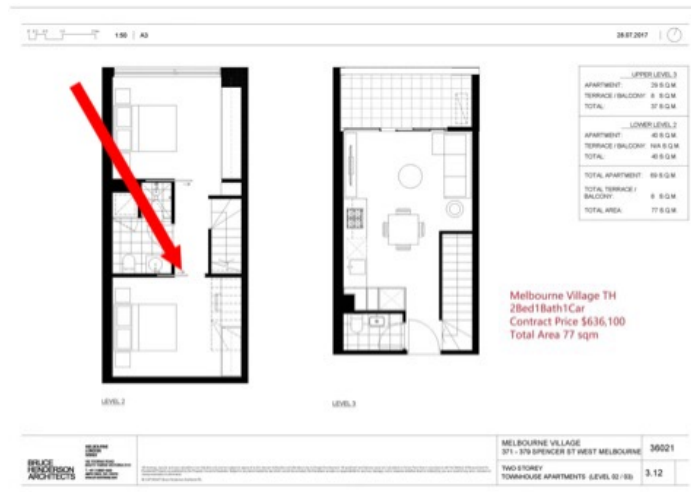
Sliding door is not installed as per drawings in the study room

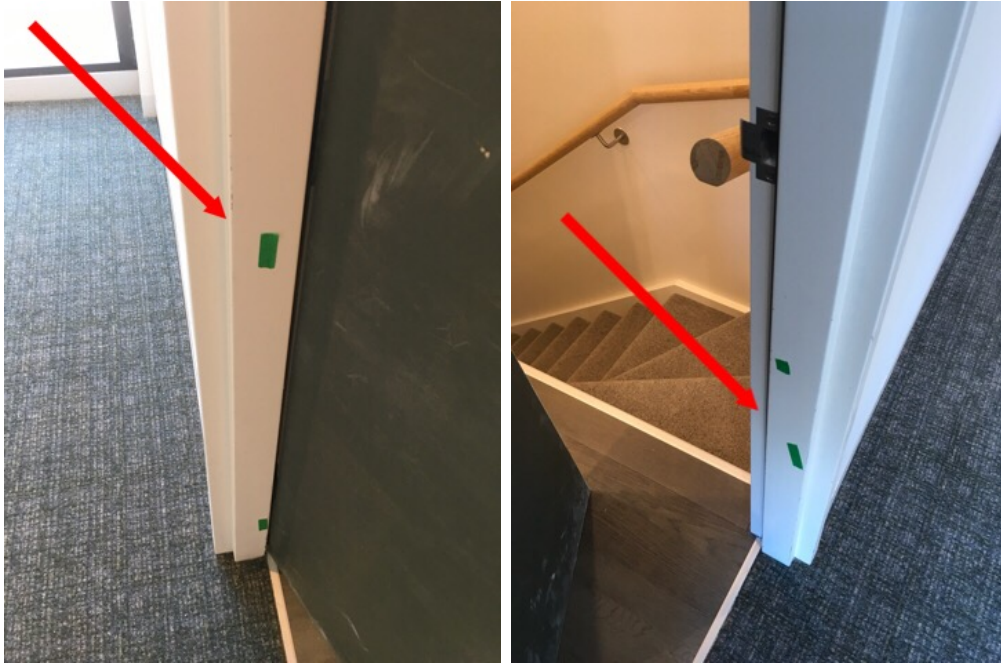
Door

Minor dents, chips and scratches noted - touch up will satisfy

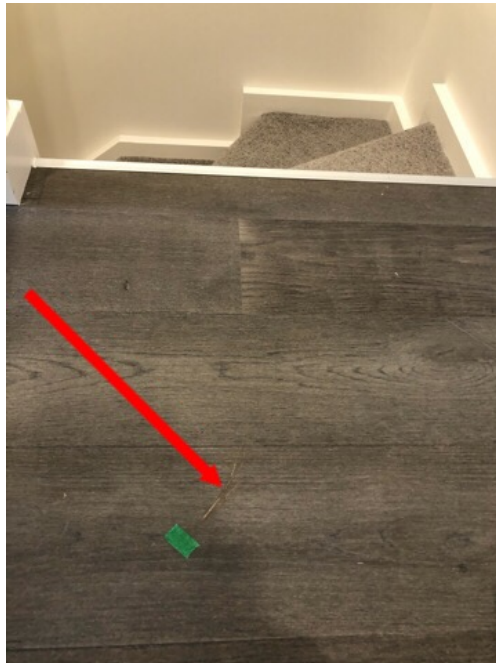
Flooring

Minor dents, chips and scratches noted, touch up will satisfy.

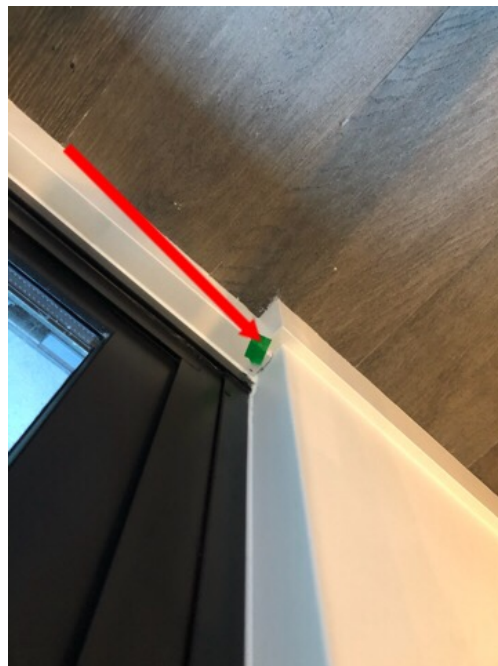
Flooring

Minor dents, chips and scratches noted, touch up will satisfy.

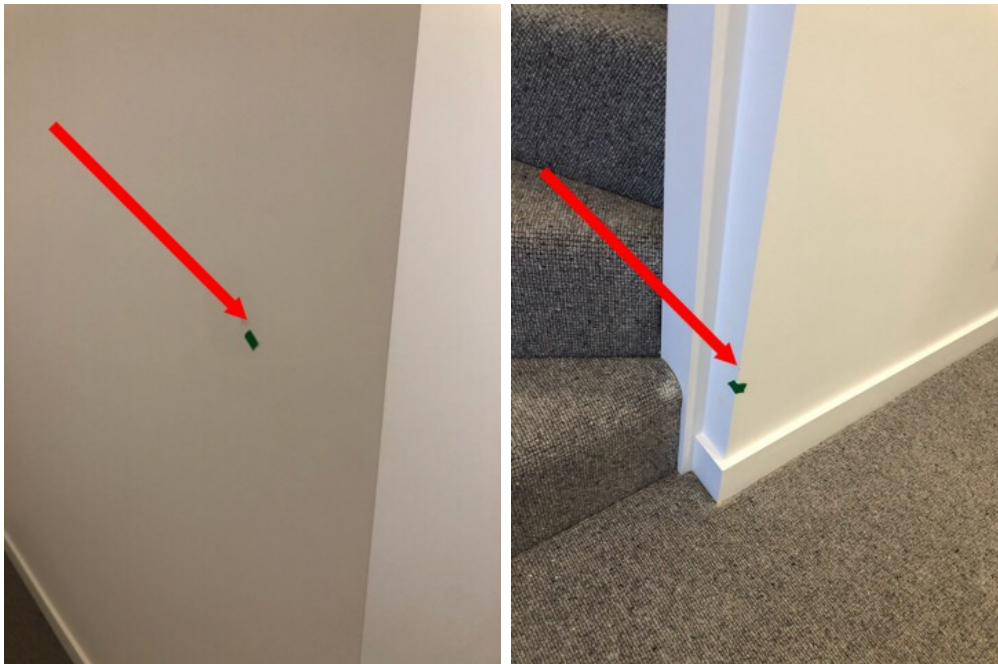
Walls

Minor dents, chips and scratches noted, touch up will satisfy.

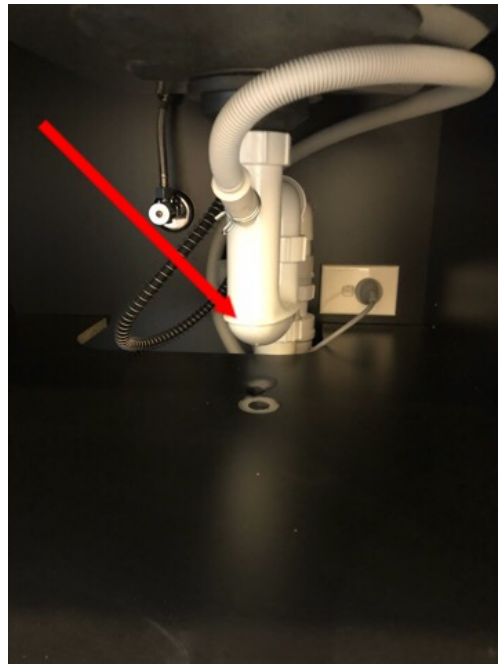
Sink and Taps

The trap under the sink is leaking. A qualified plumber should be engaged for advice and recommendations.

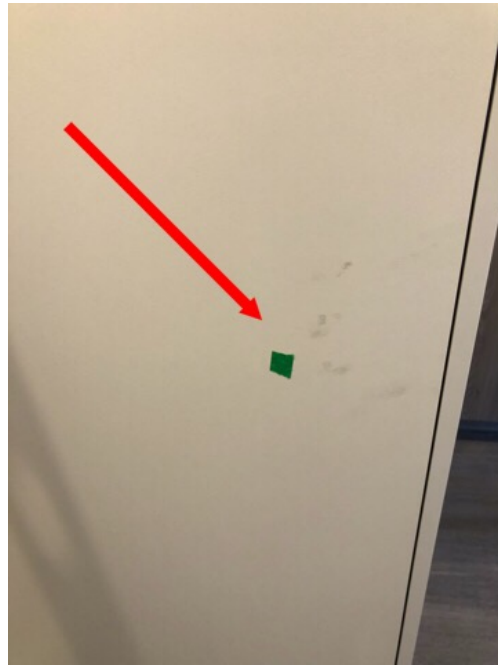
Cupboards And Bench Tops

Minor dents, chips and scratches noted - touch up will satisfy

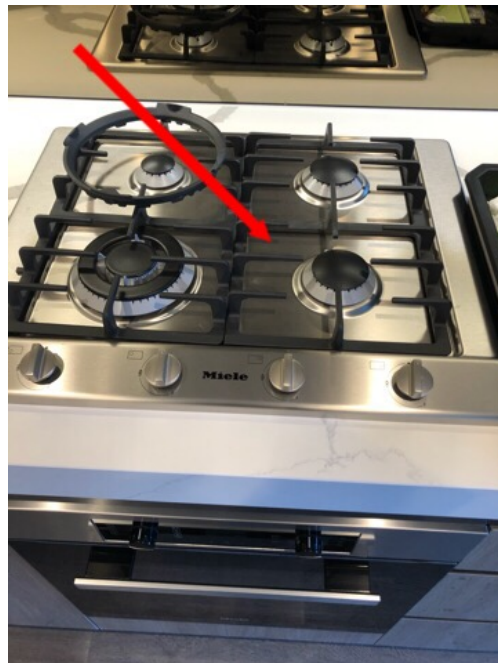
Cooktops

The cooktops is not working at the time of inspection

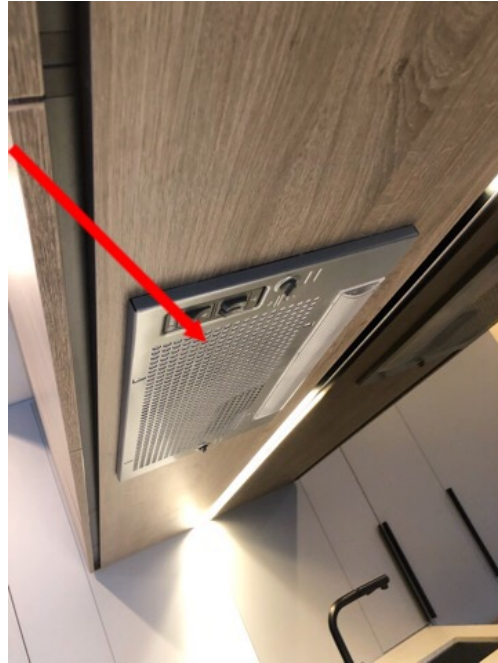
Rangehood

The rangehood is not working at the time of inspection

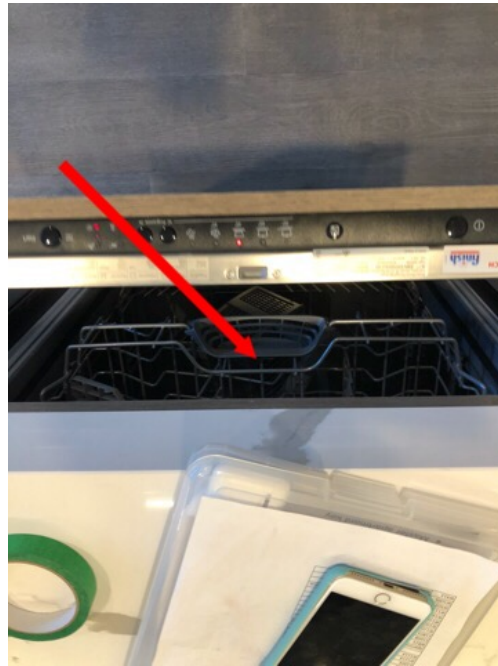
Dishwasher

The dishwasher is not working at the time of inspection

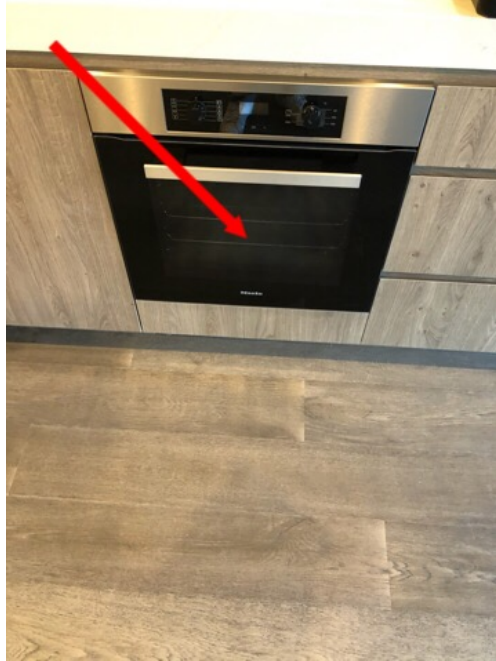
Oven

The oven is not working at the time of inspection

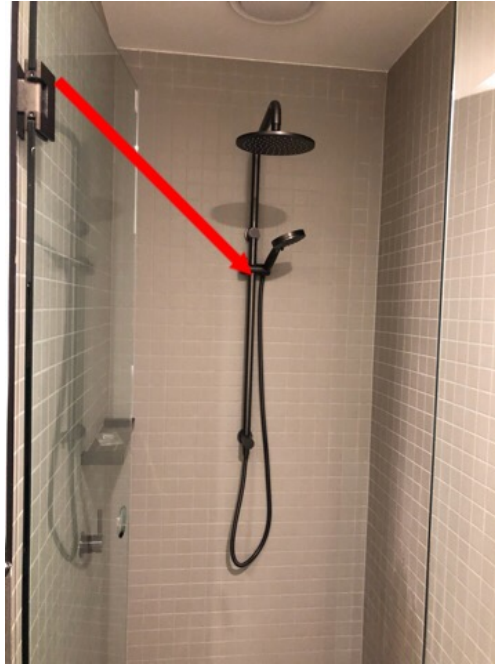
Shower

There is excessive pipe knocking or water hammer to the shower taps. Recommendations. Installing a Water Hammer Arrestor may resolve this, however speak with a licensed plumber for further recommendations.
