Building Inspection Report

FANGS BUILDING INSPECTIONS

John St, Balwyn North, VIC, 3104

Report/Agreement # 22111905371251

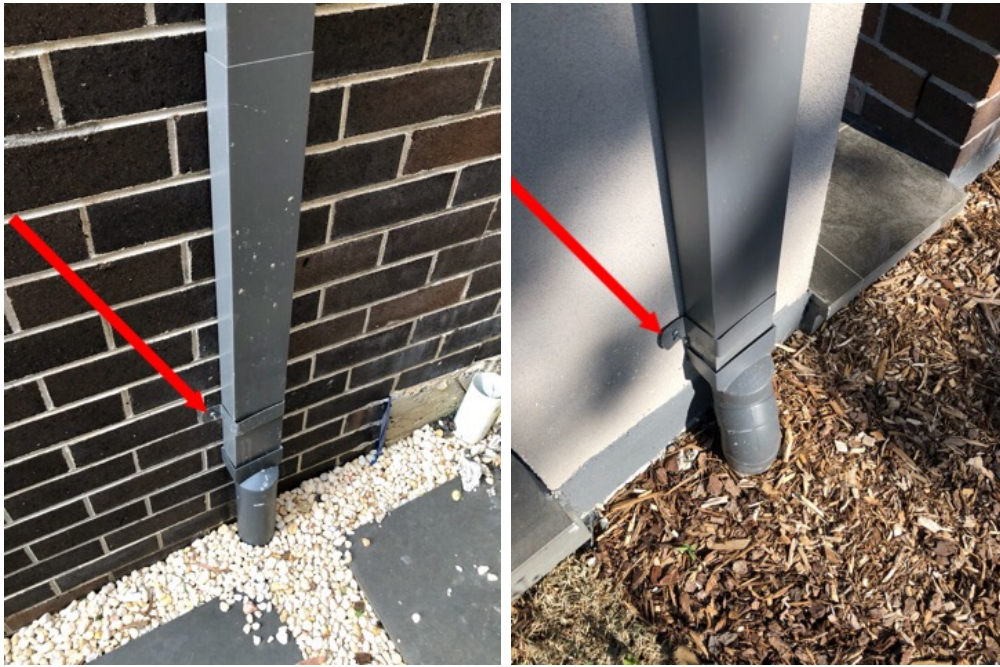
Down Pipe Findings

The down pipe/s wall clips is detached or missing. Recommendations: Although minor and easily rectifiable, we recommend a licensed roof plumber be engaged for repairs

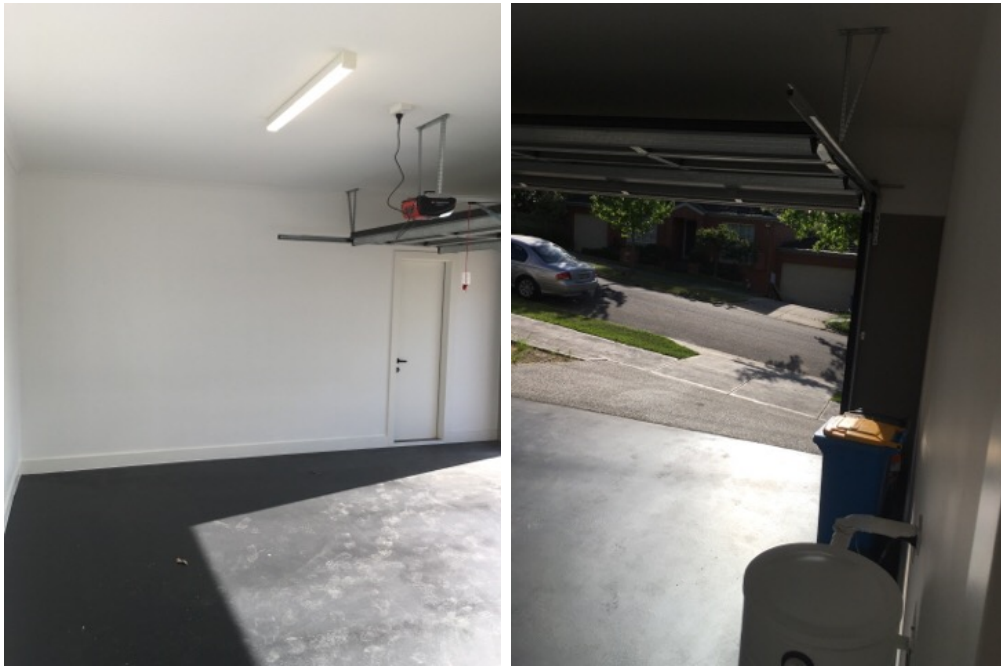
Internal Wall Findings

Internal wall deviation over standard and tolerance in the referred area.

The magnitude of the deviation is regarded as a major defect.

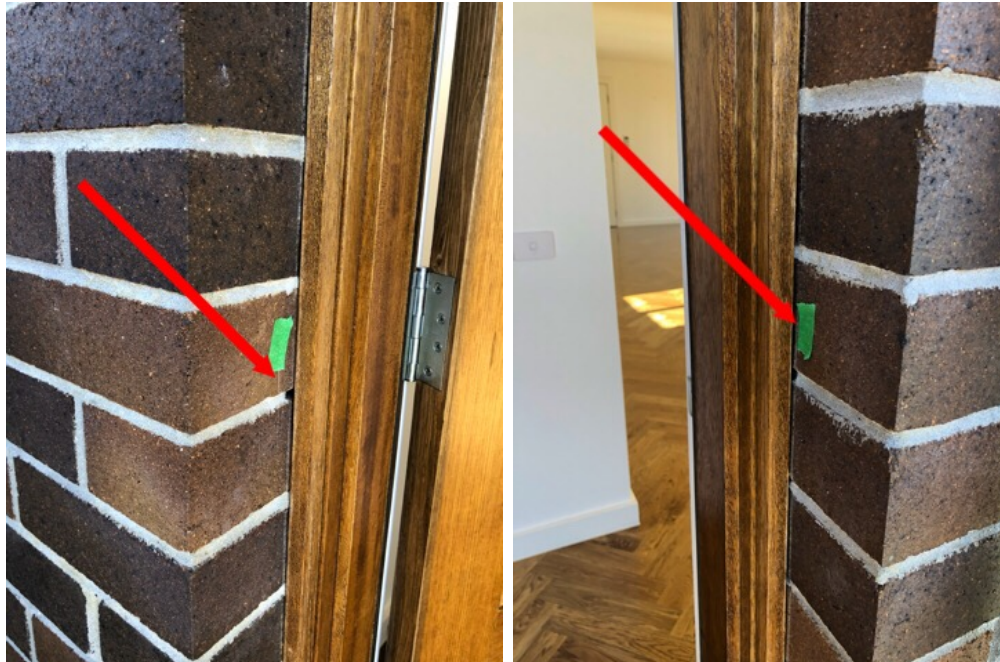
Door

Gaps noted, caulking required to the referred area

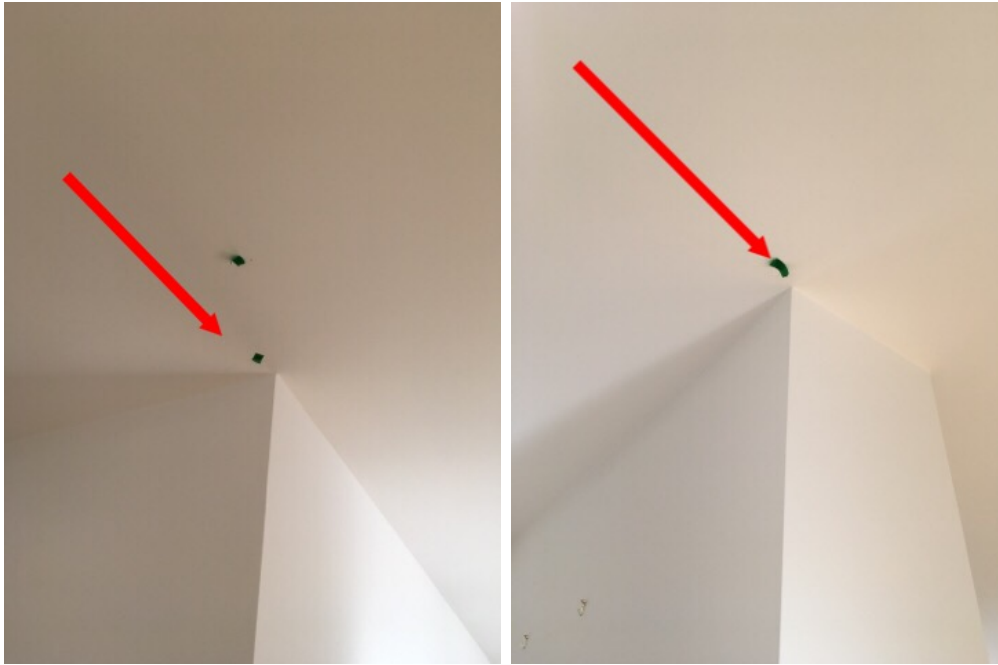
Walls

Minor dents, chips and scratches noted, touch up will satisfy.

Minor cracking noted, touch up will satisfy.

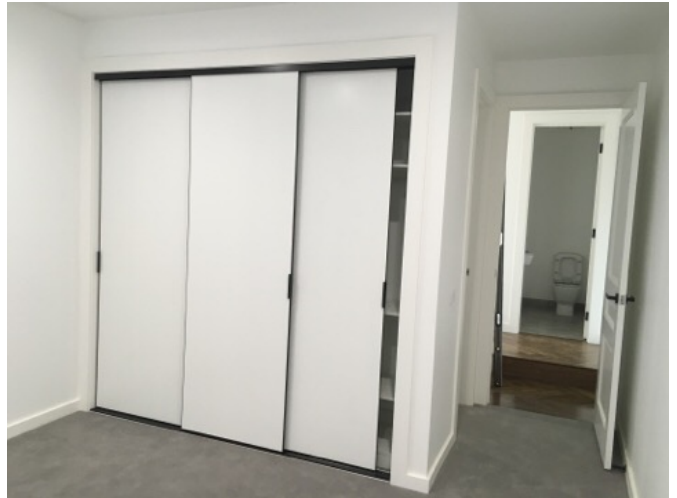
Door

Minor dents, chips and scratches noted - touch up will satisfy

Minor cracking noted, touch up will satisfy.

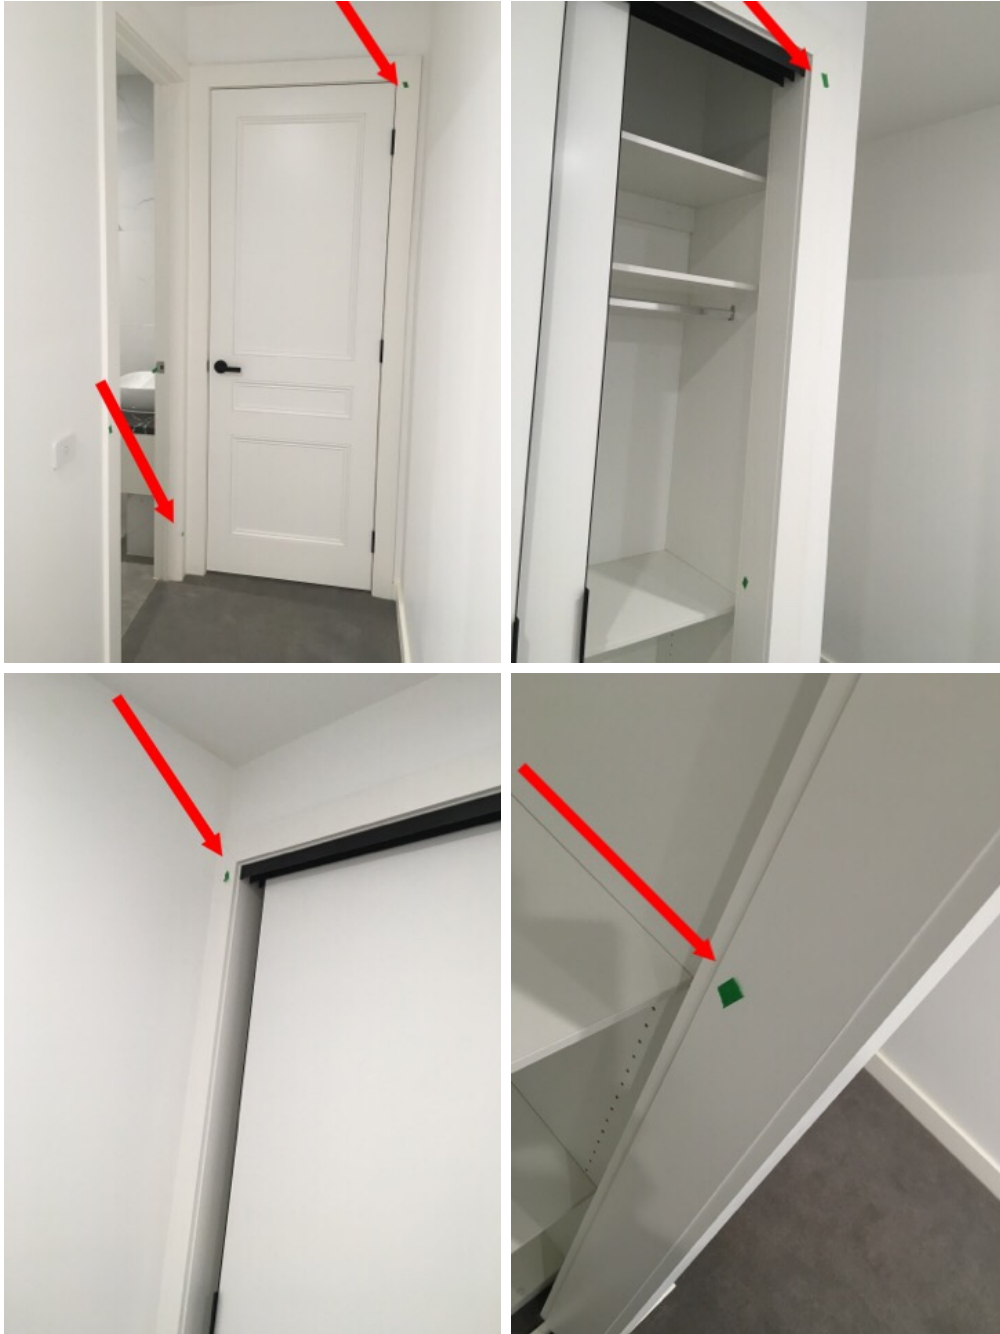
Walls

Minor dents, chips and scratches noted, touch up will satisfy.

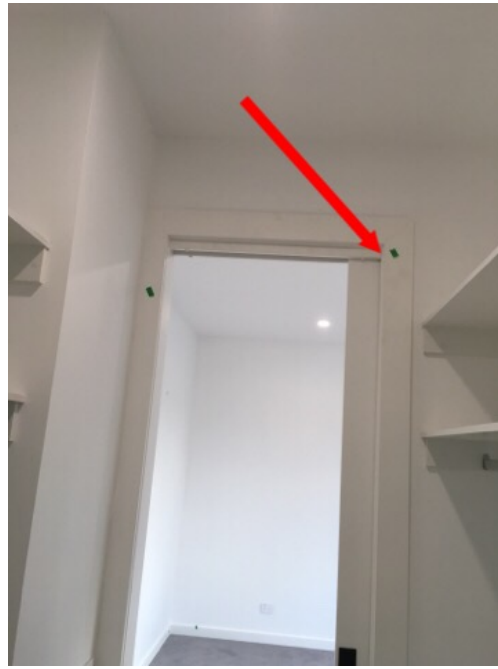
Walls

Minor dents, chips and scratches noted, touch up will satisfy.

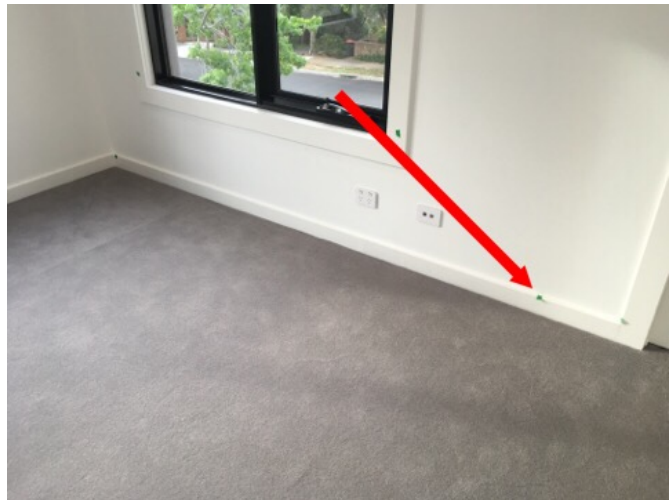
Windows

Minor cracking noted, touch up will satisfy.

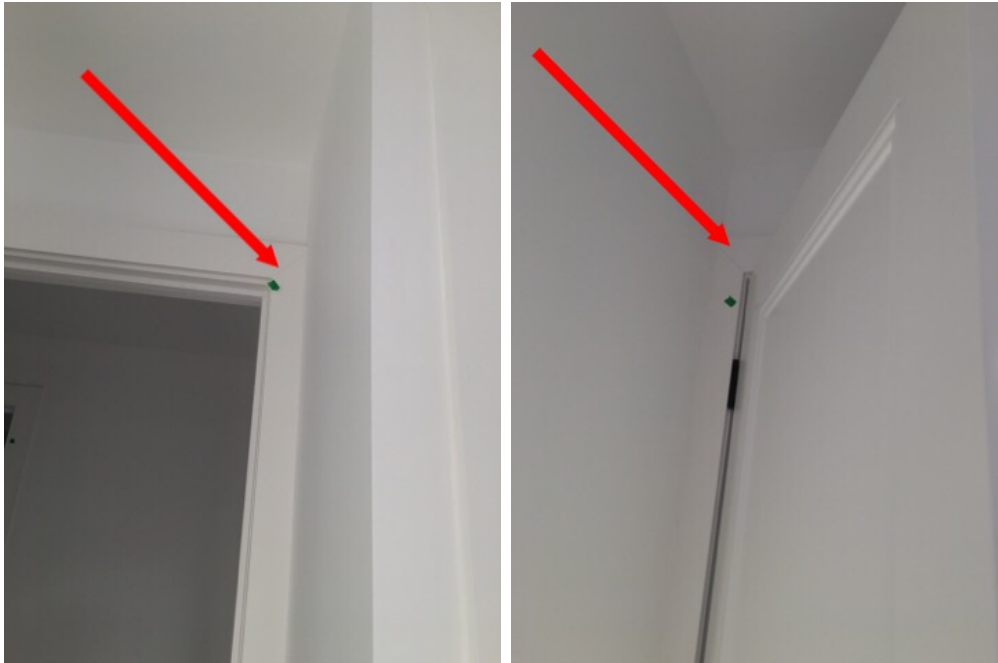
Walls

Minor dents, chips and scratches noted, touch up will satisfy.

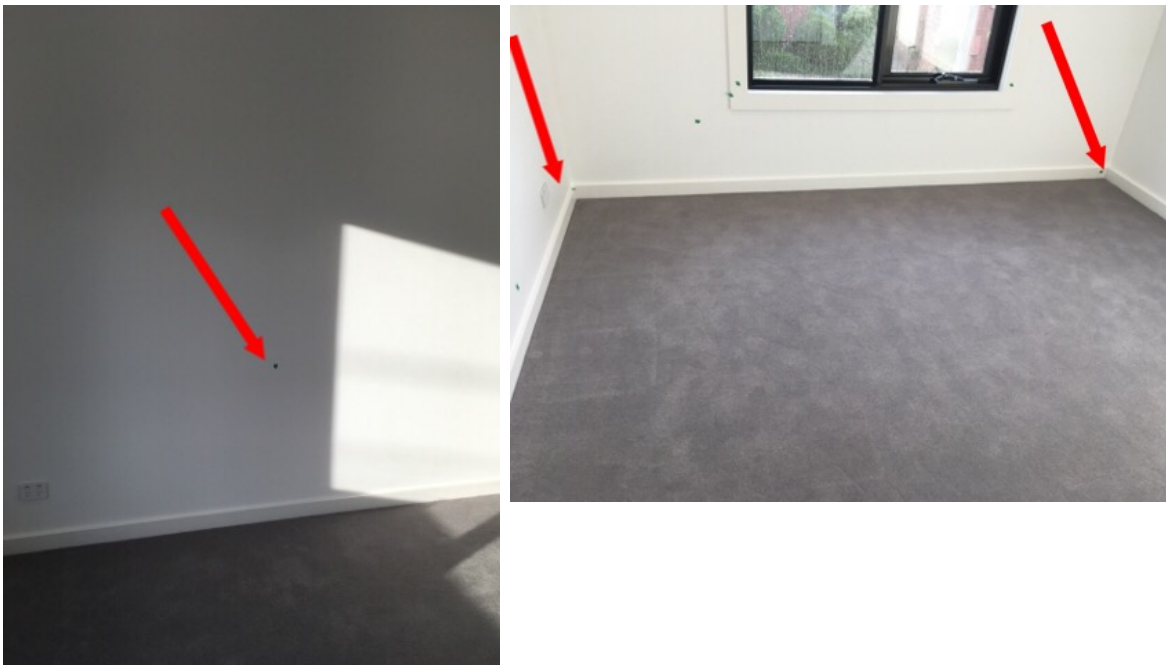
Windows

Minor cracking noted, touch up will satisfy.

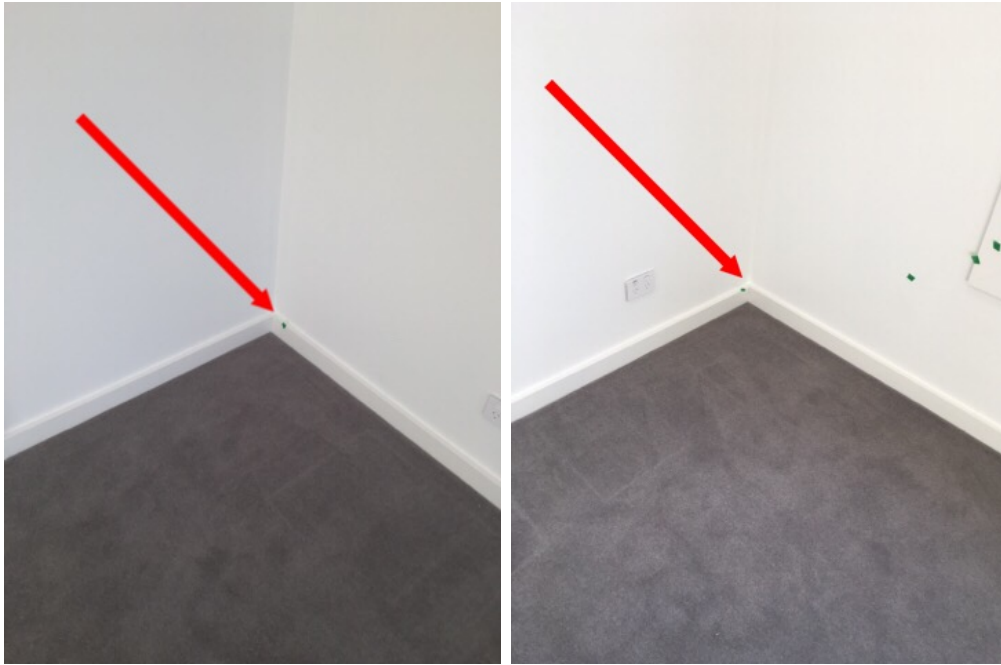
Flooring

Minor cracking noted, touch up will satisfy.

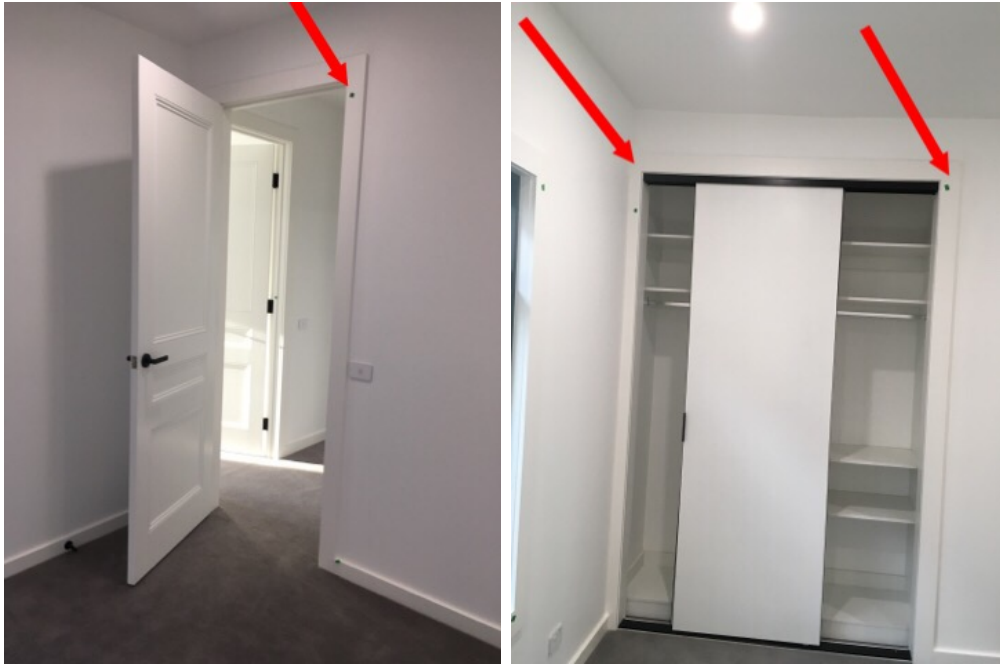
Walls

Minor dents, chips and scratches noted, touch up will satisfy.

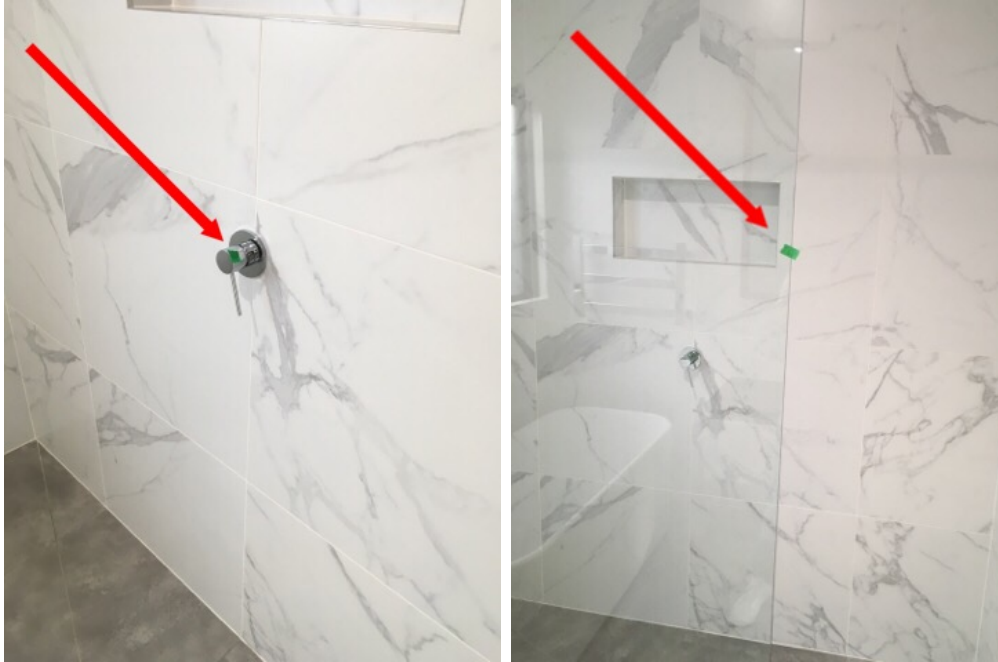
There is excessive pipe knocking or water hammer to the shower taps. Recommendations. Installing a Water Hammer Arrestor may resolve this, however speak with a licensed plumber for further recommendations.

Shower screen not secured, consider as a safety issue
