Building Inspection Report

Fangs Building Inspections

lot 555, 12 Ninevah Avenue, Clyde North, VIC

Inspection Date: 12 Dec 2019

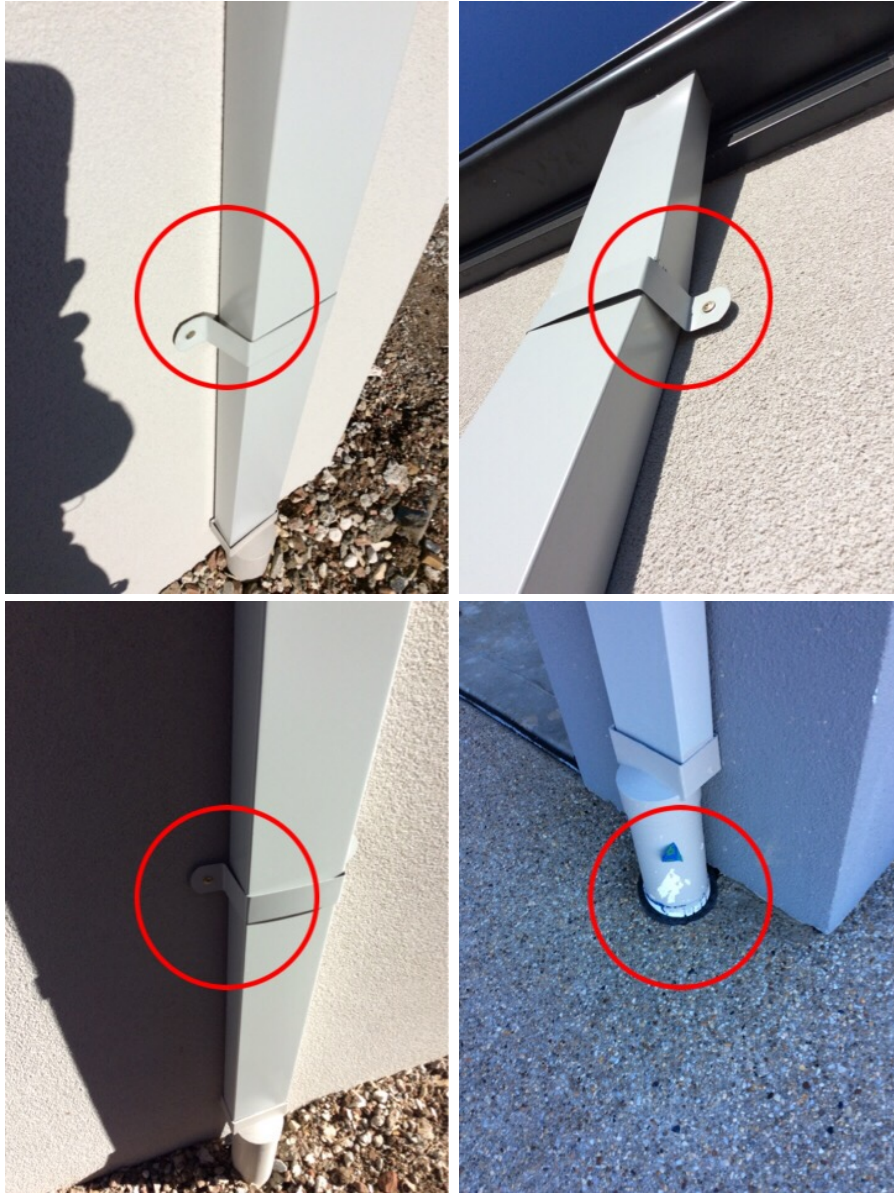
The down pipe/s wall clips is detached or missing. Recommendations: Although minor and easily rectifiable, we recommend a licensed roof plumber be engaged for repairs

Downpipes should be finished in a protective coating to preserve integrity and minimise the likelihood of corrosion.

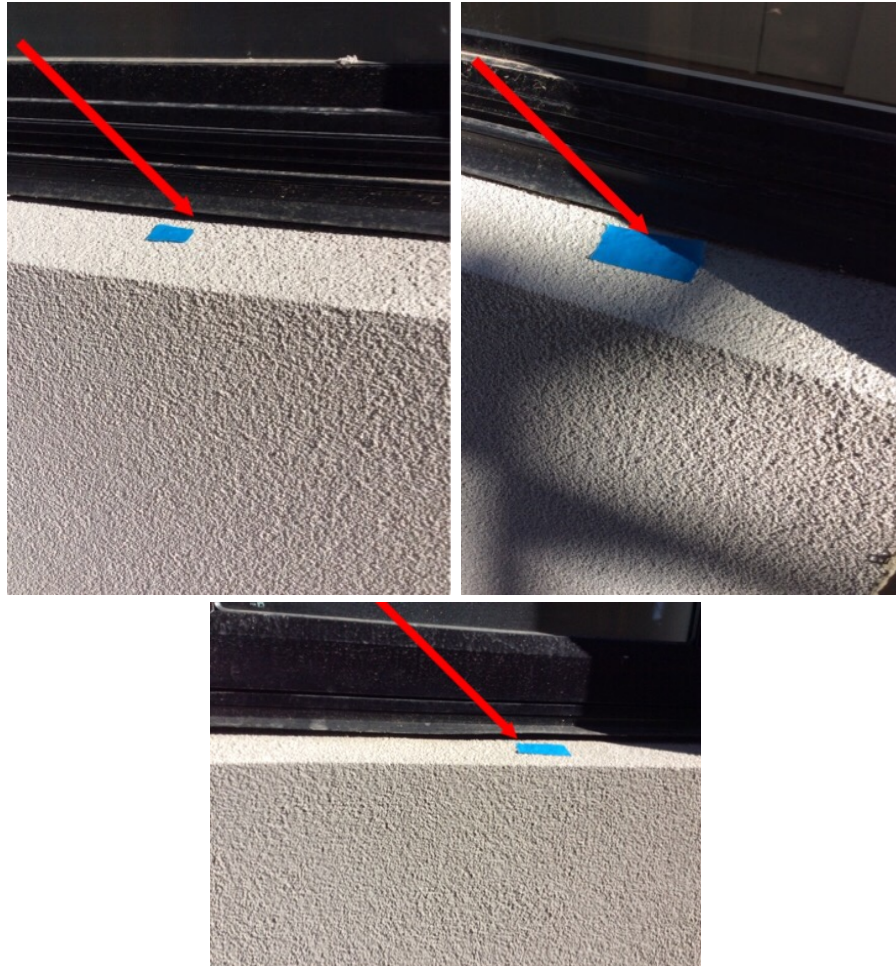
Gaps between window frame and wall cladding evident, caulking required to the referred area.

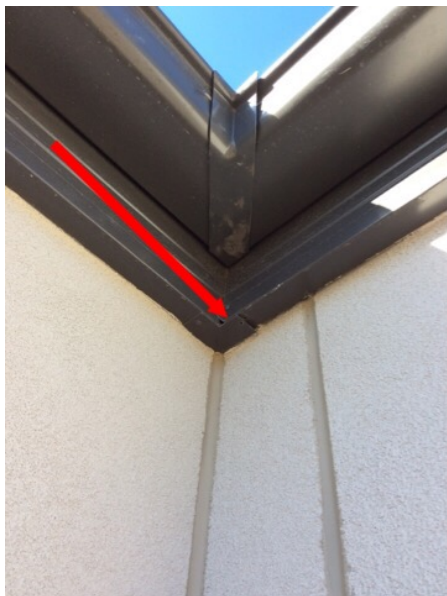
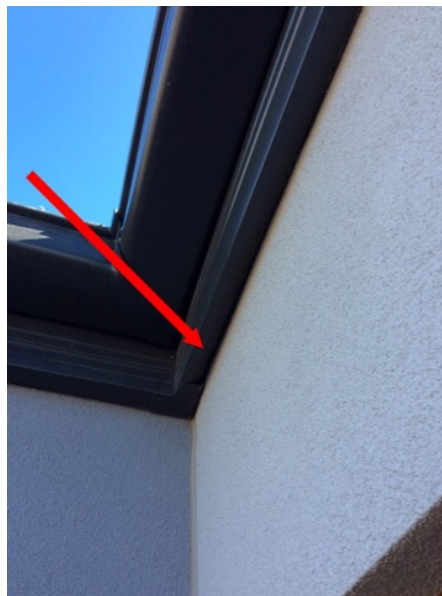
Impact/Denting damage observed.

Requires screws

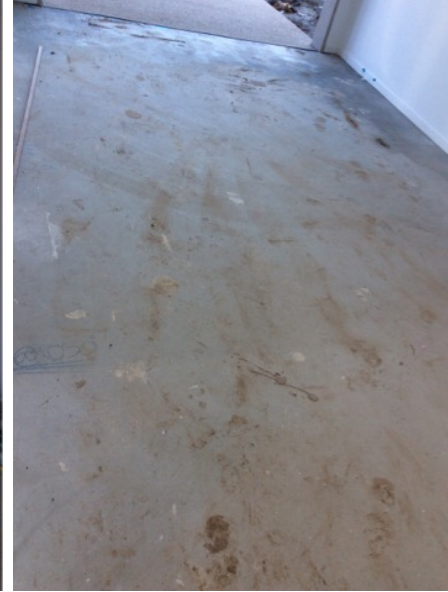
Cleaning requires

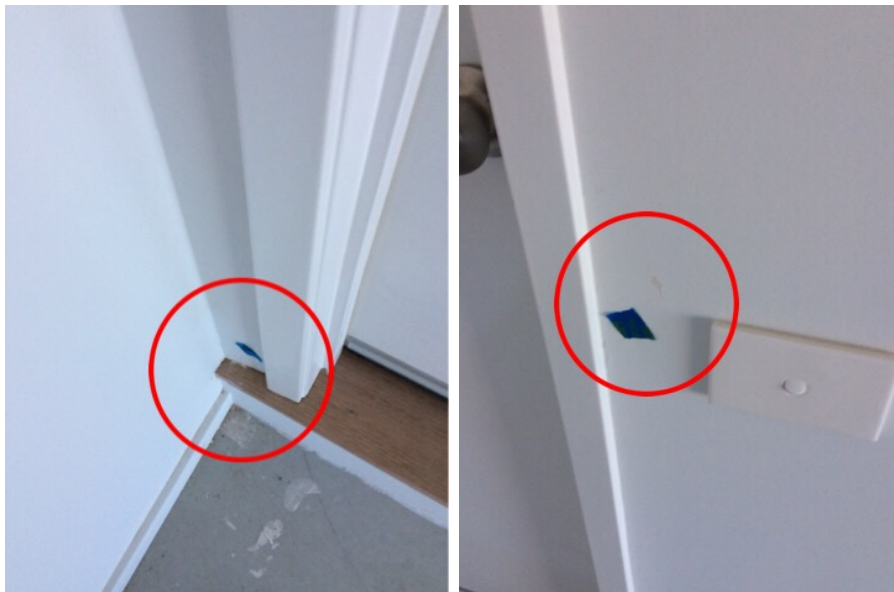
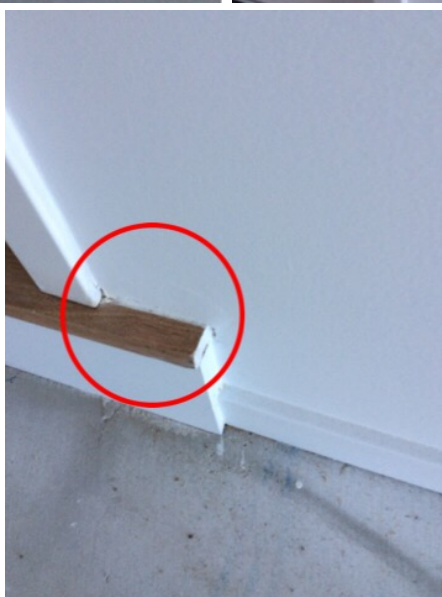
Minor dents, chips and scratches noted, touch up will satisfy.

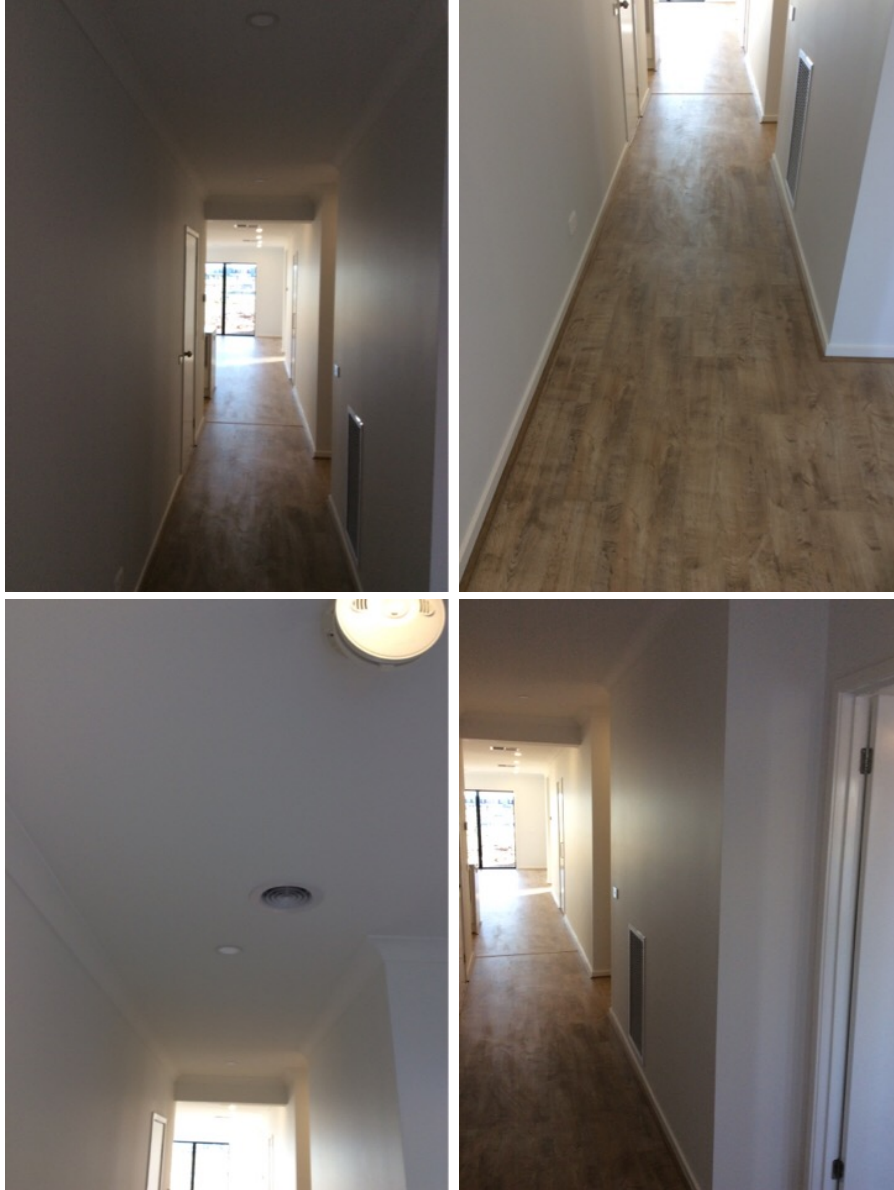
Cleaning Required

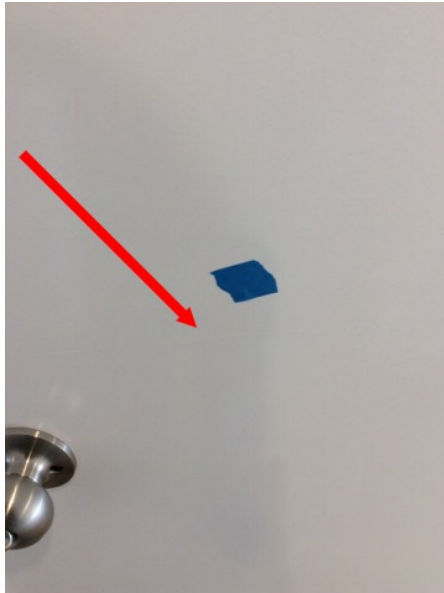
Minor dents, chips and scratches noted - touch up will satisfy
Uneven / out of square door causing binding, adjustment required.

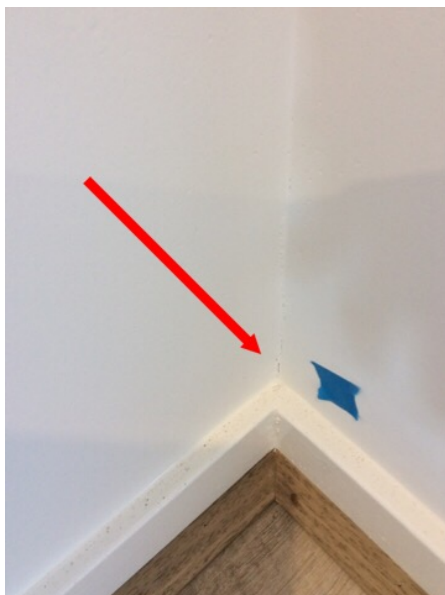
Minor cracking noted, touch up will satisfy.
Paint mark noted, touch up will satisfy.

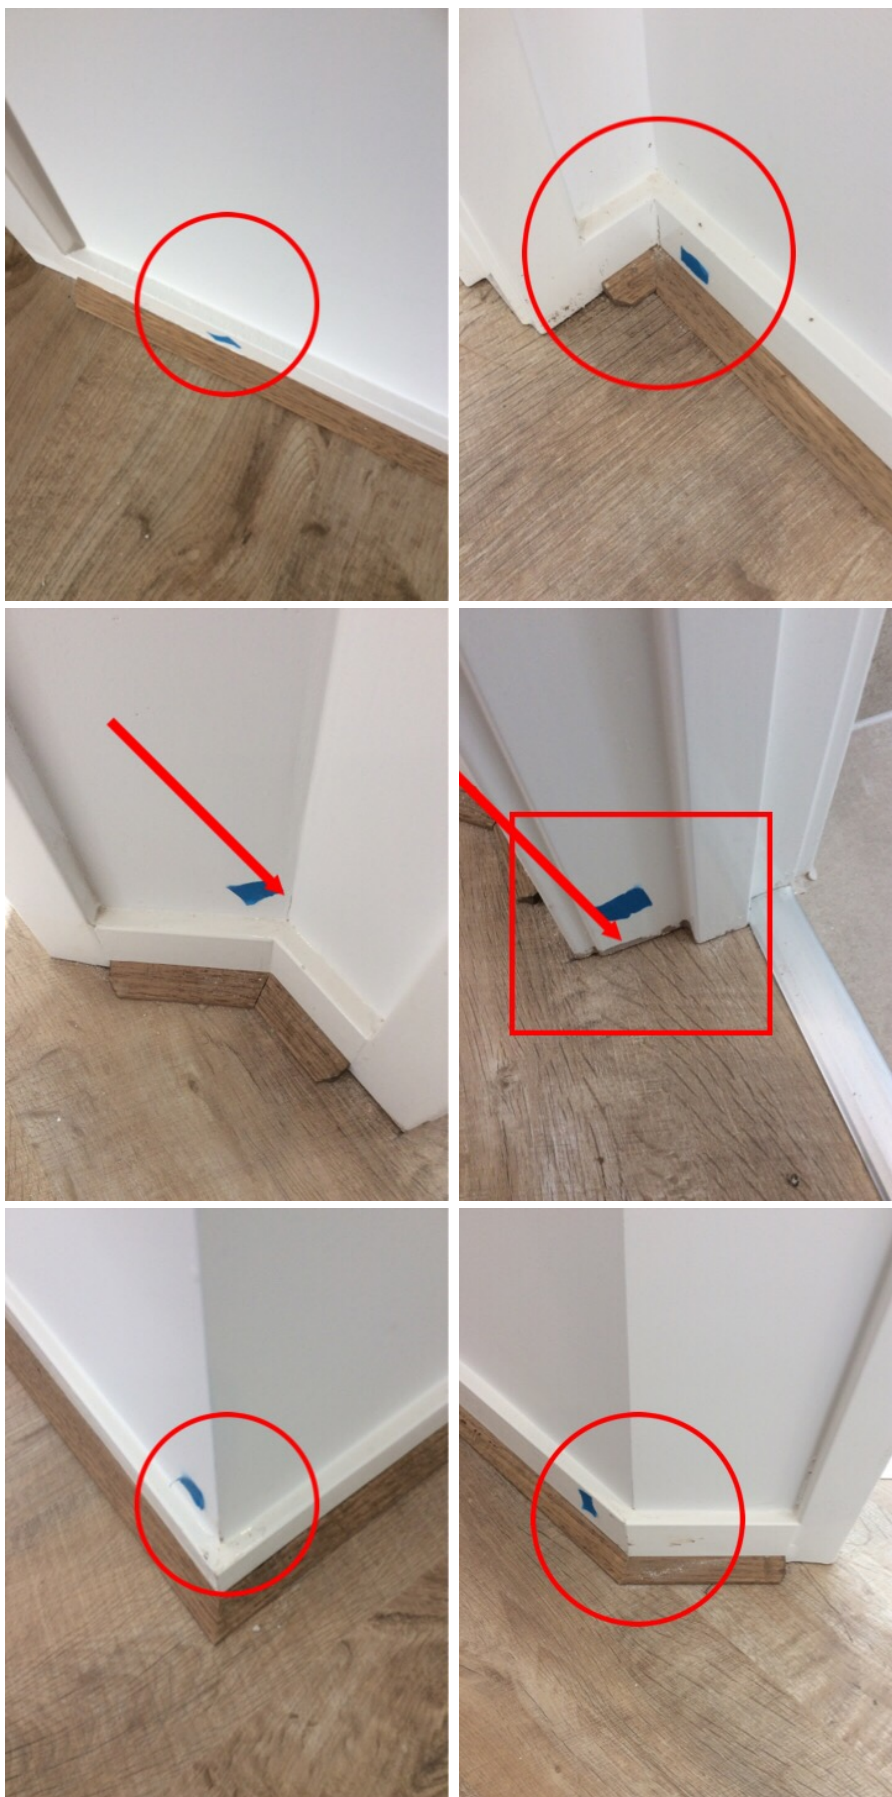
Minor dents, chips and scratches noted, touch up will satisfy.

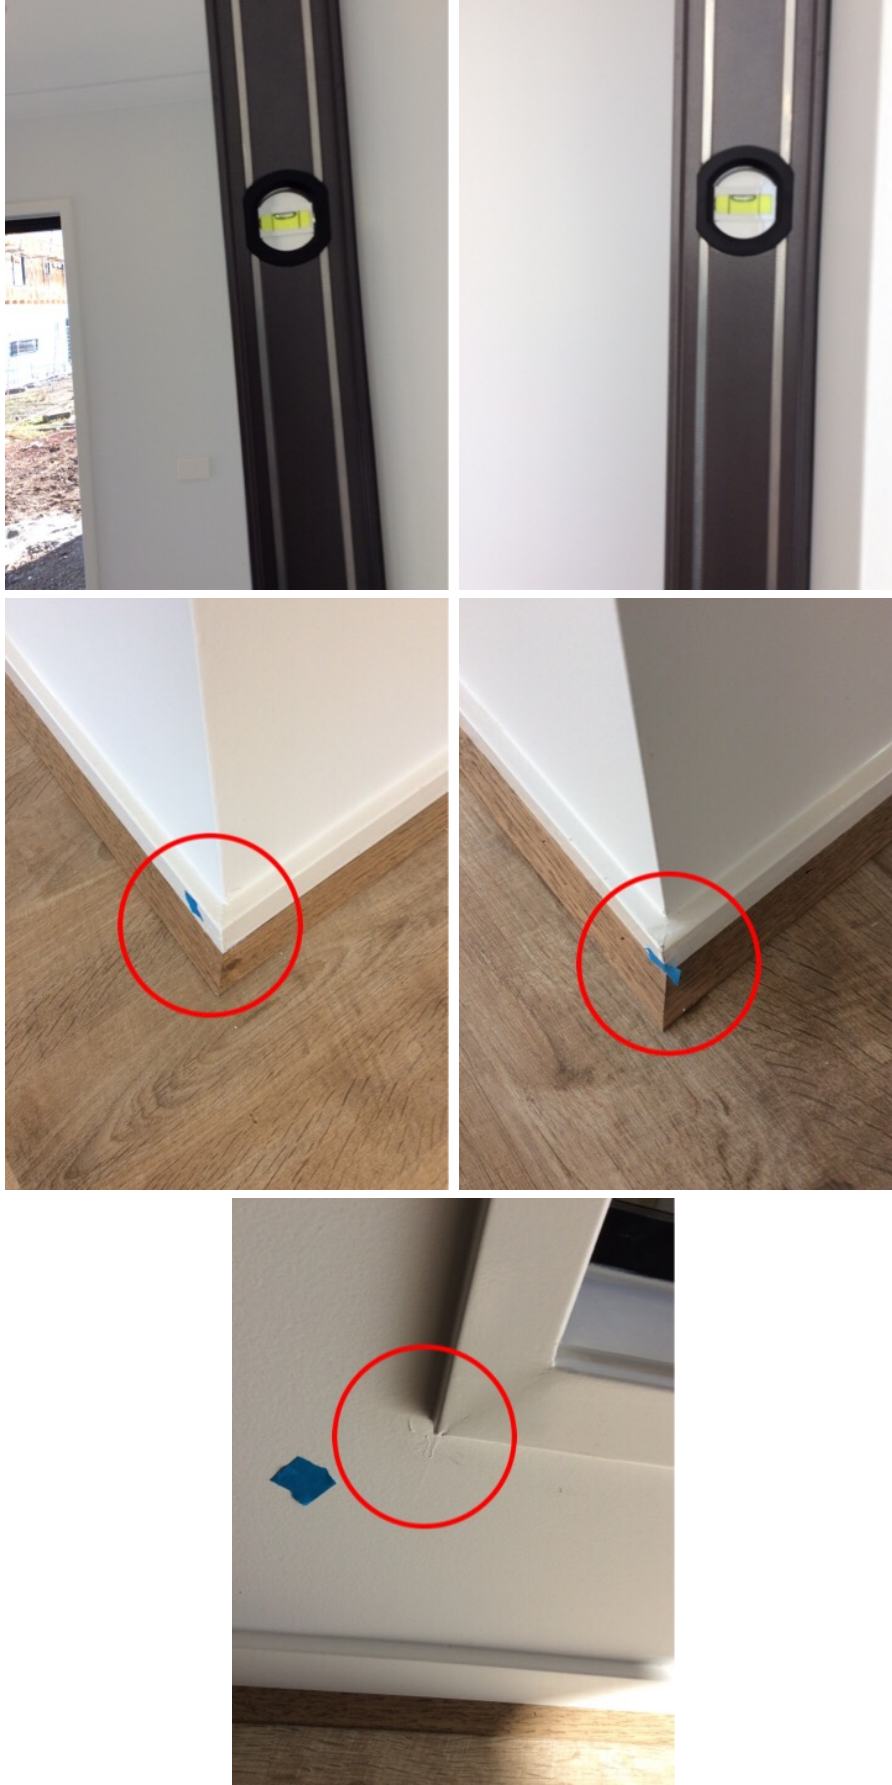
The wall is plumb / straight or has deviation that is within standards and tolerance.
Minor dents, chips and scratches noted, touch up will satisfy.

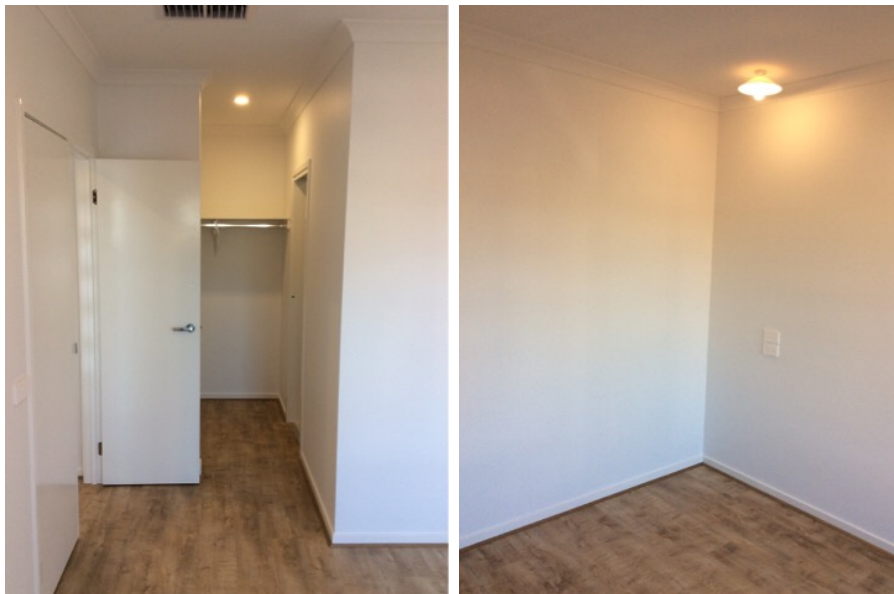
Ducted heating / cooling out cover has separated from the ceiling and requires re-attachment

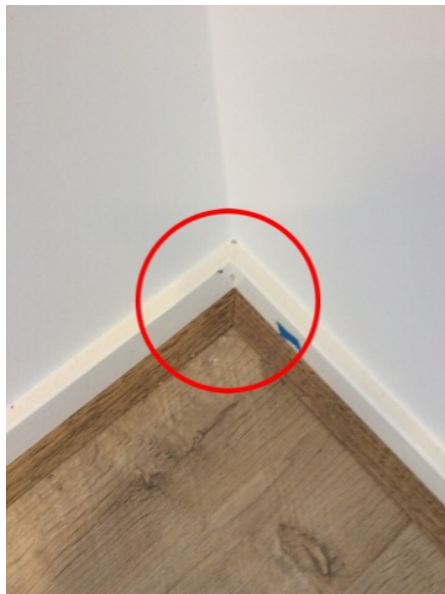
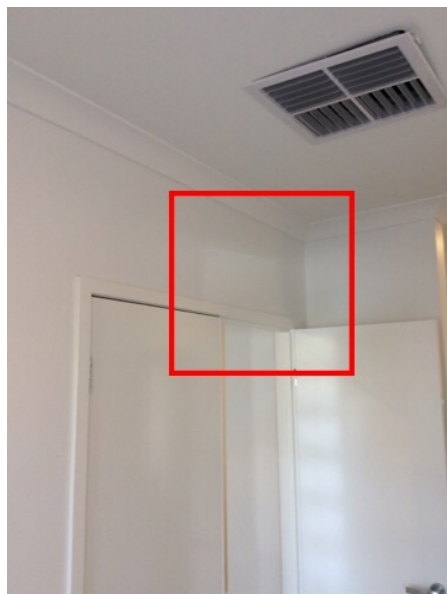
Minor dents, chips and scratches noted, touch up will satisfy.
Over painting to the referred area, touch up will satisfy.

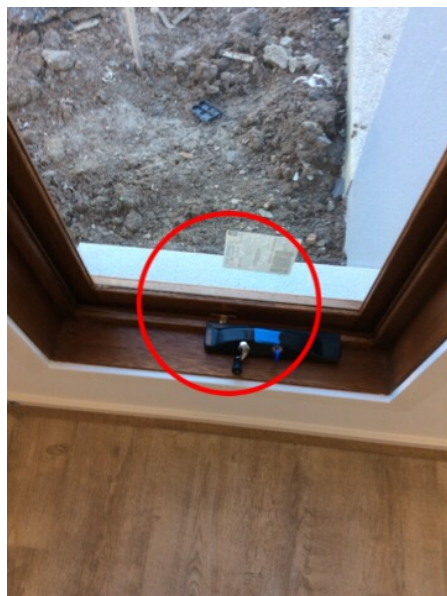
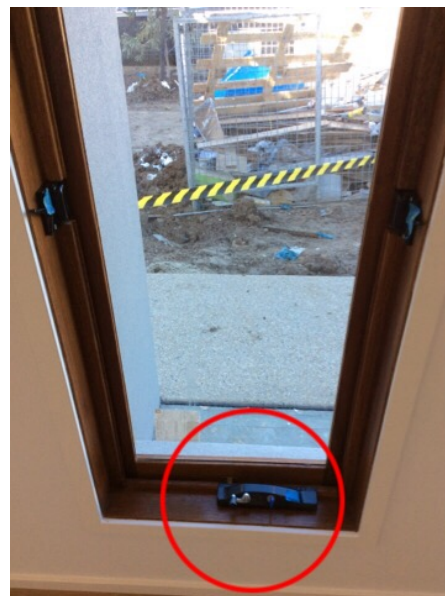
Faulty / unable to open - Recommendations: A qualified carpenter should be engaged for advice and recommendations.

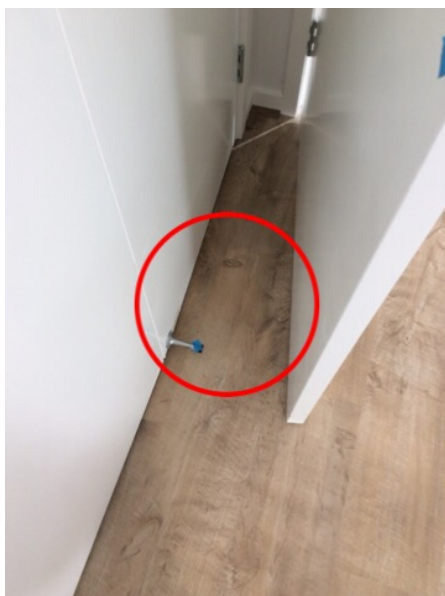
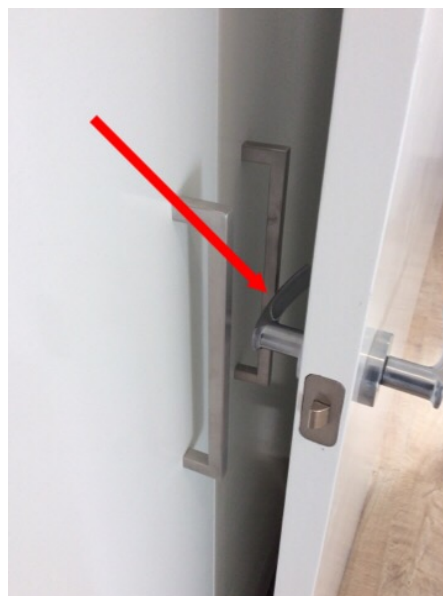
Door stopper doesn't fit for the purpose

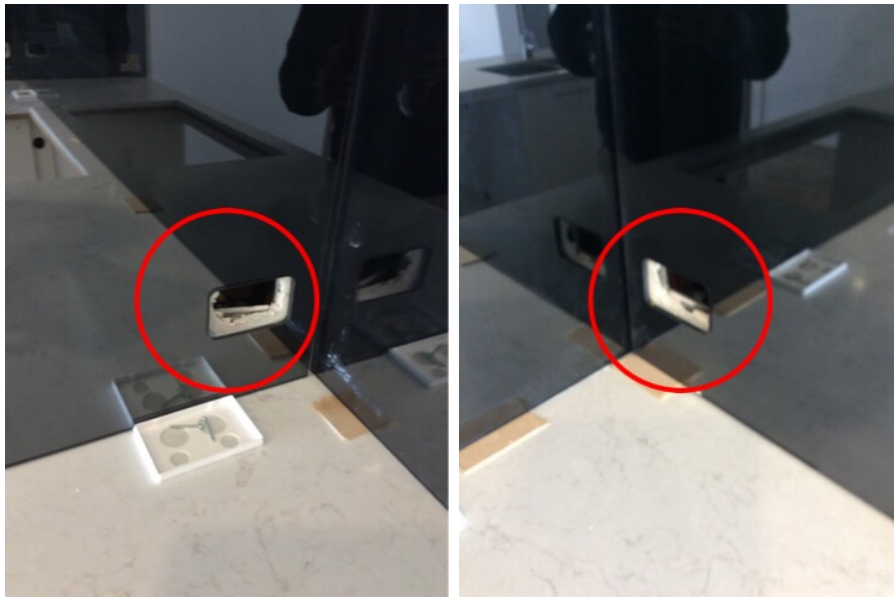
Electrical outlet(s) not Installed Properly

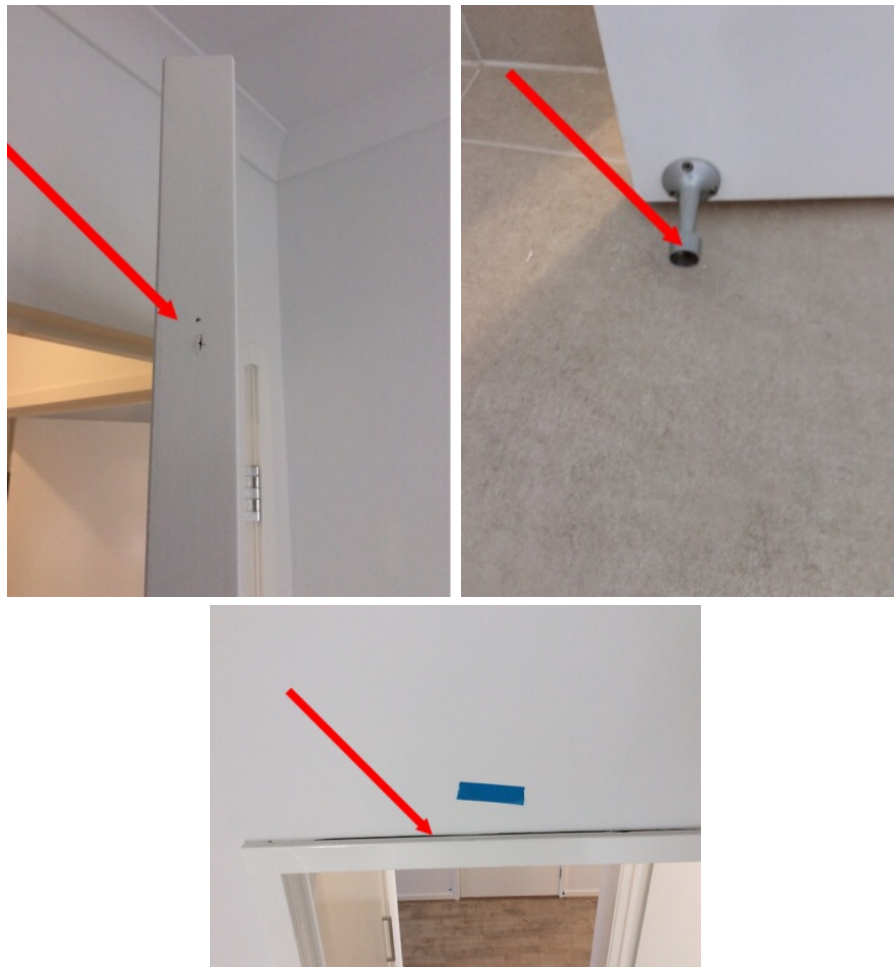
Minor dents, chips and scratches noted - touch up will satisfy
Door stopper's rubber missing

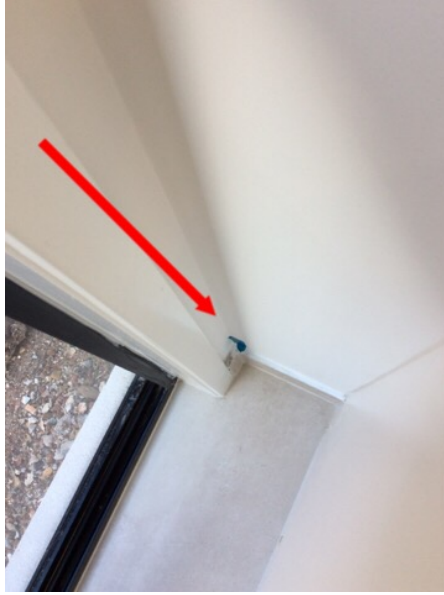
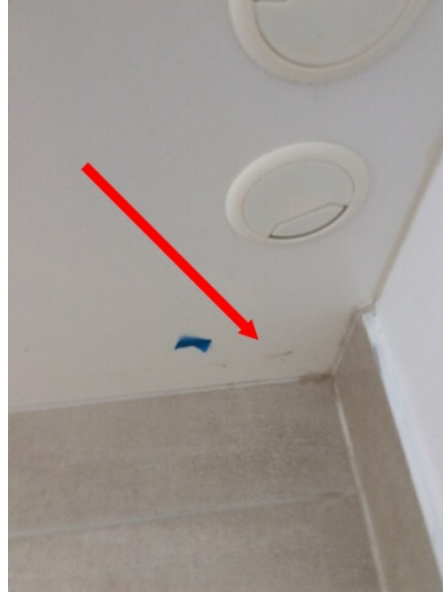
Minor dents, chips and scratches noted, touch up will satisfy.

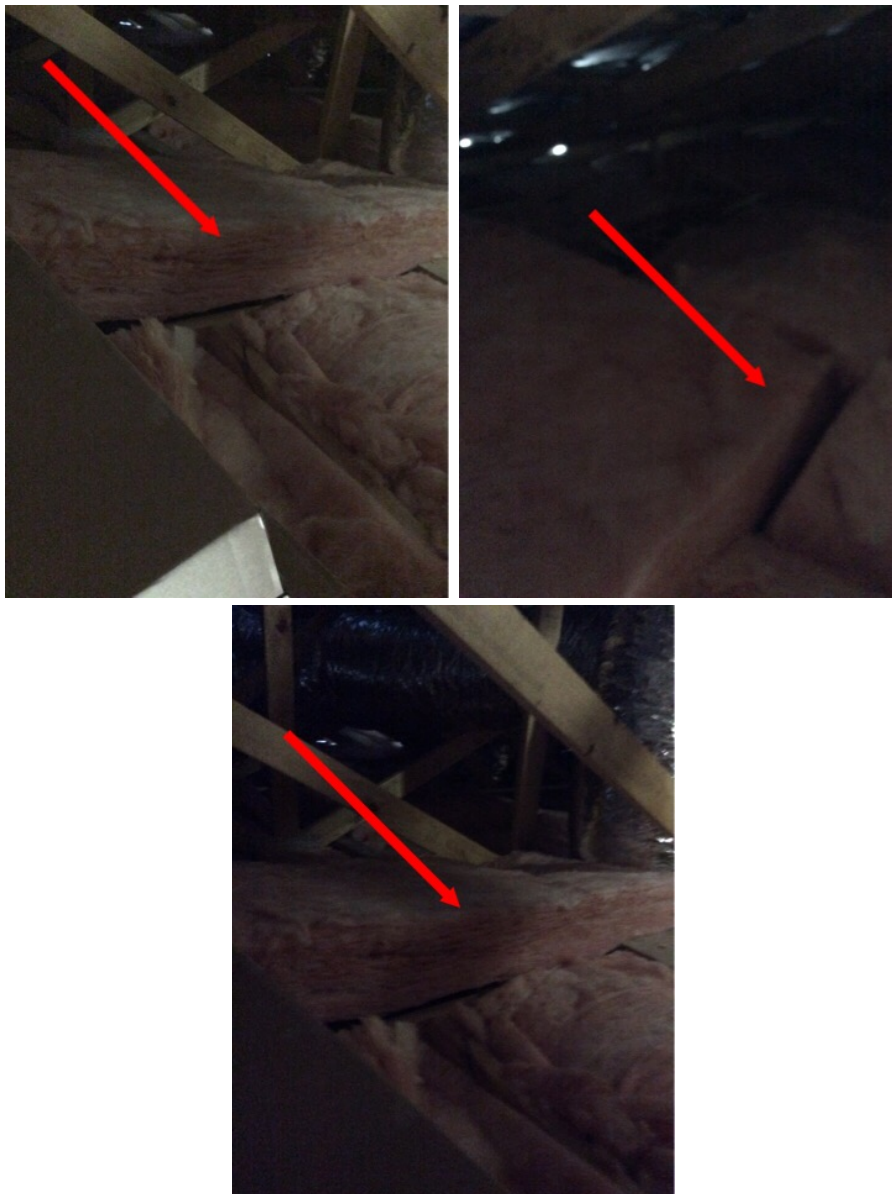
Sections of the insulation were poorly installed / laid with gaps visible in sections. Recommendations: Request builder insulation contractor to assess.
