Building Inspection Report

Fangs Building Inspections

3 Bound Avenue, Box Hill, VIC

Inspection Date: 30 Jan 2020

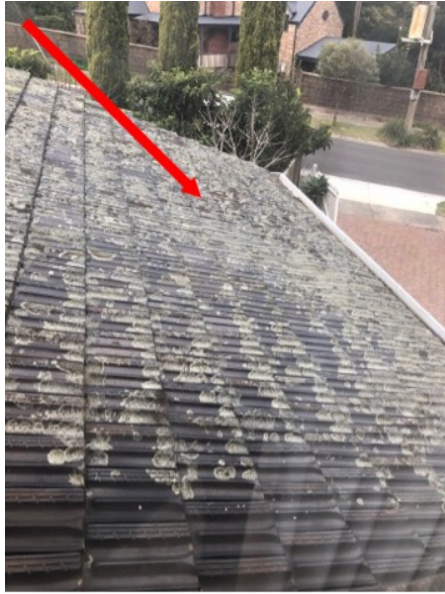
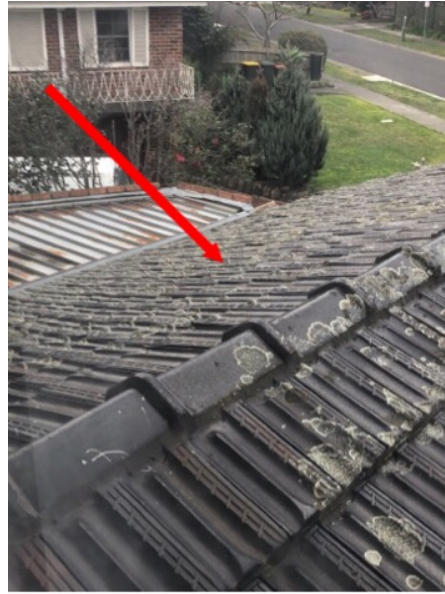
Moss has built up on the tiles over time. It is preferable to have removed / cleaned to prevent deterioration.

Recommendations: A qualified roof restoration contractor should be engaged for advice and recommendations.

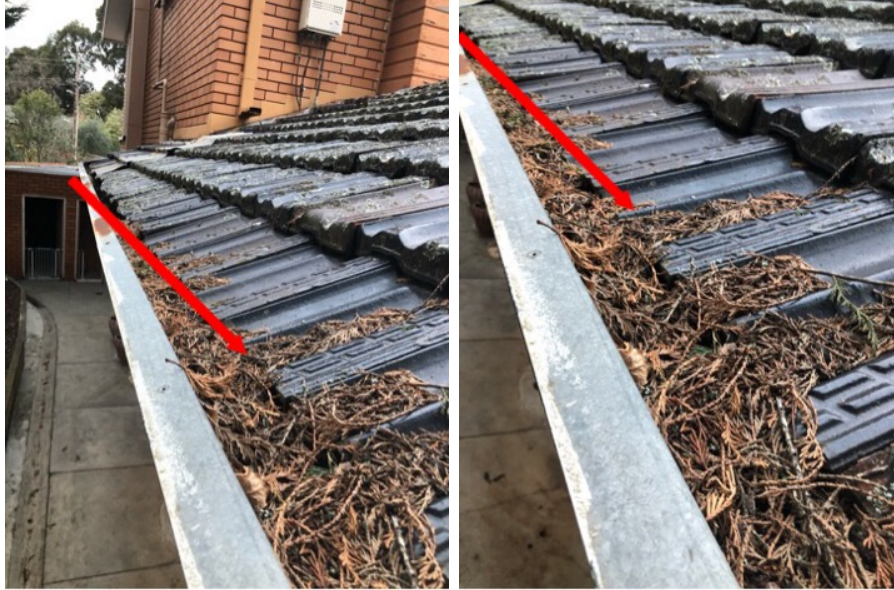
Debris in guttering areas- this requires cleaning out to prevent blocking of down pipes and leaking into eaves and fascia. Recommendations: Have gutters cleaned and assessed by a plumber for adequate fall. Also regularly clean to prevent ponding. Ponding water will contribute to rust.

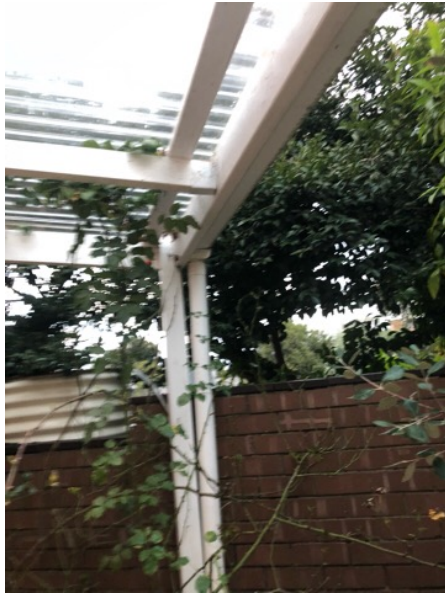
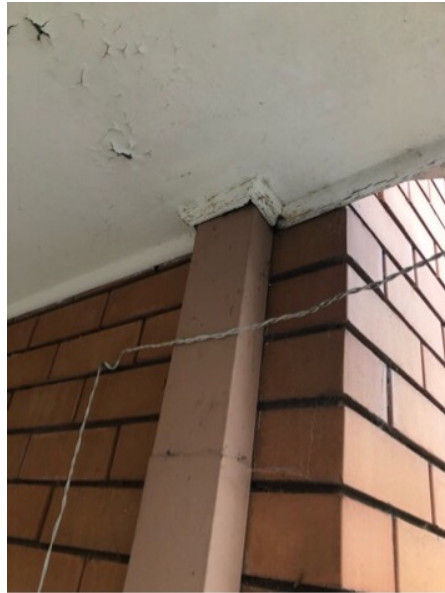
Minor down pipe rust visible. Recommendations: A qualified plumber should be engaged for advice and recommendations - Replacement may be necessary.

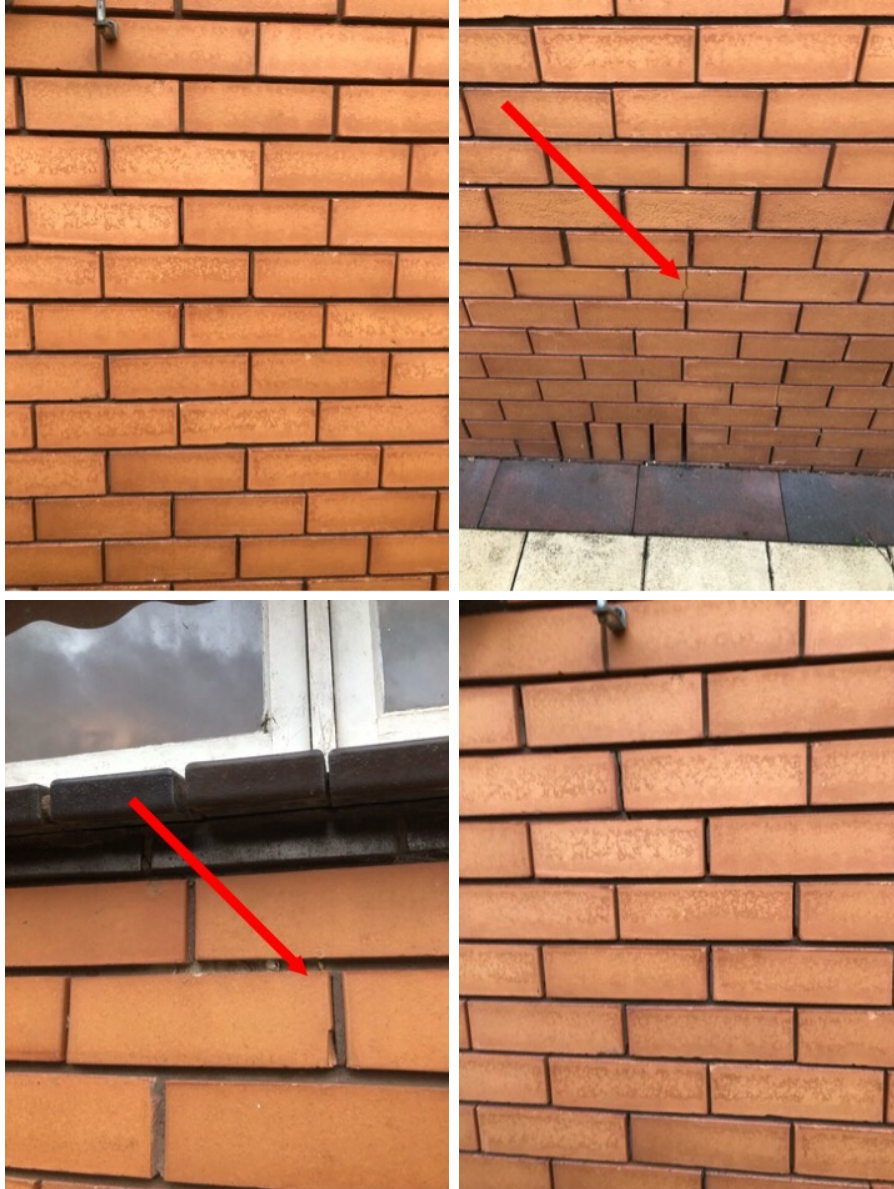
There appears to have been some settlement in the building which has caused some cracking to the walls. These cracks are categorized as 0 to 2 <5mm. This can also cause some doors to bind or be out of square. In the inspectors opinion these cracks are due to settlement, usually due to ground movement and subsequent movement to building materials can be expected. Any cracks should be monitored and if cracks increase in size, further investigation should be carried out by a structural engineer.

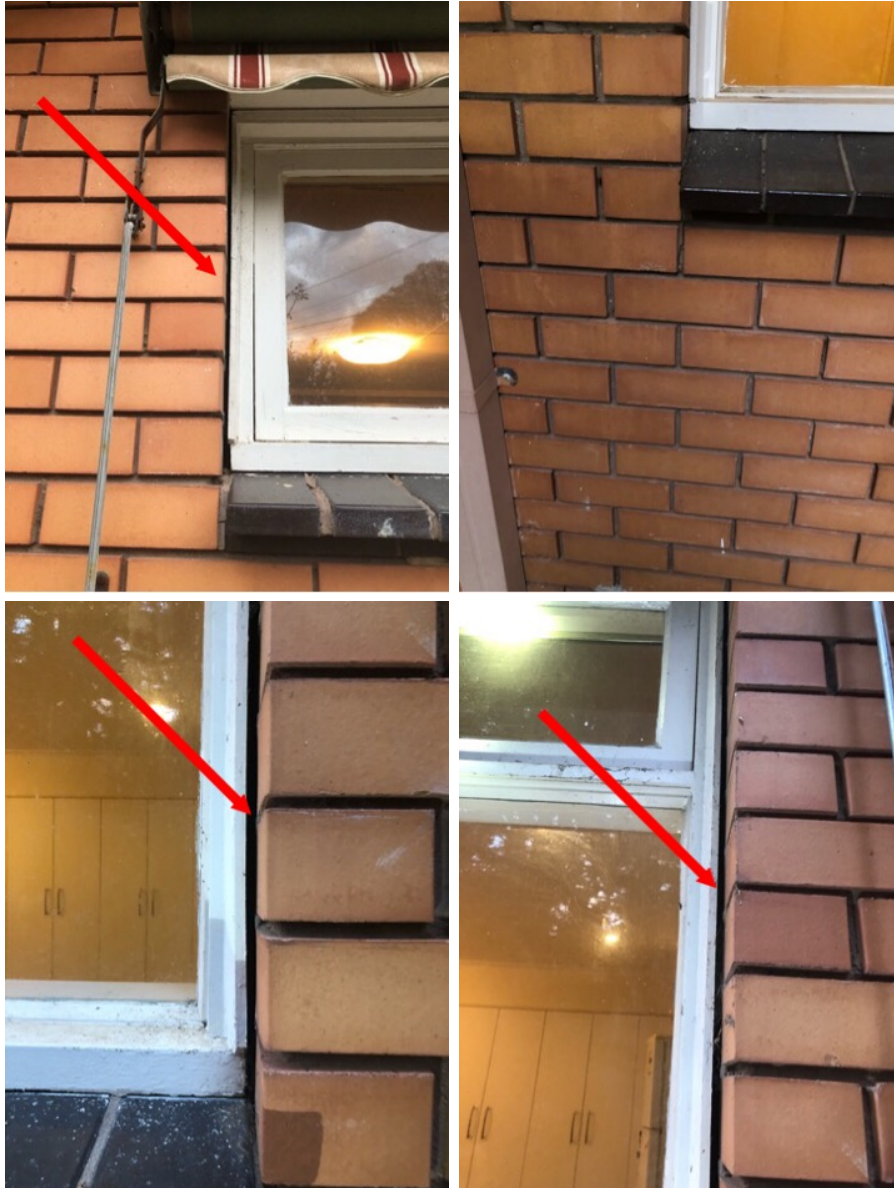
Gaps between window frame and wall cladding evident - This can be due to poor workmanship, wall movement, footings settlement. Recommendations: A qualified carpenter should be engaged for advice and recommendations.

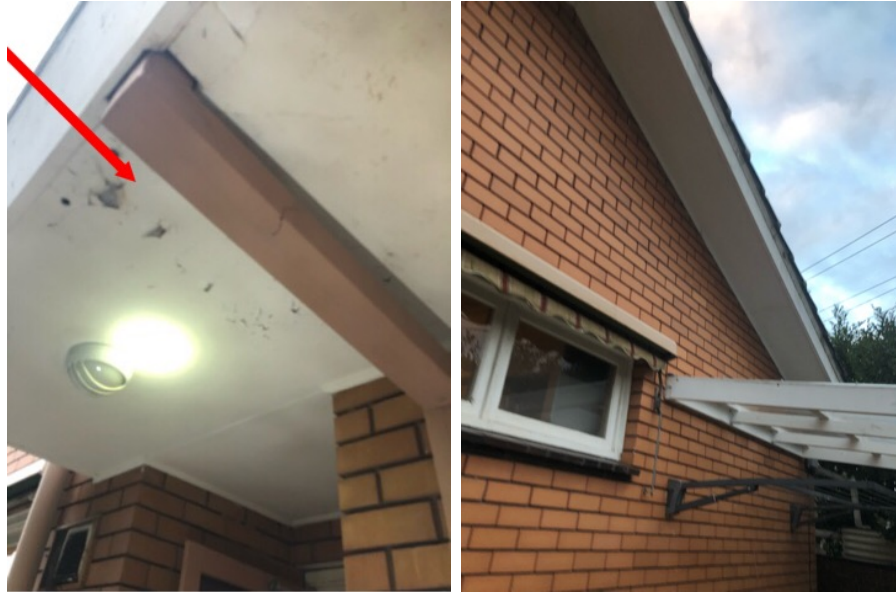
Paint flake/deterioration is evident. Recommendations: General maintenance / painting as required.

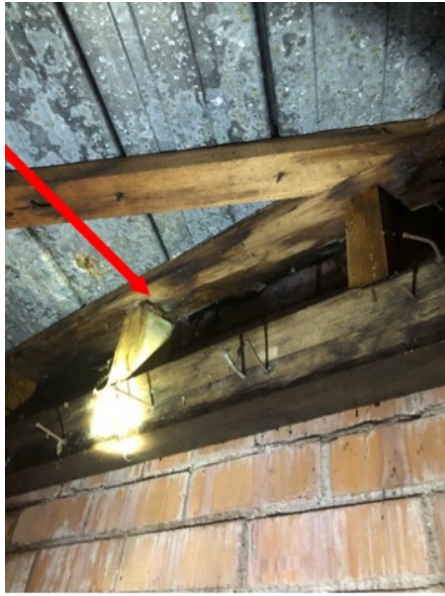
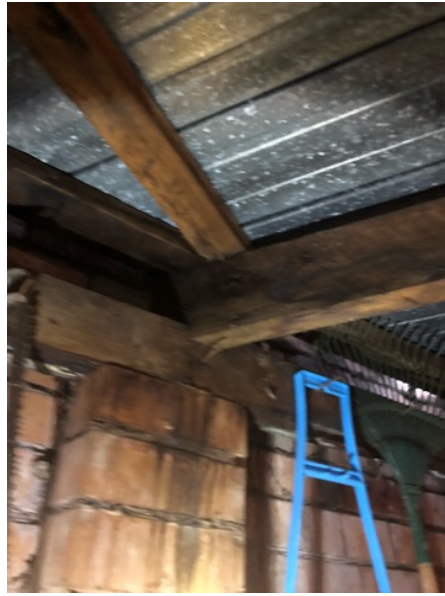
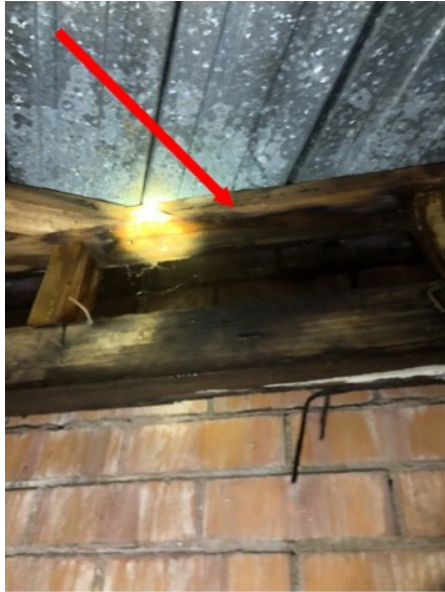
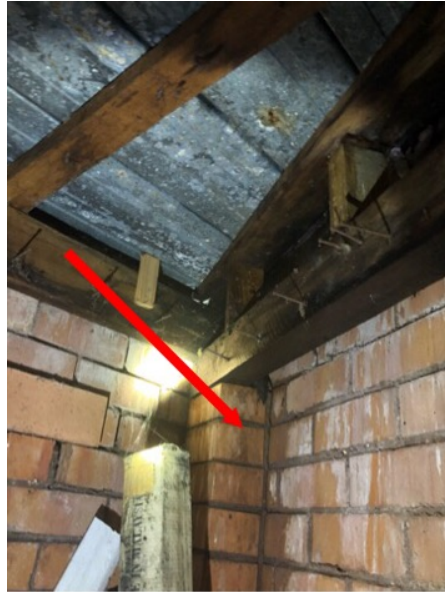
Ceiling stains - Moisture readings obtained - Possibly still active leaking. Recommendations: A qualified plumber should be engaged for advice and recommendations. We strongly recommend that all water damaged plaster be replaced by a qualified plasterer due to potential detachment or collapse. Considered a Major Defect and a Safety Hazard

The roof appears to be leaking. Monitor this in periods of rain and contact a licensed roofer for repairs. Considered a Minor Defect however has the potential to be a Major Defect based on roofers recommendation.

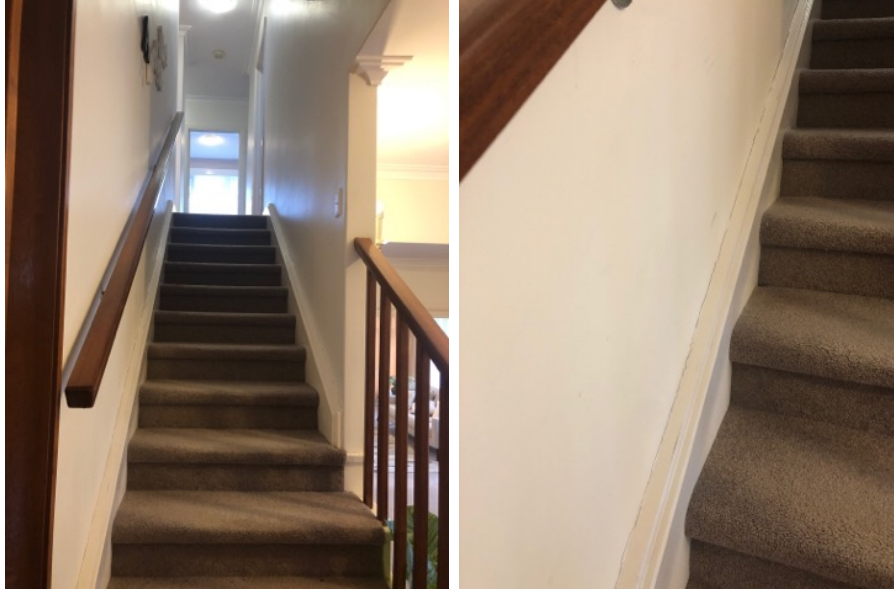
The internal stair case is in a serviceable condition for the age with no notable defects sighted. Settlement cracks noted to the wall. These are typical and generally patch and paint will suffice, however we recommend monitor these cracks and if become wider or longer, you will need to contact a structural engineers to assess.

Squeaky floor at landing noted. Re-fixing the floor boards may fix this issue.

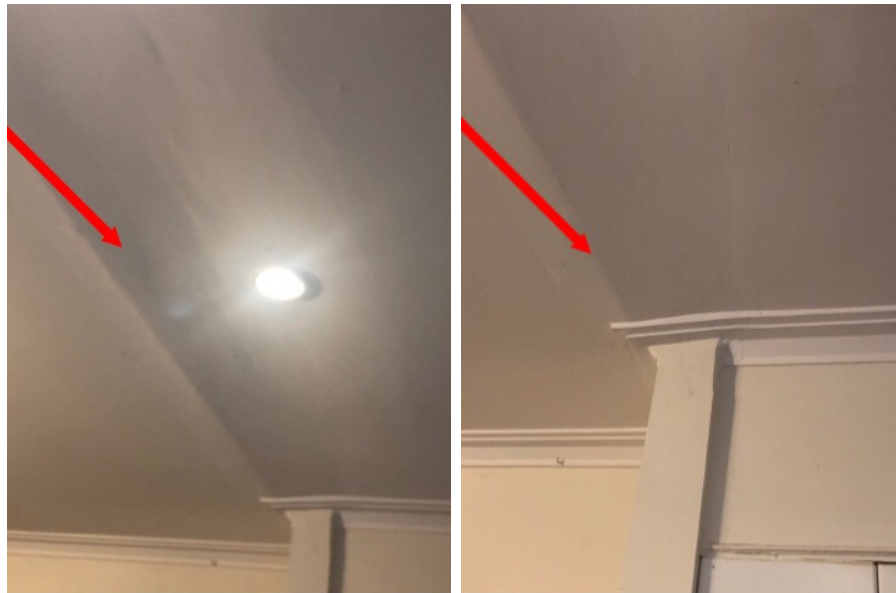
There appears to have been some settlement in the building which has caused some cracking to the ceiling. These cracks are categorized as 0 to 2 <5mm. This can also cause some doors to bind or be out of square. In the inspector's opinion these cracks are due to settlement, usually due to ground movement and subsequent movement to building materials can be expected. Any cracks should be monitored and if cracks increase in size, further investigation should be carried out by a structural engineer.

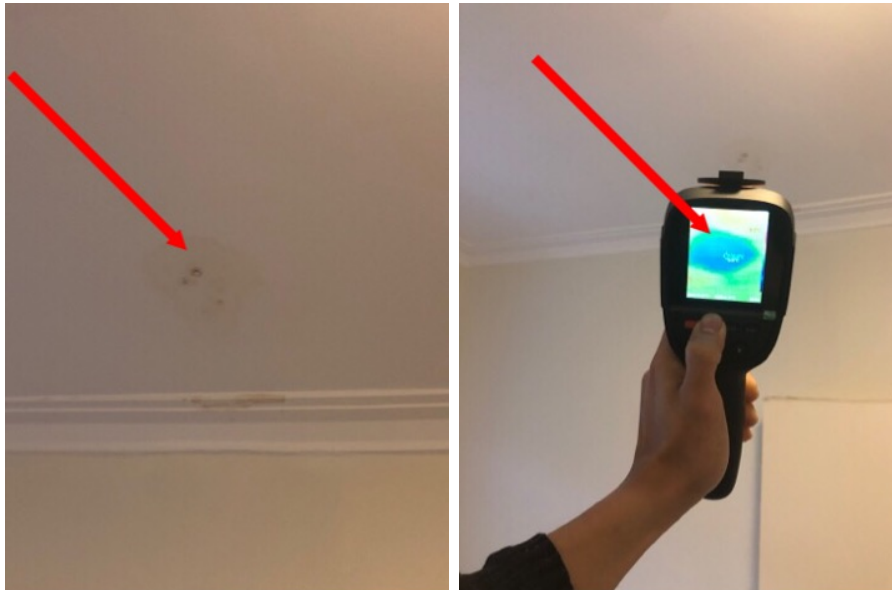
Ceiling stains - Moisture readings obtained. In the absence of rain It's difficult to ascertain with certainty the location of the leak. Recommendations: A qualified roofer should be engaged for advice and recommendations. All water damaged plaster should be replaced by a qualified plasterer.

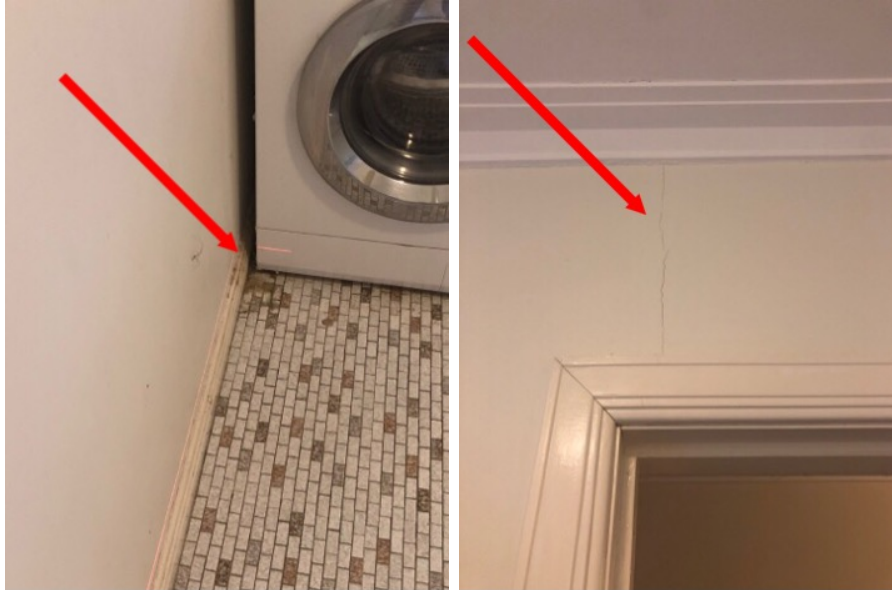
There appears to have been some settlement in the building which has caused some cracking to the walls. These cracks are categorized as 0 to 2 <5mm. This can also cause some doors to bind or be out of square. In the inspector's opinion these cracks are due to settlement, usually due to ground movement and subsequent movement to building materials can be expected. Any cracks should be monitored and if cracks increase in size, further investigation should be carried out by a structural engineer.

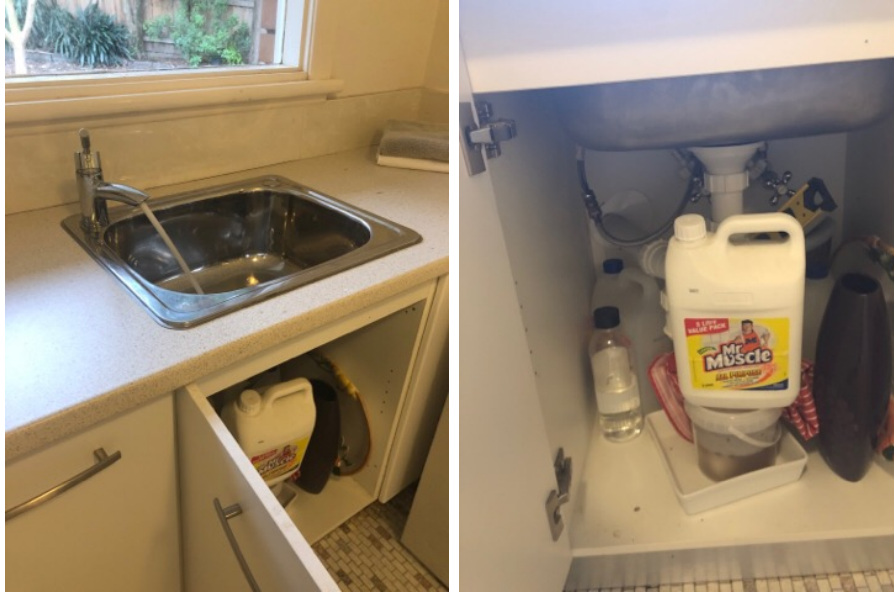
Bench top and splash back junction sealing deteriorated / missing - Recommendations: Re-sealing by a plumber or general maintenance contractor is recommended to prevent water access behind the bench.

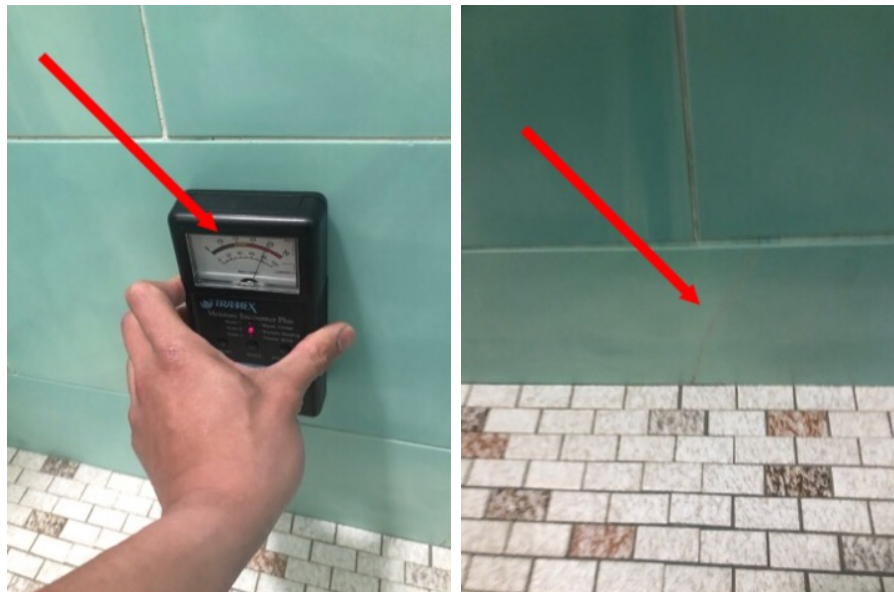
Excess moisture readings were obtained on the wall linings adjacent bathroom/shower. This may be related to the shower recess/plumbing in wall cavity leaking or failed waterproofing membrane to the wet area.

There appears to have been some settlement in the building which has caused some cracking to the walls. These cracks are categorized as 0 to 2 <5mm. This can also cause some doors to bind or be out of square. In the inspectors opinion these cracks are due to settlement, usually due to ground movement and subsequent movement to building materials can be expected. Any cracks should be monitored and if cracks increase in size, further investigation should be carried out by a structural engineer.

Cracked tile/s noted. A qualified tiler should be engaged for advice and recommendations.

Recommendations: Engage a plumber and a licensed waterproofer for advice and recommendations.

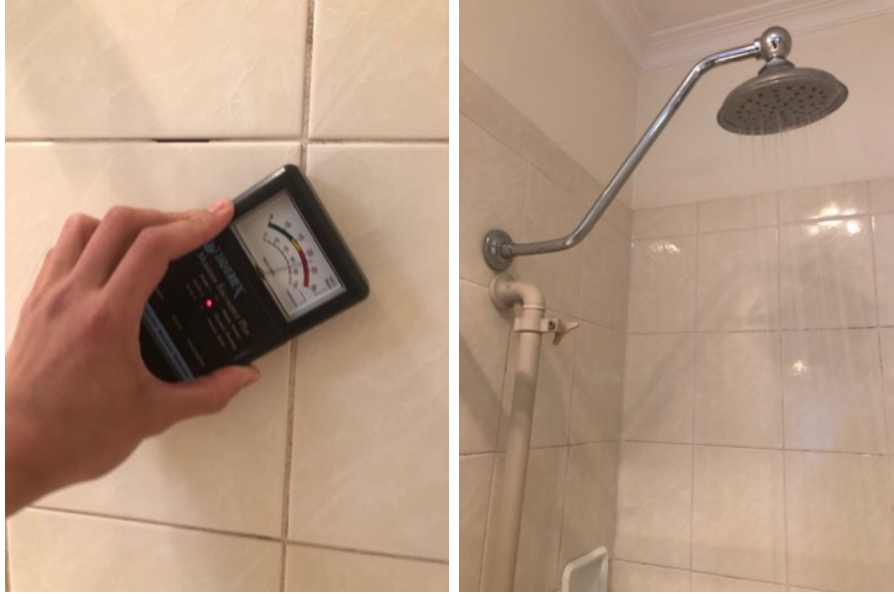
Tile grout deterioration. Re-grout / seal the shower tiles and screen junctions. A qualified plumber should be engaged for advice and recommendations.

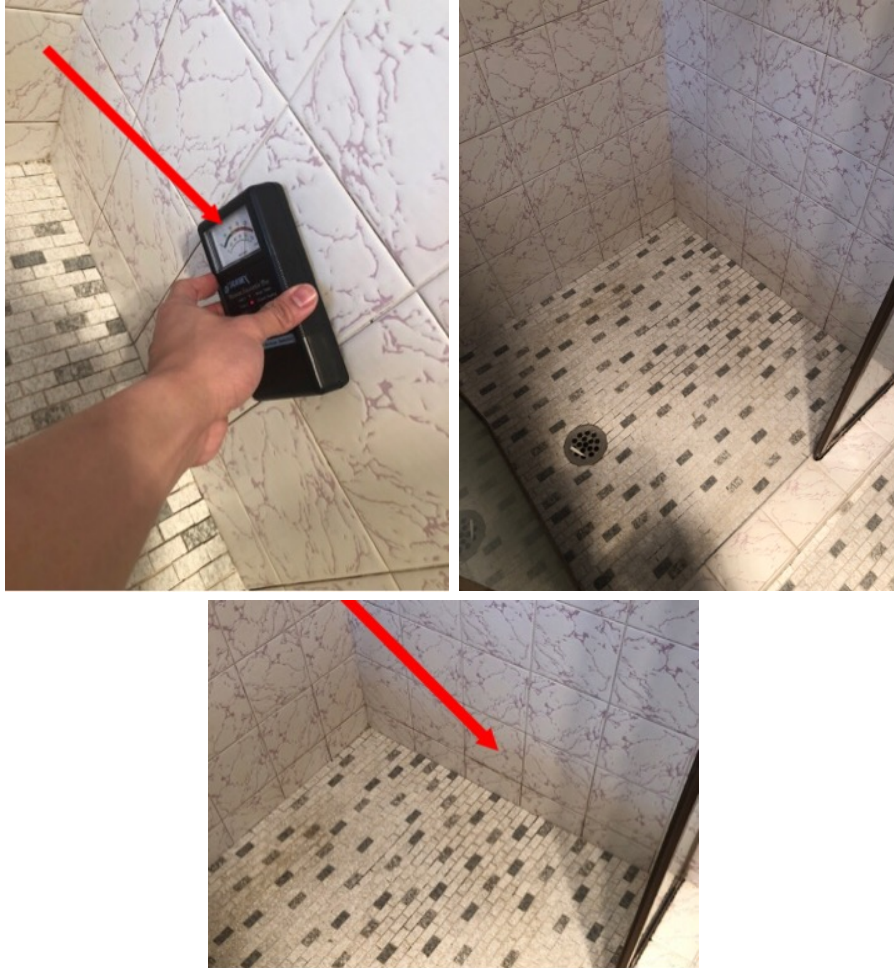
Excess moisture readings were obtained on the wall linings adjacent bathroom/shower. This may be related to the shower recess/plumbing in wall cavity leaking or failed waterproofing membrane to the wet area.

Recommendations: Engage a plumber and a licensed waterproofer for advice and recommendations.

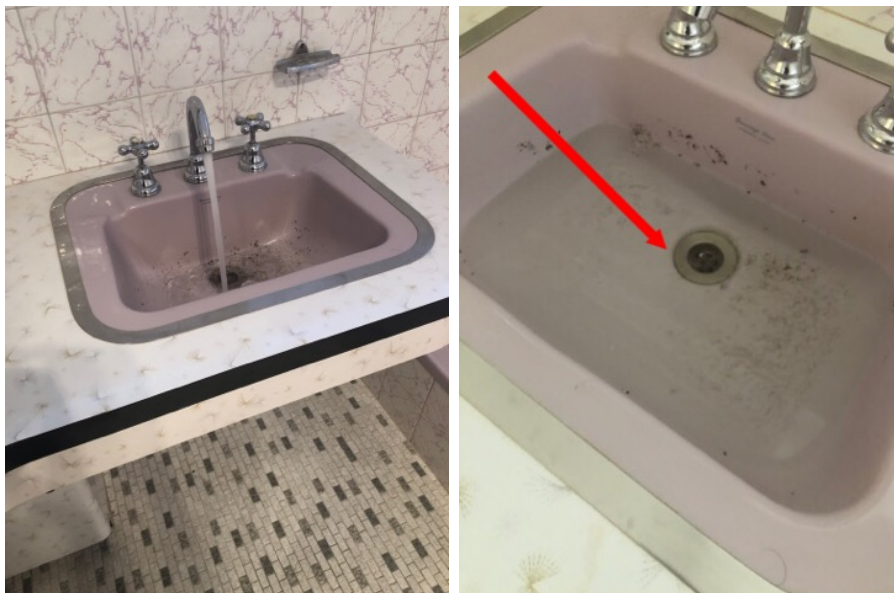
Slow to drain possible blockage and may worsen overtime. Have checked by a plumber.
