# Building Inspection Report

FANGS BUILDING INSPECTIONS

## Inspection Address John St, Bayswater, VIC

Inspection Date:        31 May 2019

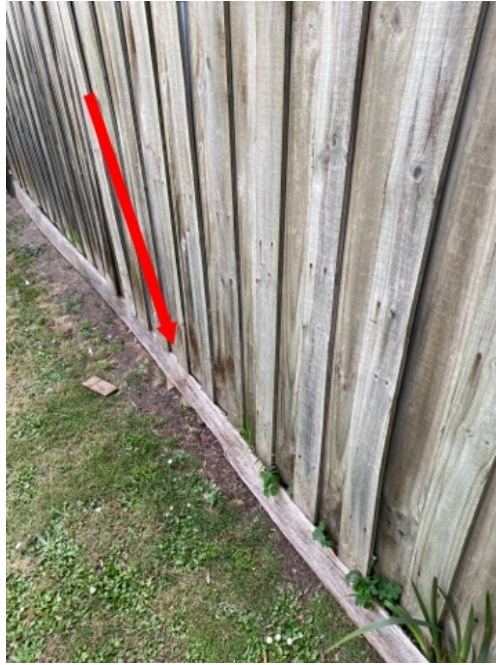
General fence components have rot - Recommendations: Repairs are required by fencing contractor.

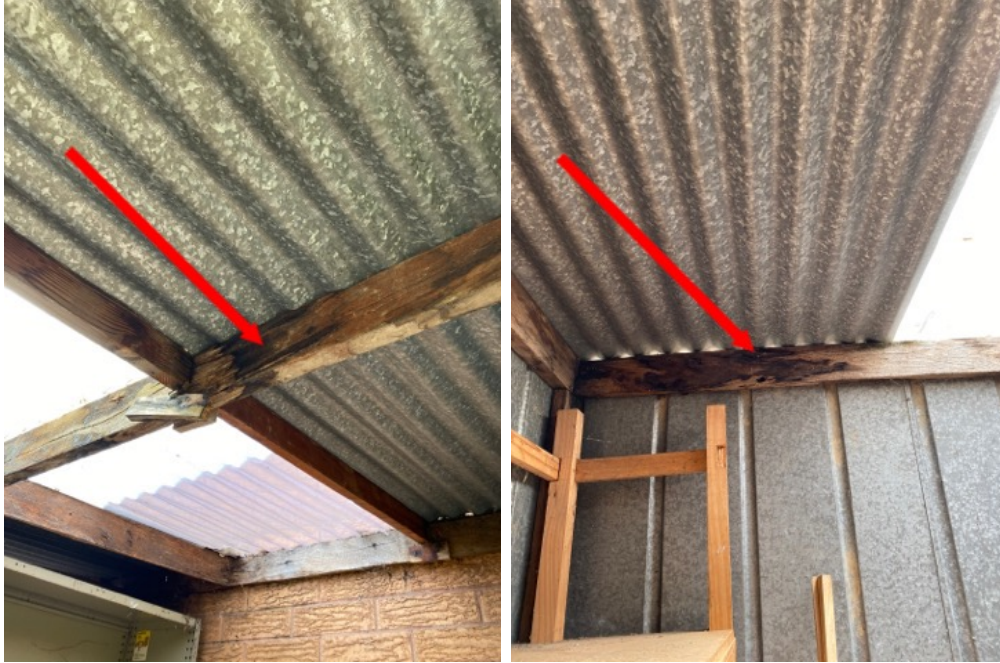
The shed is considered in poor condition and repairs/replacement should be considered. A replacement shed should be considered.

Rot timber noted,replace required

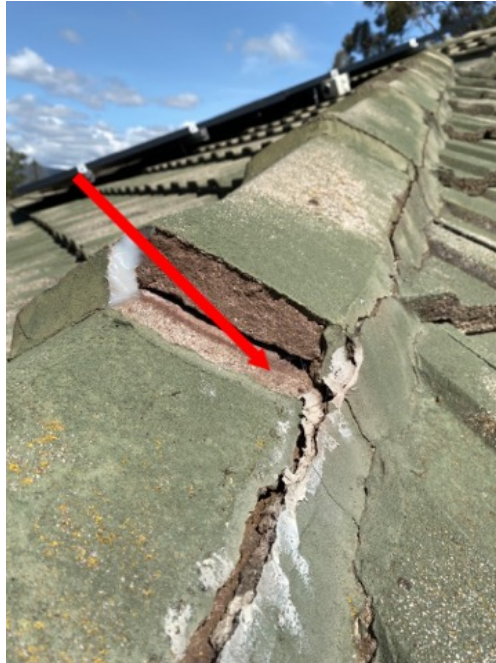
Mortar cracks visible. We recommend having these repaired by a licensed roofer as they contribute to water ingress. Whilst common on properties of this age we recommend repair it may result in water ingress into the roof cavity

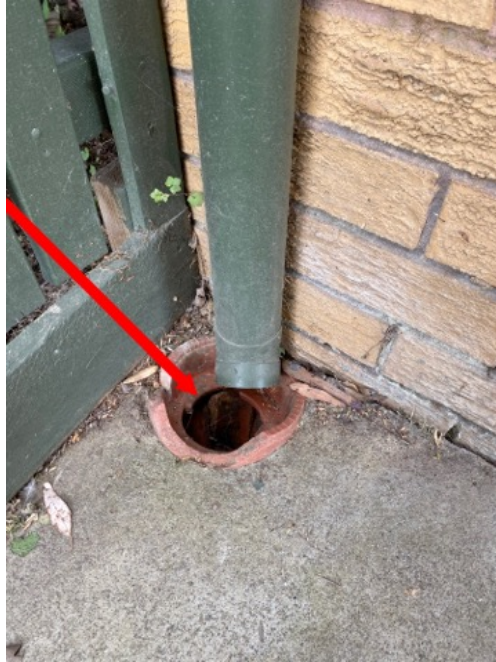
Down pipe/s not connected to storm water discharge - Down pipes not connected to storm water have the potential to cause differential settlement to the footings, cause rising damp and is also conducive to termite infestation. Recommendations: A qualified plumber should be engaged for advice and recommendations.

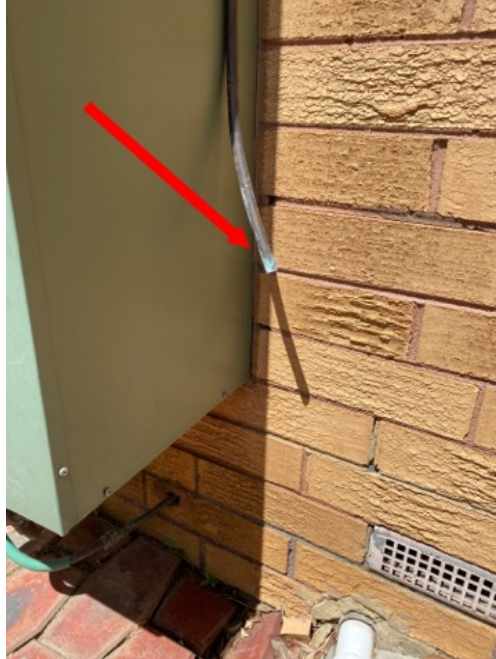
It appears that some of the plumbing are not connected to a sewer system. Contact a licensed plumber for assessment and repairs. Considered a Minor Defect however has the potential to become Major due to costs

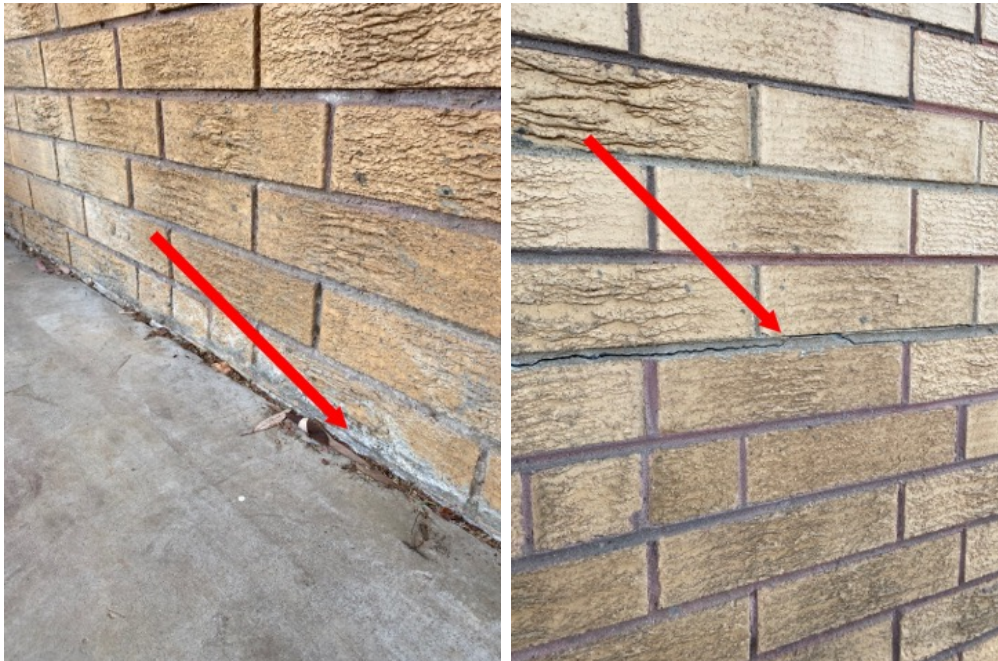
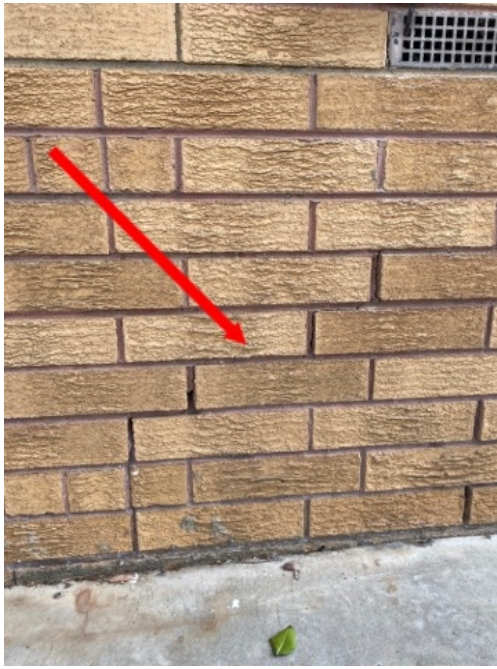
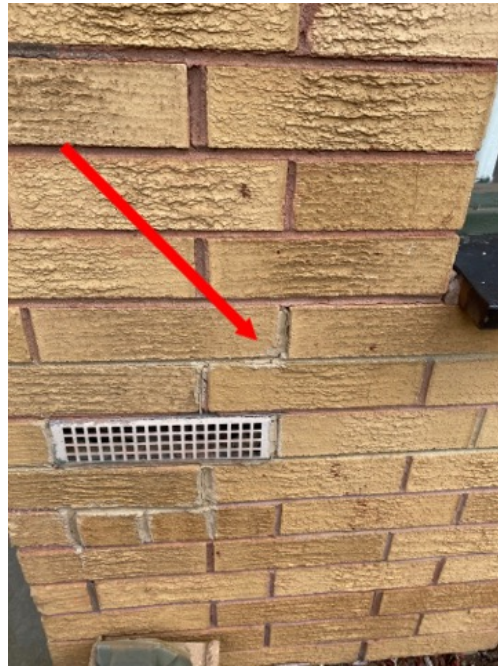
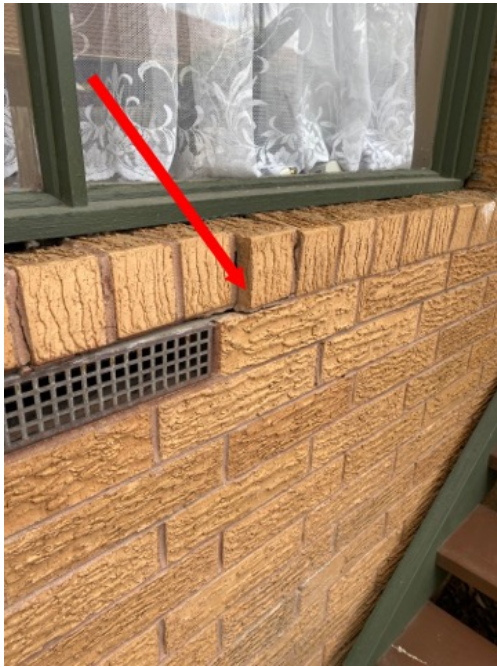
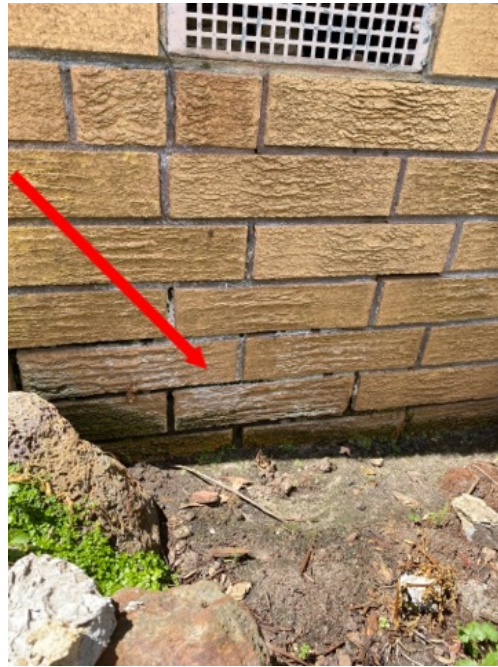
There appears to have been some settlement in the building which has caused some cracking to the walls. These cracks are categorized as 0 to 2 <5mm. This can also cause some doors to bind or be out of square. In the inspectors opinion these cracks are due to settlement, usually due to ground movement and subsequent movement to building materials can be expected. Any cracks should be monitored and if cracks increase in size, further investigation should be carried out by a structural engineer.

Rising damp detected. A qualified damp proof specialist should be engaged for advice and recommendations. Accurate diagnosis of the cause and extent of the damp problem is very important. Note: It is imperative that specialist advice be sought to obtain accurate diagnosis of the cause and extent of the damp problem and it is advised that you have assessed prior to purchasing the dwelling as can be quite costly if a damp proof course has to be reinstated.

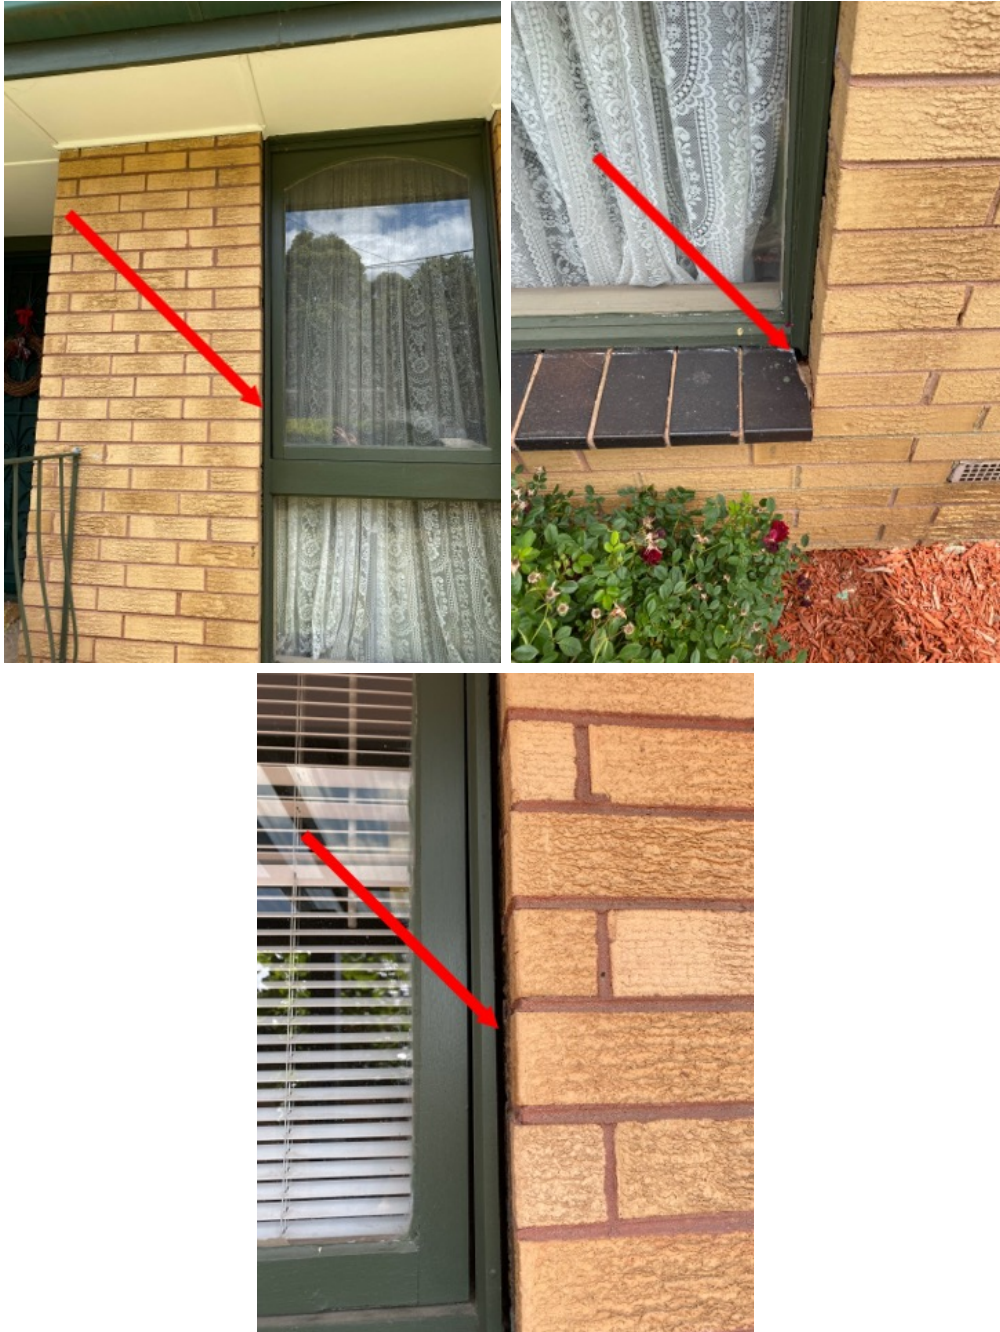
Gaps between window frame and wall cladding evident - This can be due to poor workmanship, wall movement, footings settlement. Recommendations: A qualified carpenter should be engaged for advice and recommendations.

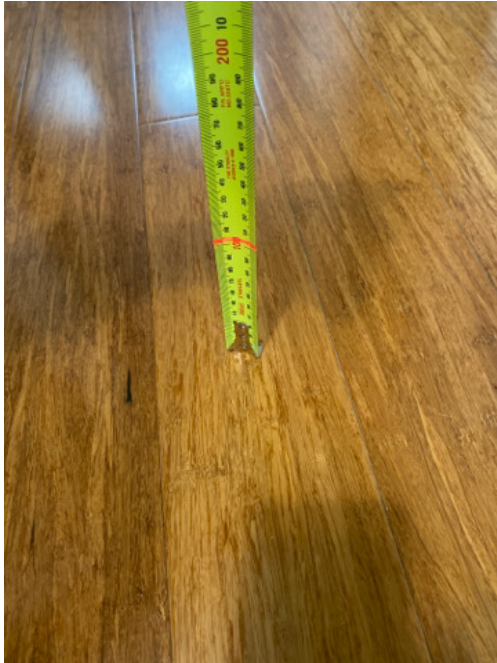
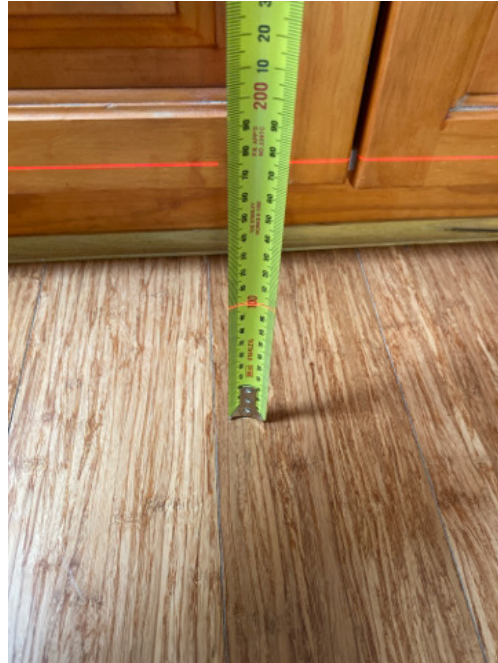
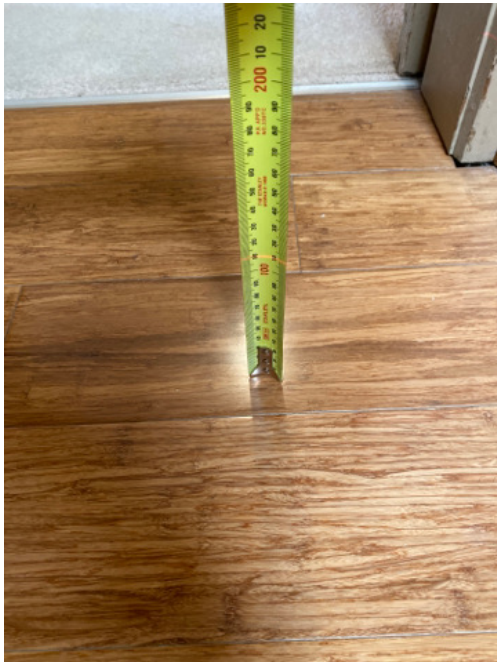
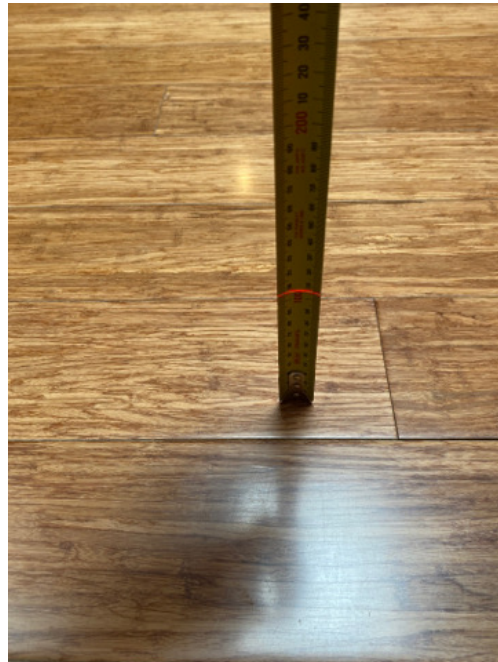
The flooring evenness has minor deviation of less than 20mm. There appears to have been some settlement in the building which has caused some unevenness to the floor. This can also cause some doors to bind or be out of square. In the inspector's opinion these deviations are due to settlement, usually due to ground movement and subsequent movement to building materials can be expected. Any cracks caused should be monitored if unevenness increases in magnitude.

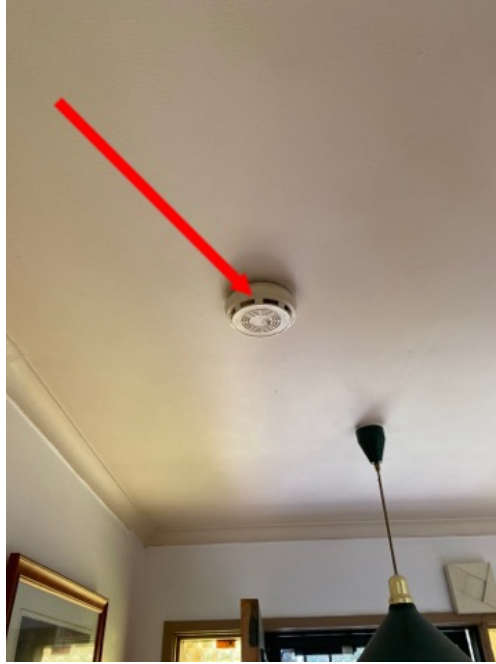
Smoke alarm sighted but not working during time of inspection. A possible cause is the alarm is out of battery.

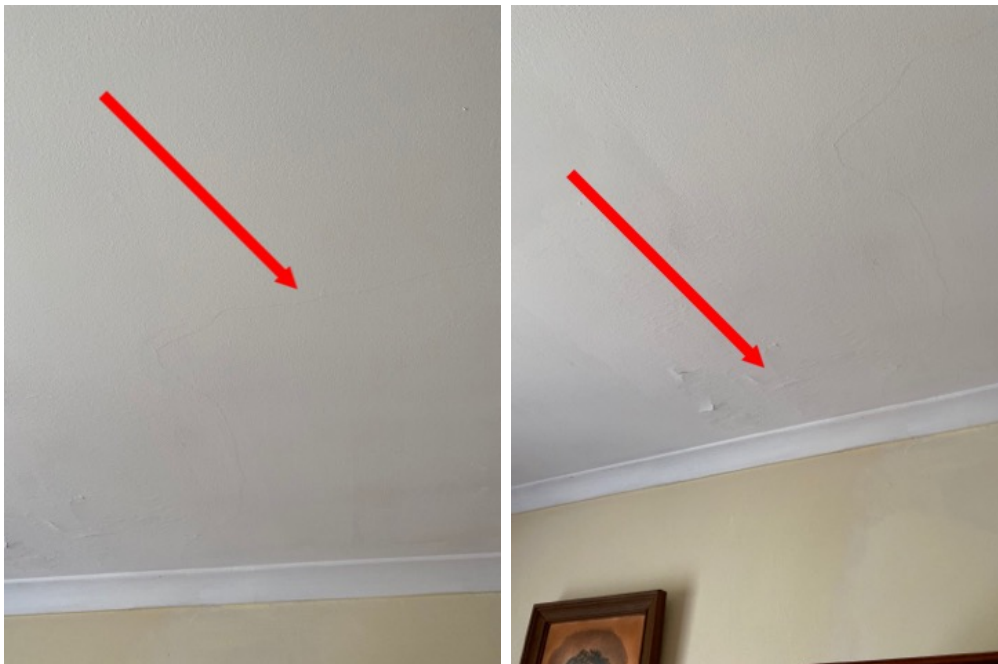
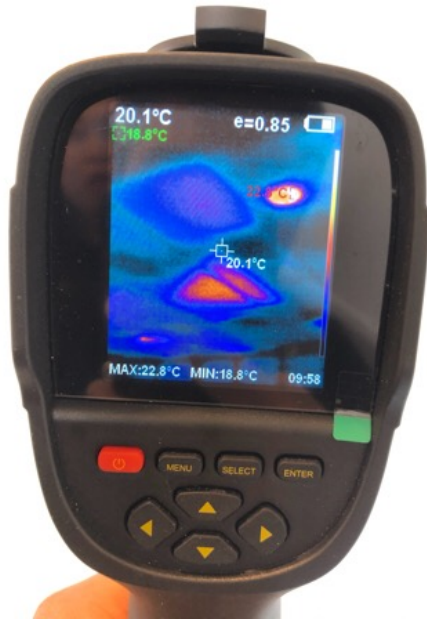
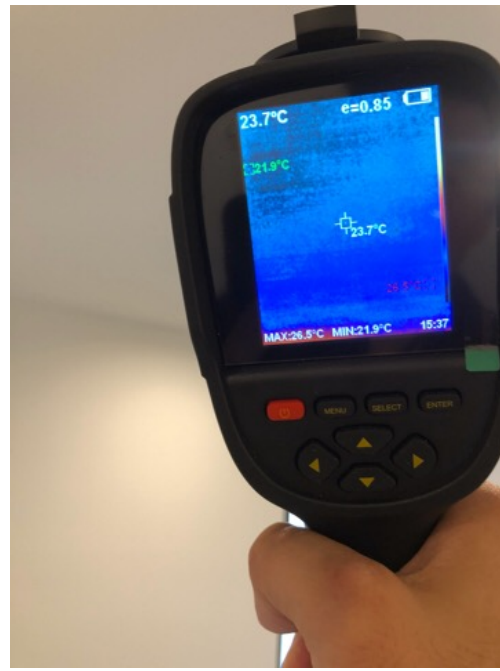
There appears to have been some settlement in the building which has caused some cracking to the ceiling. These cracks are categorized as 0 to 2 <5mm. This can also cause some doors to bind or be out of square. In the inspectors opinion these cracks are due to settlement, usually due to ground movement and subsequent movement to building materials can be expected. Any cracks should be monitored and if cracks increase in size, further investigation should be carried out by a structural engineer.

Ceiling paint flake/deterioration is evident. Recommendations: General maintenance / painting as required.

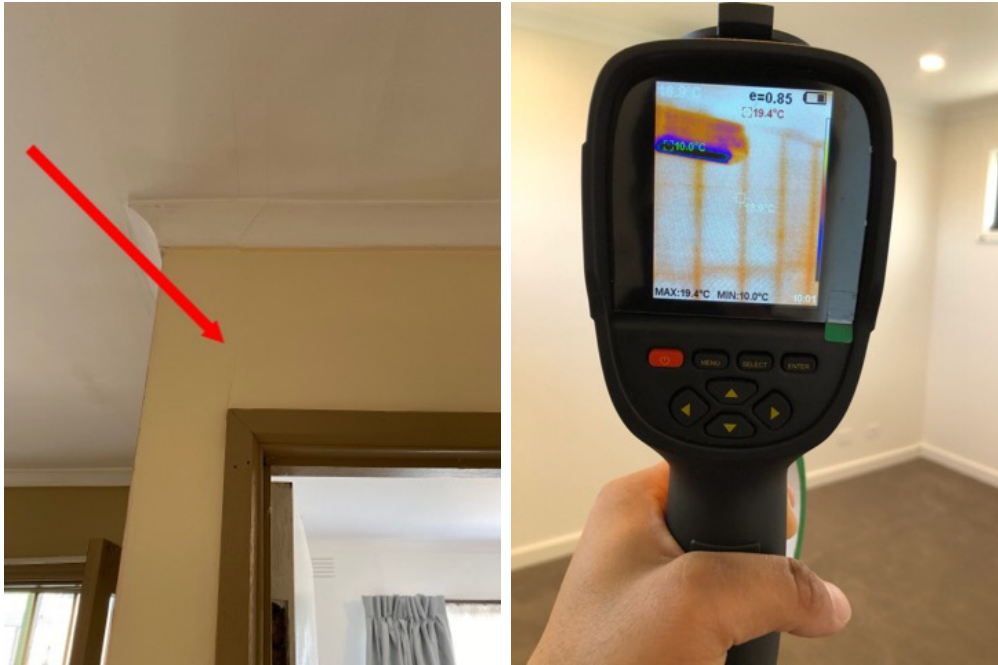
There appears to have been some settlement in the building which has caused some cracking to the walls. These cracks are categorized as 0 to 2 <5mm. This can also cause some doors to bind or be out of square. In the inspectors opinion these cracks are due to settlement, usually due to ground movement and subsequent movement to building materials can be expected. Any cracks should be monitored and if cracks increase in size, further investigation should be carried out by a structural engineer.

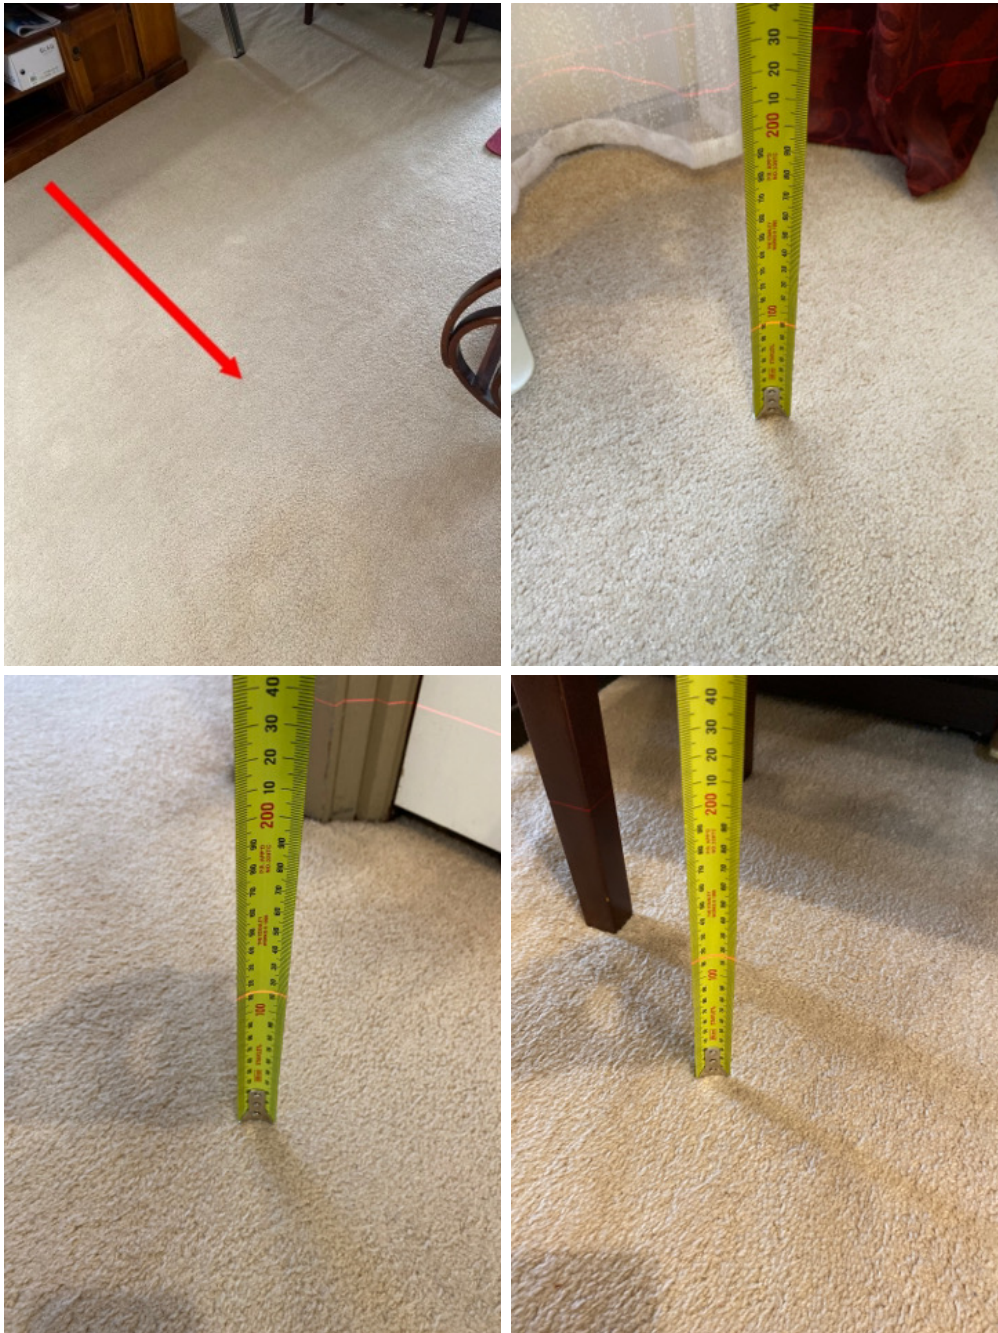
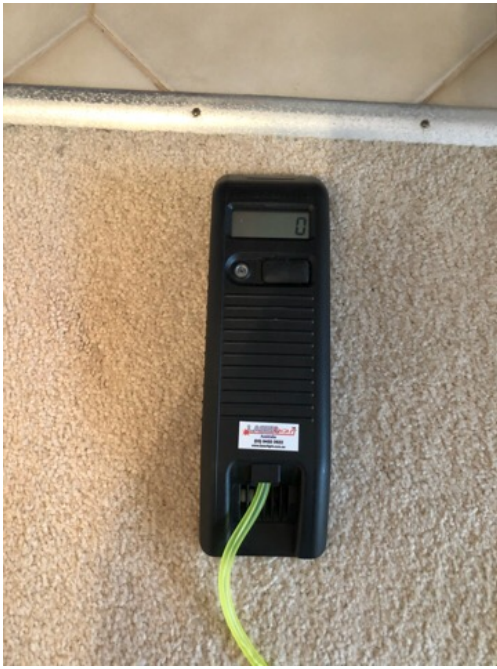
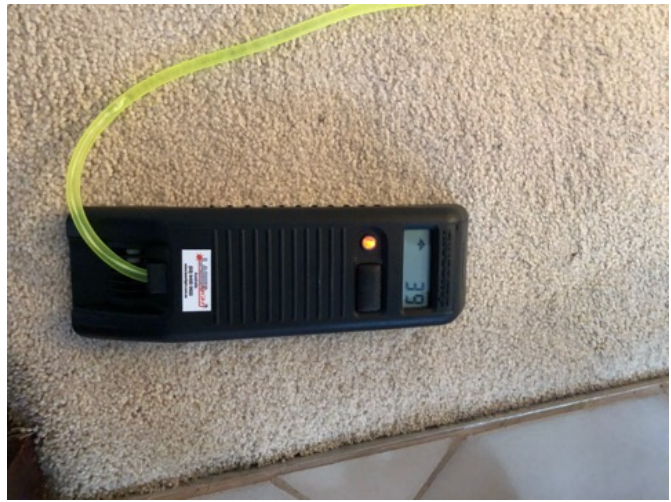
The flooring evenness has medium deviation of greater than 20mm but less than 40mm.

Deviation of this magnitude is regarded as minor structural defects at the moment, however have the potential to become major structural defect and pose as safety hazard to inhabitant. Rectification work can be costly.

Possible causes may be foundation movement. Support structure deflection. Thermal movement and moisture uptake or loss, failure under external loads. In the inspector's opinion the unevenness require further assessment. A structural engineer should be consulted for further evaluation and advice.

Squeaky floor boards noted. Re-fixing the floor boards may fix this issue.

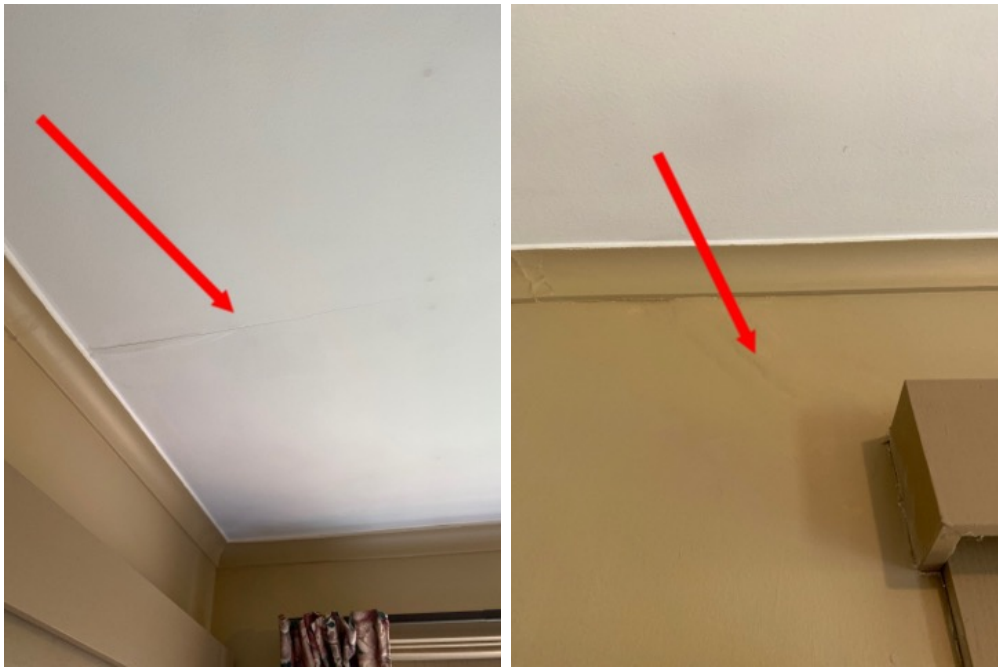
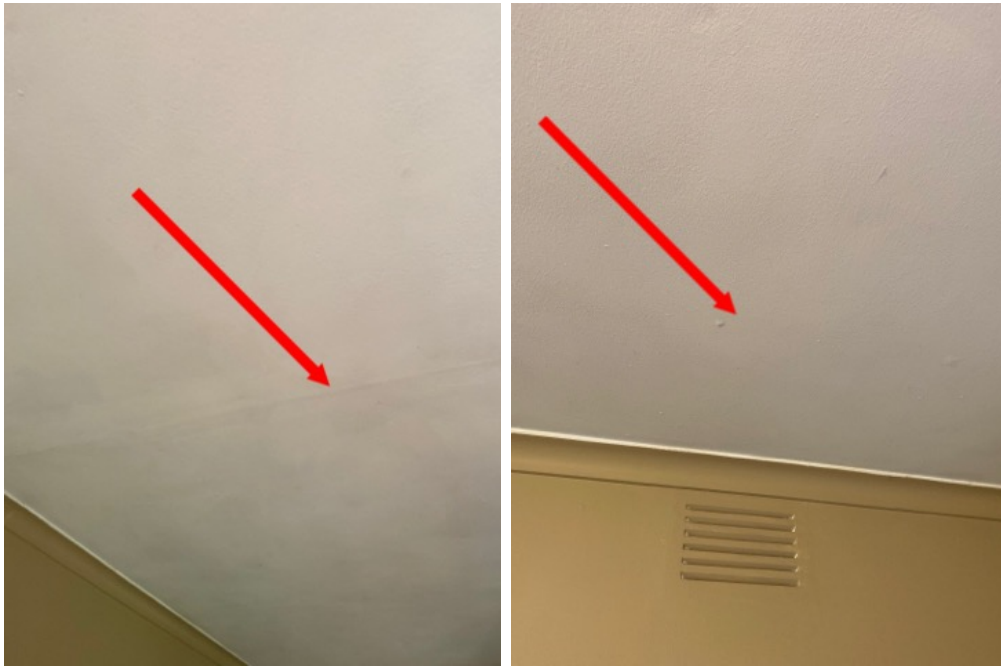
There appears to have been some settlement in the building which has caused some cracking to the ceiling. These cracks are categorized as 0 to 2 <5mm. This can also cause some doors to bind or be out of square. In the inspectors opinion these cracks are due to settlement, usually due to ground movement and subsequent movement to building materials can be expected. Any cracks should be monitored and if cracks increase in size, further investigation should be carried out by a structural engineer.

Poor butt joint finish Visible under normal light conditions. Contact a licensed plasterer for repairs.

Ceiling paint flake/deterioration is evident. Recommendations: General maintenance / painting as required.

Nail popping observed to the ceiling lining. This is a Safety Hazard And should be repaired as soon as possible by a licensed plasterer to avoid any unsafe conditions.

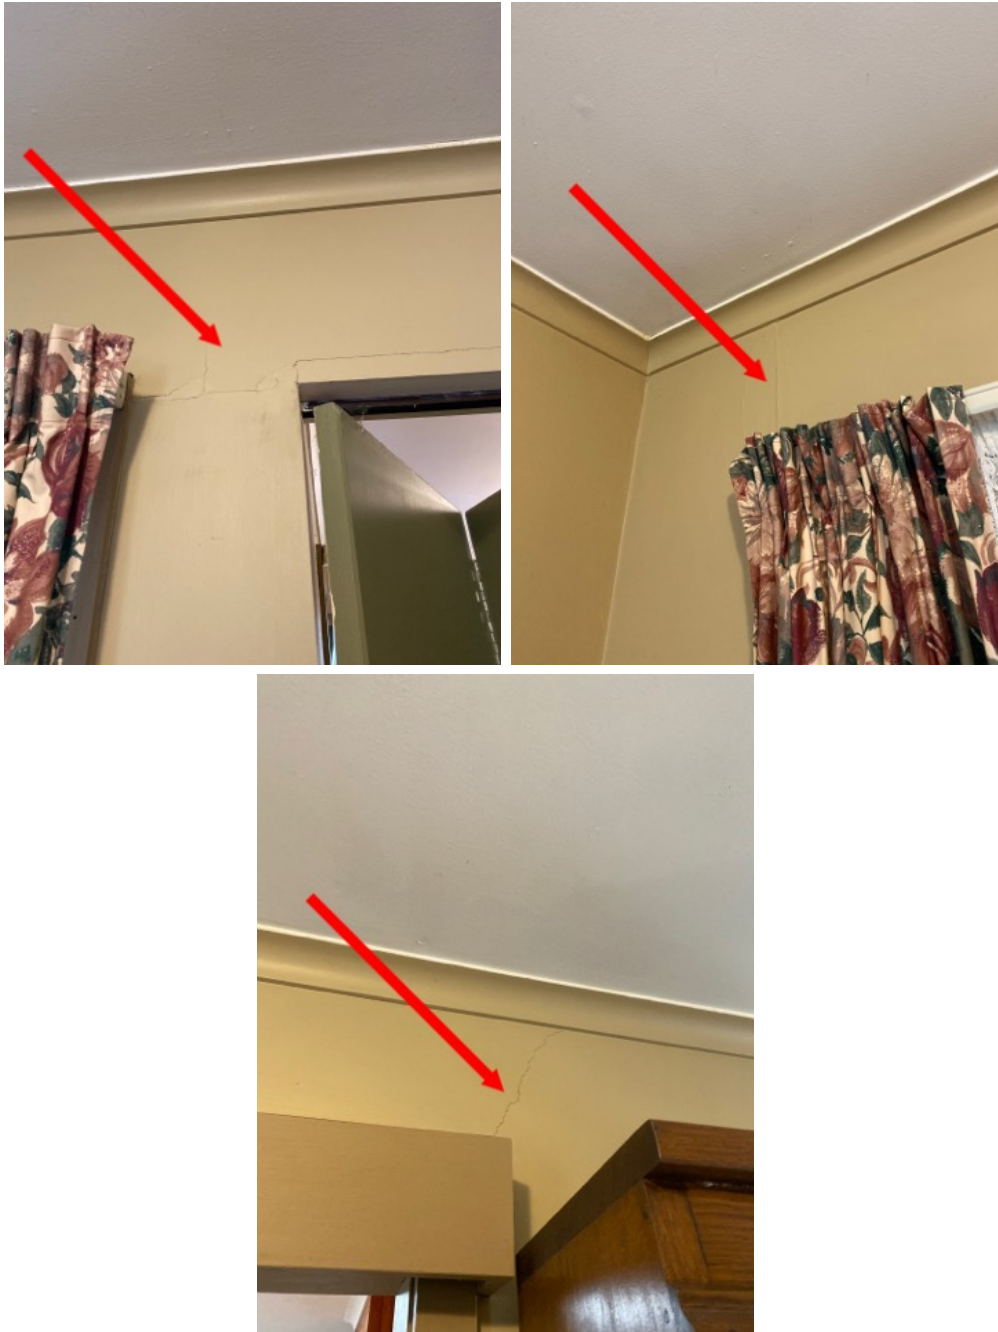
There appears to have been some settlement in the building which has caused some cracking to the walls. These cracks are categorized as 0 to 2 <5mm. This can also cause some doors to bind or be out of square. In the inspectors opinion these cracks are due to settlement, usually due to ground movement and subsequent movement to building materials can be expected. Any cracks should be monitored and if cracks increase in size, further investigation should be carried out by a structural engineer.

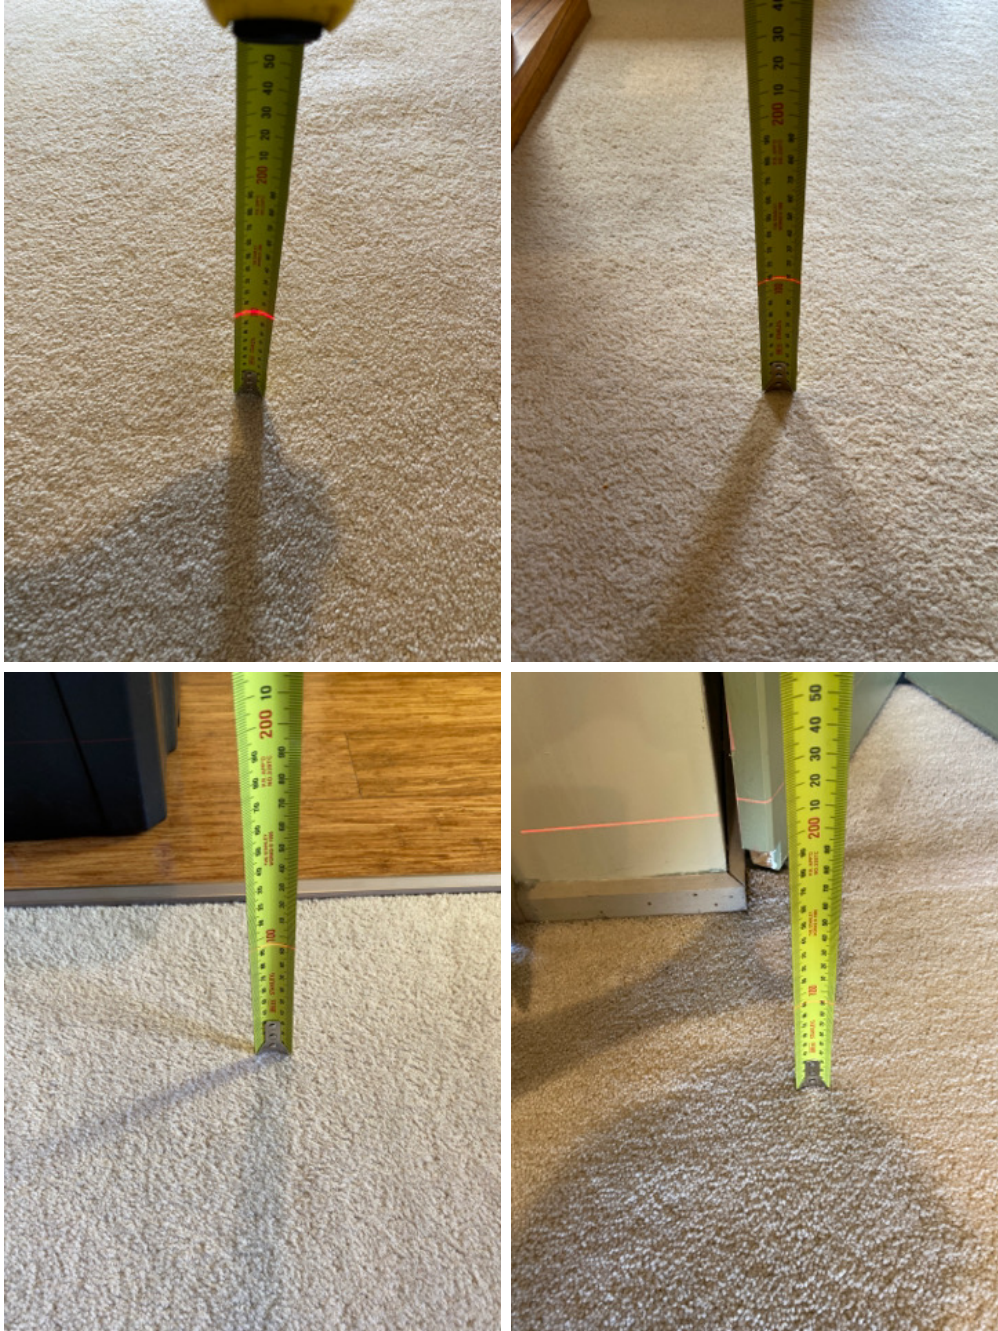
The flooring evenness has minor deviation of less than 20mm. There appears to have been some settlement in the building which has caused some unevenness to the floor. This can also cause some doors to bind or be out of square. In the inspector's opinion these deviations are due to settlement, usually due to ground movement and subsequent movement to building materials can be expected. Any cracks caused should be monitored if unevenness increases in magnitude.

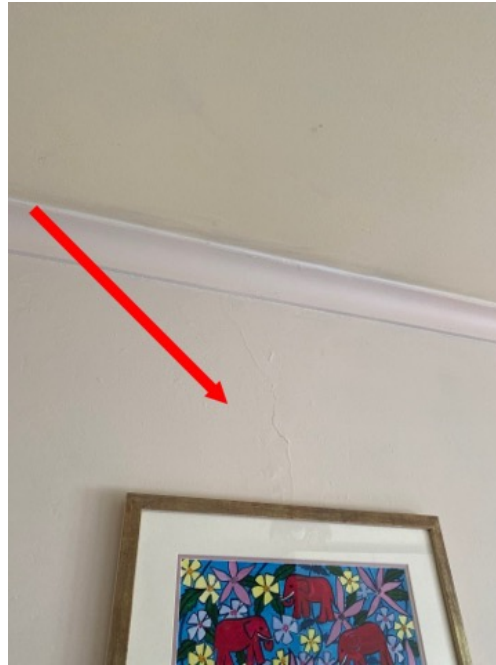
There appears to have been some settlement in the building which has caused some cracking to the walls. These cracks are categorized as 0 to 2 <5mm. This can also cause some doors to bind or be out of square. In the inspectors opinion these cracks are due to settlement, usually due to ground movement and subsequent movement to building materials can be expected. Any cracks should be monitored and if cracks increase in size, further investigation should be carried out by a structural engineer.

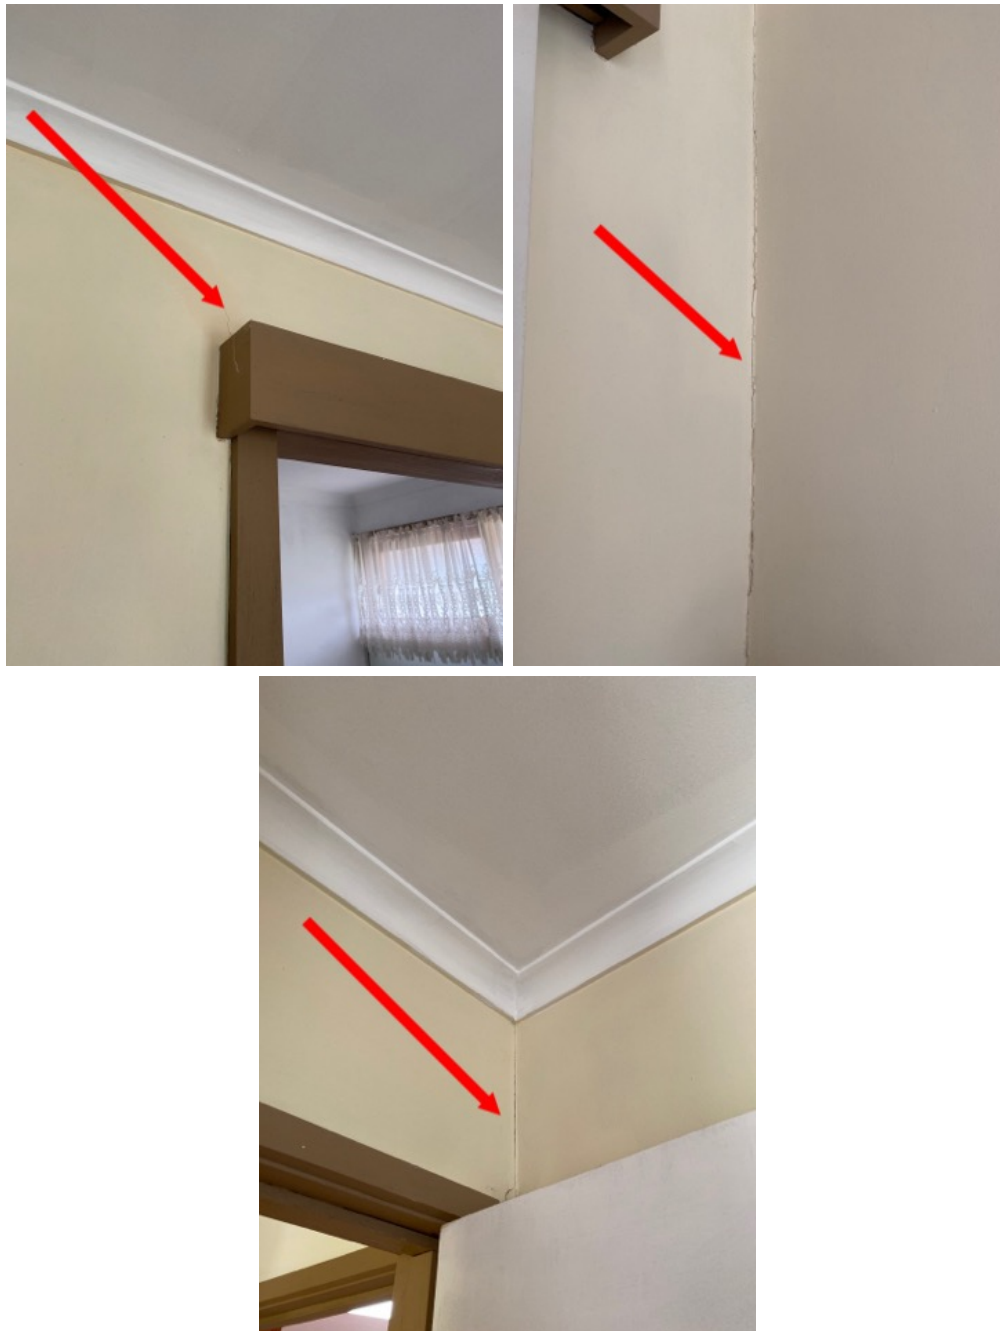
There appears to have been some settlement in the building which has caused some cracking to the walls. These cracks are categorized as 0 to 2 <5mm. This can also cause some doors to bind or be out of square. In the inspectors opinion these cracks are due to settlement, usually due to ground movement and subsequent movement to building materials can be expected. Any cracks should be monitored and if cracks increase in size, further investigation should be carried out by a structural engineer.

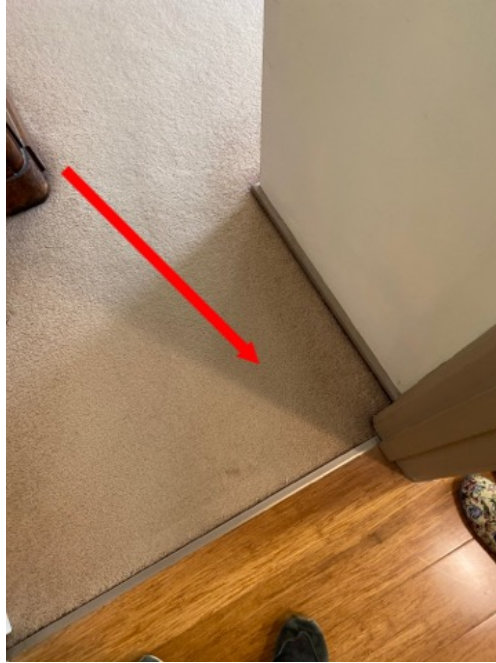
Squeaky floor boards noted. Re-fixing the floor boards may fix this issue.

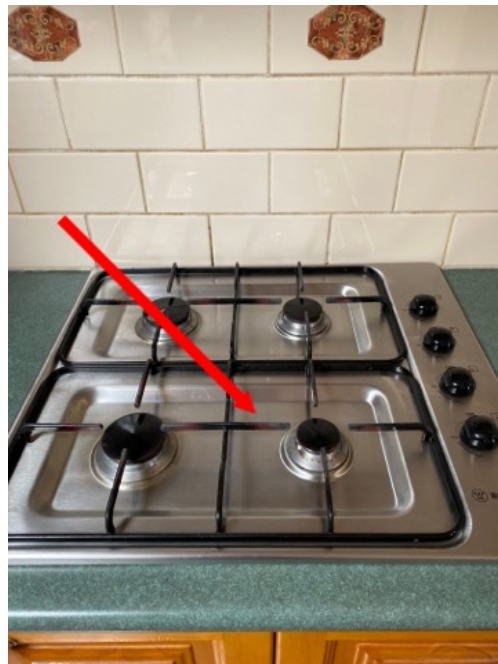
The entire cooktop is not serviceable at the time of inspection.

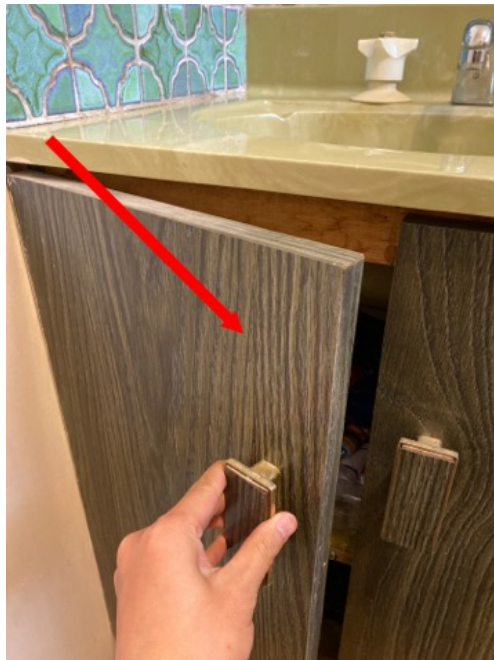
Cabinet door / drawer cannot be closed properly noted. Engage a licensed carpenter to adjust the door / drawer.

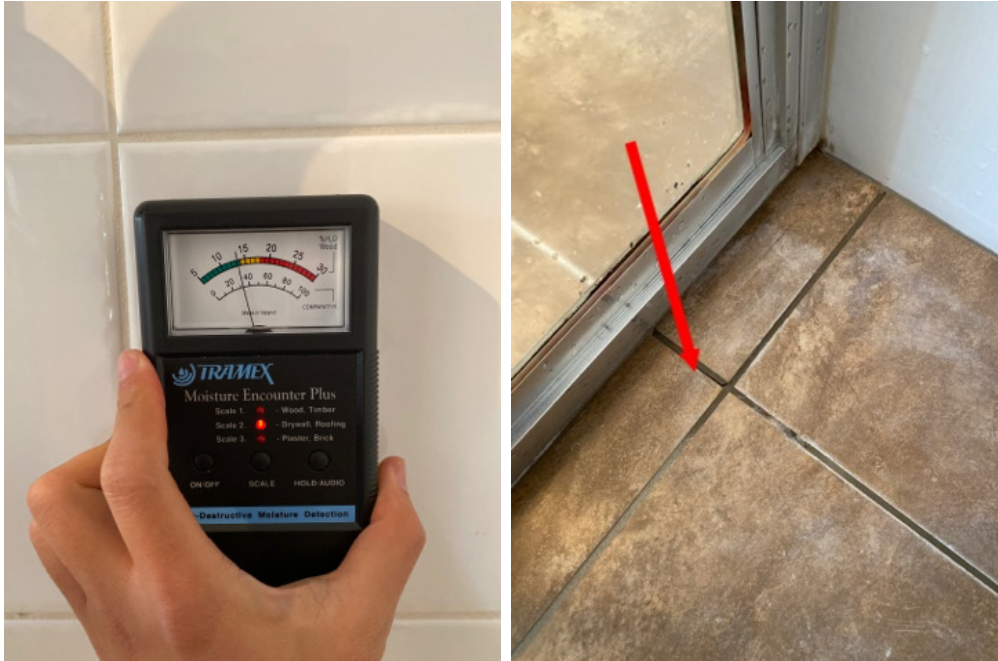
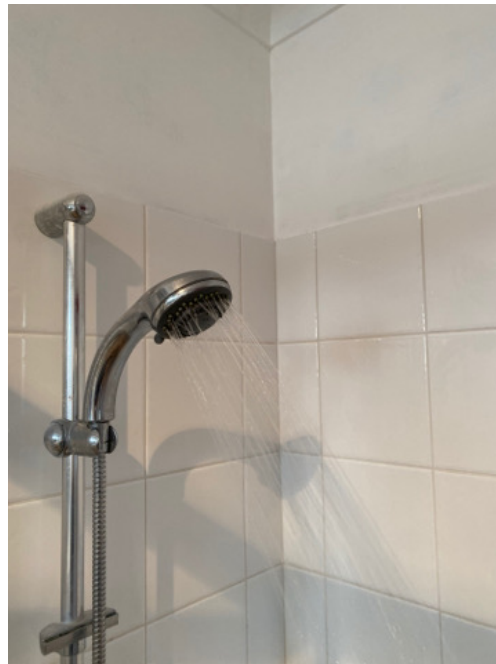
Tile grout deterioration. Re-grout / seal the shower tiles and screen junctions. A qualified plumber should be engaged for advice and recommendations.

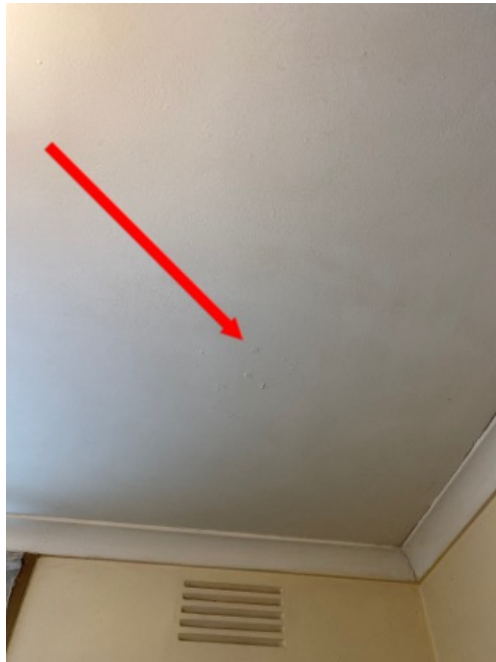
Ceiling paint flake/deterioration is evident. Recommendations: General maintenance / painting as required.

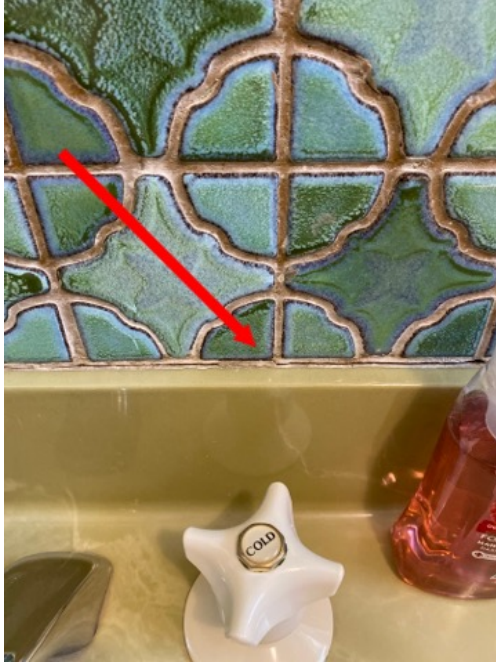
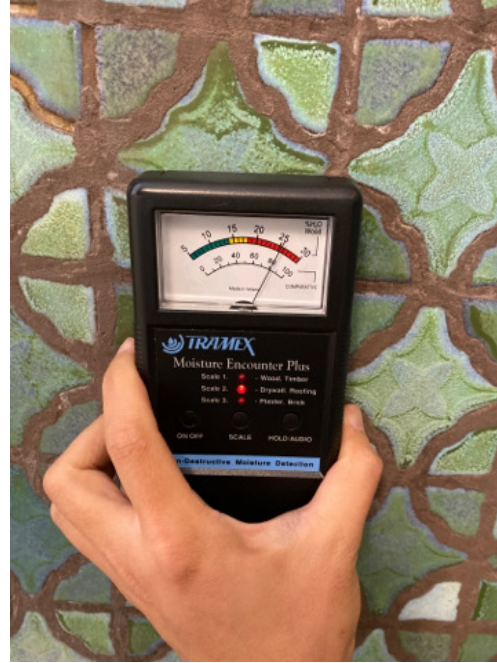
Excess moisture readings were obtained on the wall linings adjacent bathroom/shower. This may be related to the shower recess/plumbing in wall cavity leaking or failed waterproofing membrane to the wet area. Recommendations: Engage a plumber and a licensed waterproofer for advice and recommendations.

Caulking required to the referred area.
