# Building Inspection Report

FANGS BUILDING INSPECTIONS

**Lotxx Evesham Drive, Point Cook, VIC, 3030**

Inspection Date:        01 Mar 2019

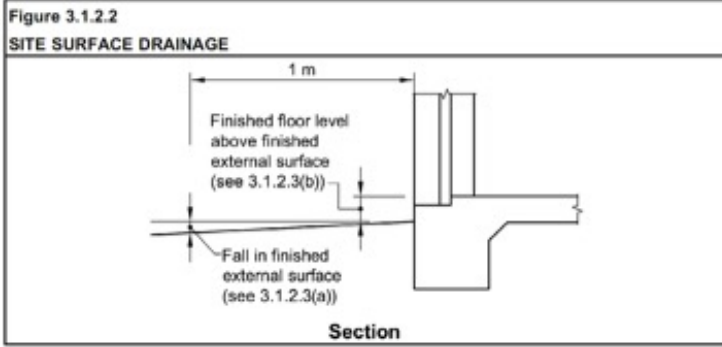
Water management on site is paramount to ensuring that the foundations are not damaged. Water, when seeping down beside the slab, between the slab and the dirt softens the dirt. The soils capacity to withstand the downward pressure of the forces of the weight in the slab is greatly reduced. Hence slab failure occurs. It may not happen today or tomorrow, however poorly managed site water during construction is known to cause damage at a later date.

The BCA is very clear in its requirements to have the soil graded from the start away from the dwelling as a minimum of 50 mm over 1 m. This has not been done. Please refer to all of BCA, part 3.1.2.3.
