# Building Inspection Report

FANGS BUILDING INSPECTIONS

**John St , Mernda, VIC, 3754**

### Building Inspection

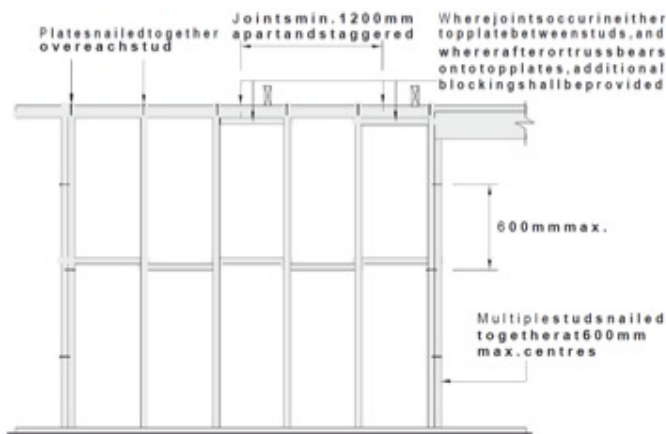
FIGURE 2.9 STUD/PLATE LAMINATION

It is a requirement of Australian Standard, A.S 1684 Residential Timber-Framed Construction, clause 2.4 Stud/Plate Lamination, that 'where joints occur in either top plate between studs, and where rafters or trusses bears onto top plates, additional blocking shall be provided.'

Please refer to below location(s) and rectify the issue as per AS1684.2 Figure 2.9 and engineering drawings before plastering

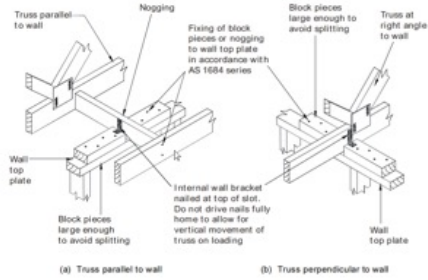
FIGURE 2.2 FIXING OF TRUSSES TO FREESTANDING NON-LOADBEARING WALL THAT IS A BRACING WALL

## Shear Block to Non-Load Bearing Braced Wall Not Installed

- (a) *Non-bracing wall* Where a non-loadbearing wall is stable in its own right, no stabilizing fixing is required.
- (b) *Bracing wall* Where a freestanding non-loadbearing wall is designated as a bracing unit in accordance with AS 1684.2 or AS 1684.3, the timber trusses shall be fixed to the top plate of the wall in such a way that the bottom chord of the truss is restrained horizontally but allows for deflection when the truss is loaded. Figure 2.2 gives an example of the fixing details.

Install Shear Block to Non-Load Bearing Braced Wall

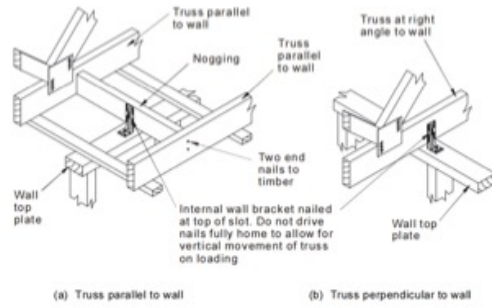
FIGURE 2.3 FIXING OF TRUSSES TO FREESTANDING NON-LOADBEARING WALL THAT IS NOT A BRACING WALL

- (c) *Non-bracing wall* For an internal non-loadbearing wall not designated as a bracing unit, stability of the wall shall be required to resist normal applied force, e.g., when closing doors. The top plate of the wall shall be stabilized at maximum 1800 mm centres. Where trusses are parallel to the wall, noggings shall be used in between the bottom chords and fixed to the bracket. Figure 2.3 gives an example of fixing details.

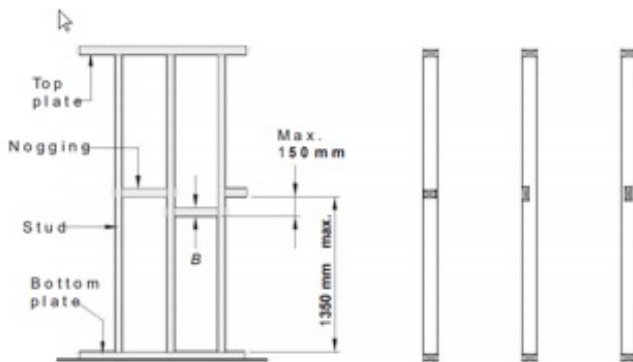
FIGURE 6.6 NOGGING

### Nogging(s) Missing - Distance In Between Exceeded 1350mm

Where required, wall studs shall have continuous rows of noggings, located on flat or on edge, at 1350 mm maximum centres.

Please refer to below location(s) and rectify the issue(s) as per AS1684.2 6.2.1.5 and engineering drawings before plastering.

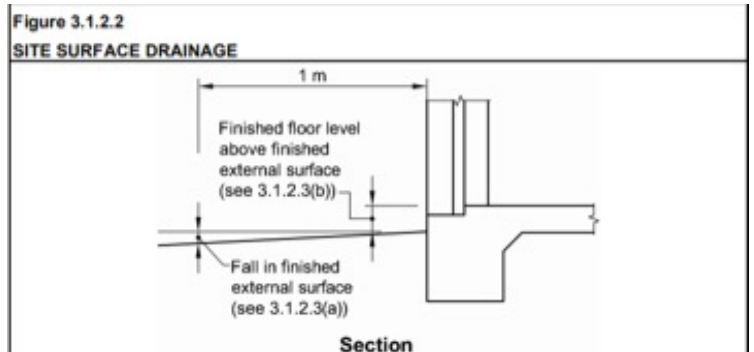
**Site Surface Drainage Inadequate - soil graded away for a min. of 50mm over 1m**

Site Surface Drainage Inadequate

- (a) Slab-on-ground — finished ground level adjacent to buildings:
  - the external finished surface surrounding the slab must be drained to move surface water away from the building and graded to give a slope of not less than (see Figure 3.1.2.2)—
  - (i) 25 mm over the first 1 m from the building in *low rainfall intensity areas* for surfaces that are reasonably impermeable (such as concrete or clay paving); or

- (ii) 50 mm over the first 1 m from the building in any other case.
- (b) Slab-on-ground — finished slab heights:
  - the height of the slab-on-ground above external finished surfaces must be not less than (see Figure 3.1.2.2)—
  - (i) 100 mm above the finished ground level in *low rainfall intensity areas* or sandy, well-drained areas; or
  - (ii) 50 mm above impermeable (paved or concreted areas) that slope away from the building in accordance with (a); or
  - (iii) 150 mm in any other case.

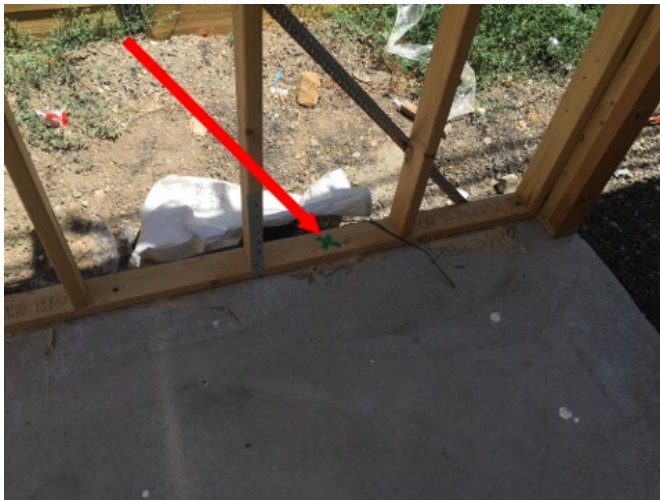
**Nail(s) missing on bottom plate to concrete (75mm nail, max 1200mm centres)**

Nail(s) missing or not affixed properly, please refer to below location(s) and rectify as per AS1684.2 and engineering drawings before plastering

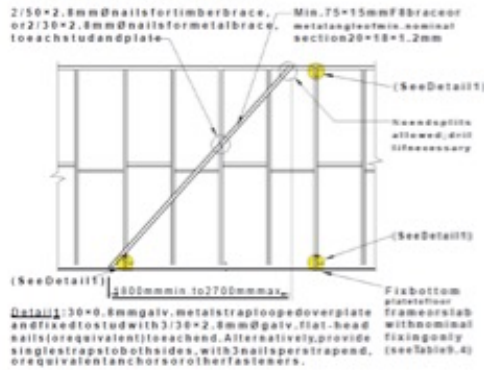
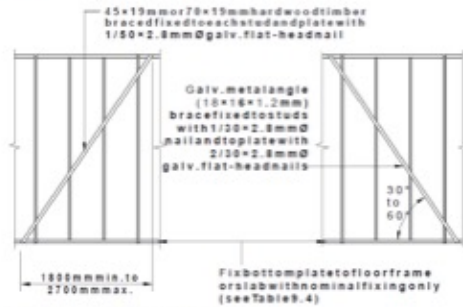
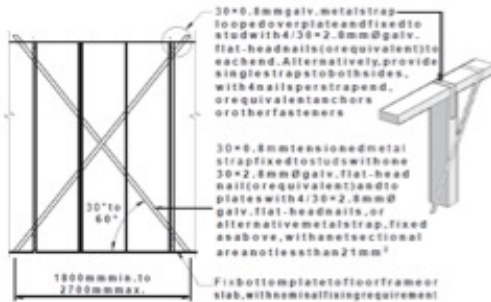
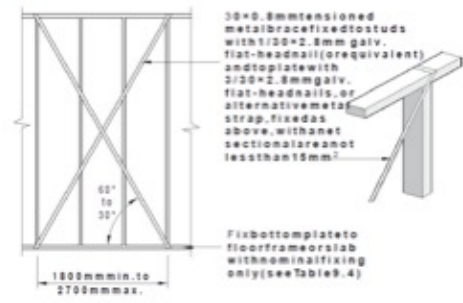
**Nail(s) missing on timber braces to studs or plates / ring beams (2/50x2.8mm nail each joint)**

2/50 × 2.8 mm dia. nails at each joint

Nail(s) missing or not affixed properly, please refer to below location(s) and rectify as per AS1684.2 and engineering drawings before plastering
