Building Inspection Report

FANGS BUILDING INSPECTIONS

John St, Burwood East, VIC, 3151

Inspection Date: 26 Oct 2019

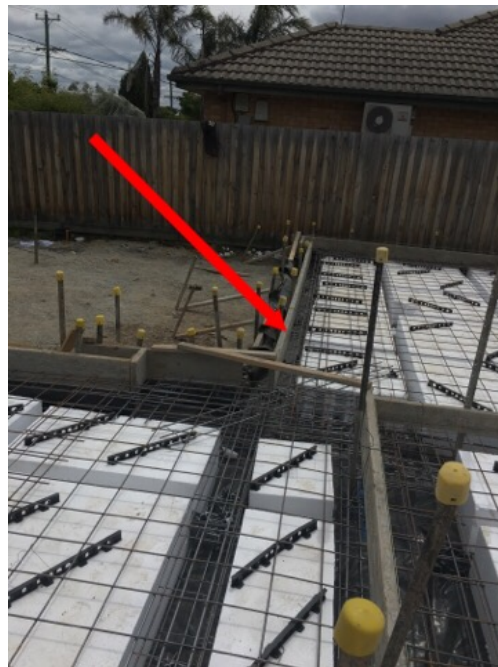
| BUILDING DEFECTS | Building Defects | 20mm Clearance Around Pipe Not Achieved | 20mm clearance around pipe is not achieved as per BCA 3.2.3.2 "(d) Footings and slabs-on-ground must have concrete cover between the outermost edge of the reinforcement (including ligatures, tie wire etc.) and the surface of the concrete of not less than: (i) 40 mm to unprotected ground. (ii) 30 mm to a membrane in contact with the ground. (iii) 20 mm to an internal surface" |

20mm clearance around pipe is not achieved as per BCA 3.2.3.2

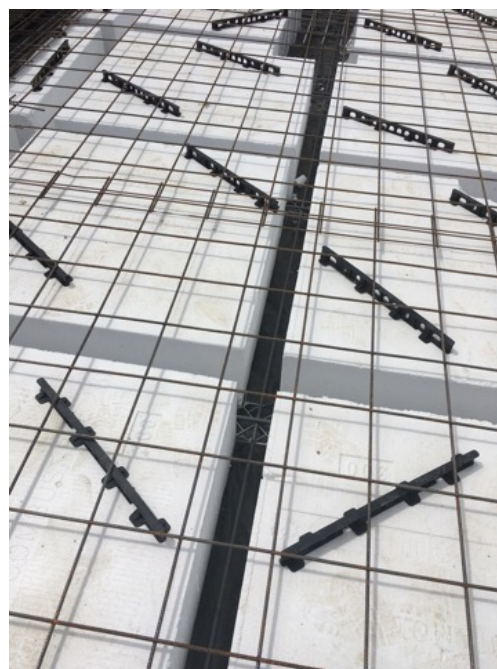
| BUILDING DEFECTS | Building Defects | Extra Support Not Provided Around Pipes | Additional reinforcing bars are required to be installed around pipe. |

Additional reinforcing bars are required to be installed around pipe.

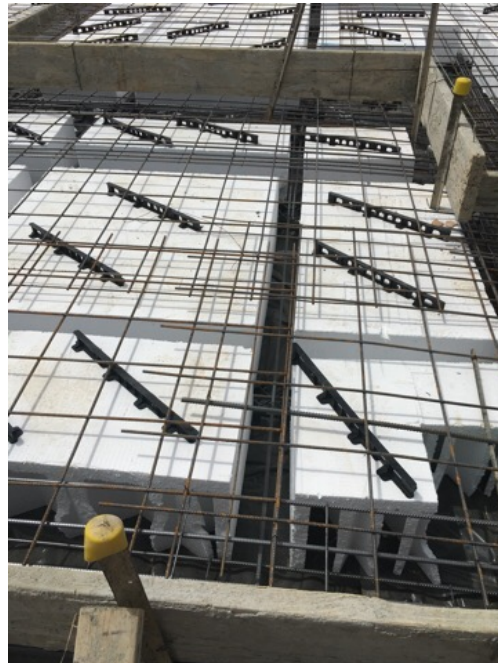
| BUILDING DEFECTS | Building Defects | Steel to Beam Clearance Not Satisfied | It is a requirement of Part 3.2.3.2 Steel Reinforcement of the BCA that 'Footings and slab- on-ground must have concrete cover between the outermost edge of the reinforcement (including ligatures, tie wire etc.) and the surface of the concrete of not less than 40mm to external exposure.' All of the reinforcement will need to be rectified and confirmed as having this minimum clearance, prior to any concrete being poured. |

It is a requirement of Part 3.2.3.2 Steel Reinforcement of the BCA that 'Footings and slab- on-ground must have concrete cover between the outermost edge of the reinforcement (including ligatures, tie wire etc.) and the surface of the concrete of not less than 40mm to external exposure.'

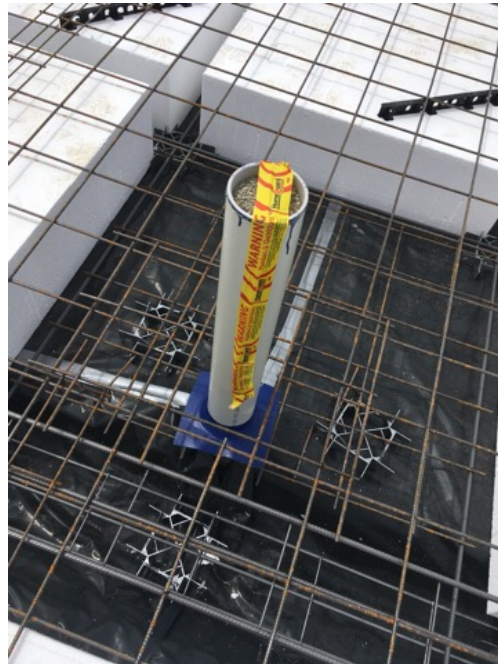
| BUILDING DEFECTS | Building Defects | Top Mesh Overlapping Not Satisfied | It is a requirement of Part 3.2.3.2 Steel Reinforcement of the BCA that Minimum laps for reinforcement as shown in Table 3.2.3.1 and Figure 3.2.3.1 must be provided where reinforcing is used. Two outermost wires lapping required. |

It is a requirement of Part 3.2.3.2 Steel Reinforcement of the BCA that Minimum laps for reinforcement as shown in Table 3.2.3.1 and Figure 3.2.3.1 must be provided where reinforcing is used. Two outermost wires lapping required.
