Building Inspection Report

Fangs Building Inspections

3 Bound Avenue, Box Hill, VIC

Inspection Date: 30 Jan 2020

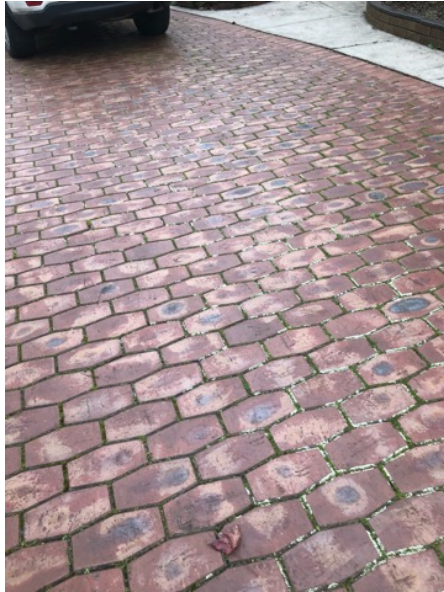
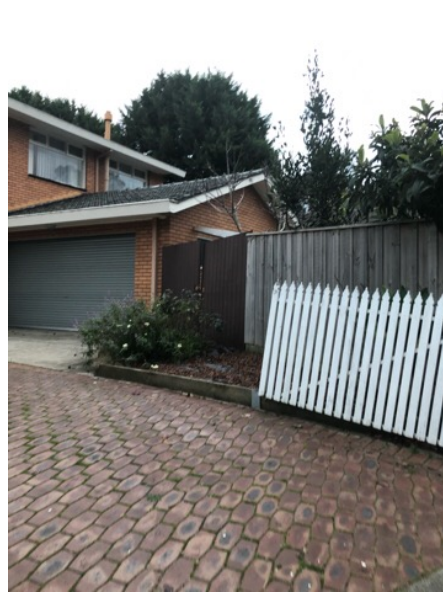
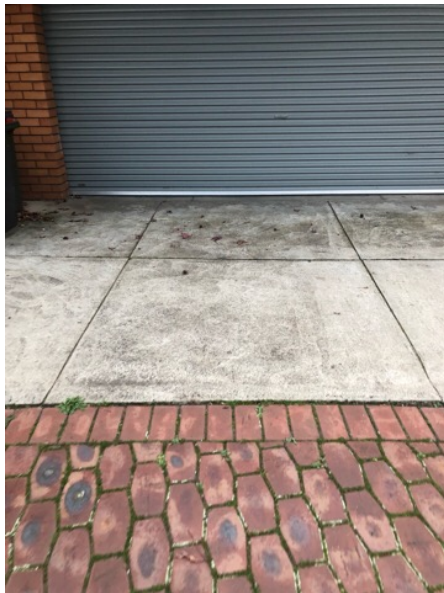
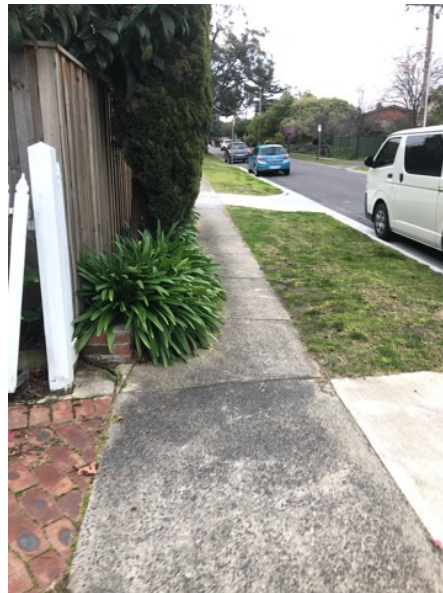
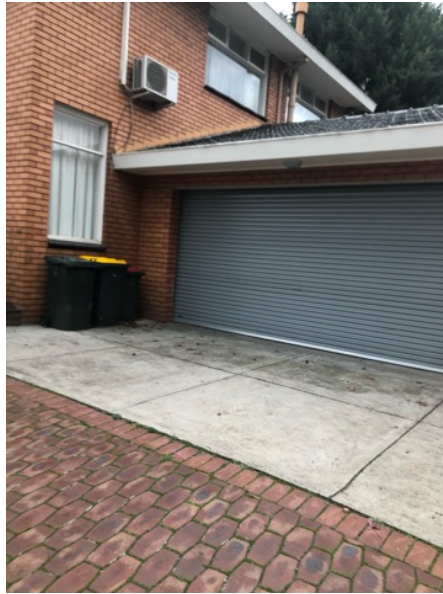
Driveway Condition

On visual inspection, the general condition of the driveway is in a serviceable condition.

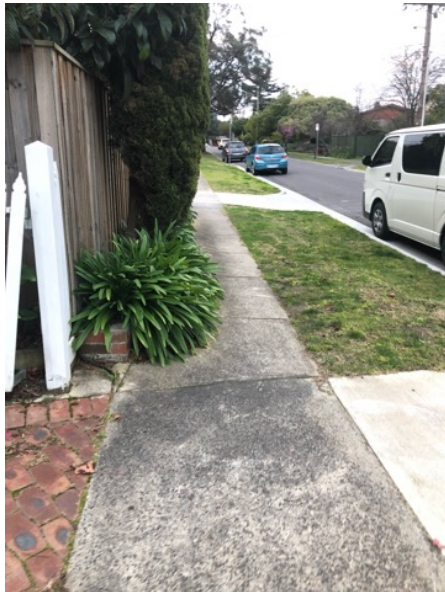
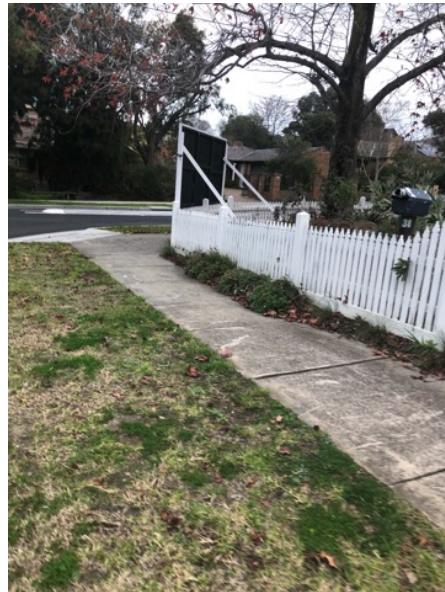
Pathways Condition

The paths around the home are in a serviceable condition for the age of this dwelling with no major defects visible.

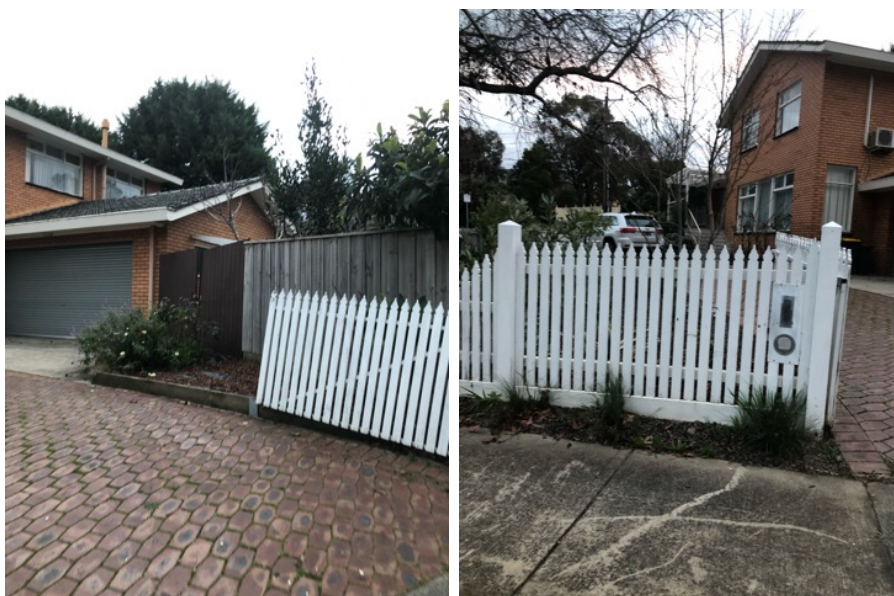
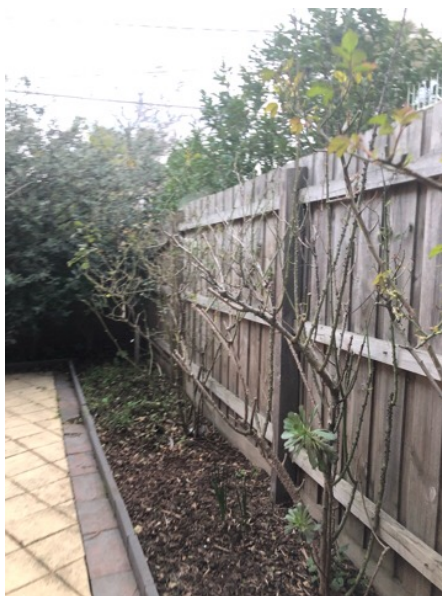
Overall Condition

Of the visible areas, the general condition of the fences and gates is serviceable for the age of dwelling.

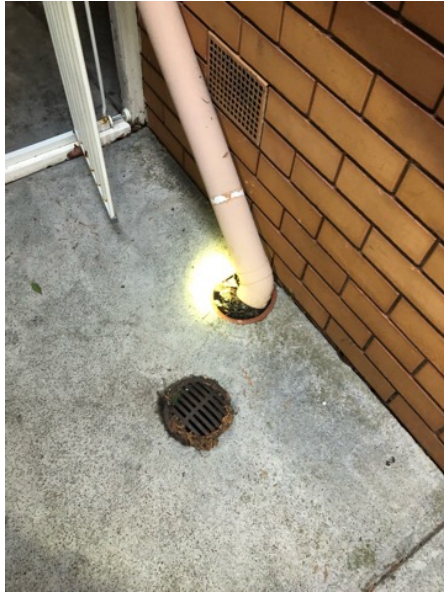
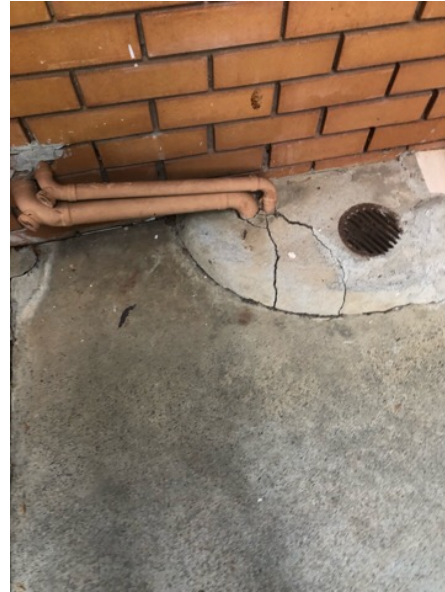
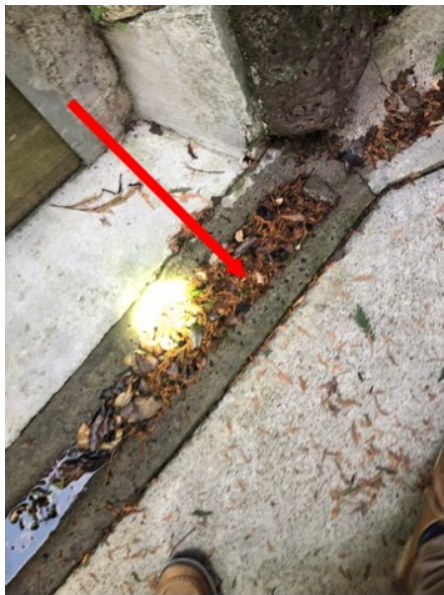
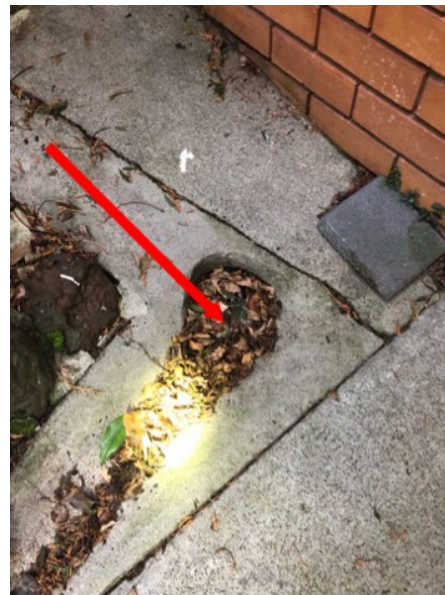
Drains

Debris evident in/around drains - Requires cleaning out.

Garage spoon drain - Debris evident. Requires cleaning out.

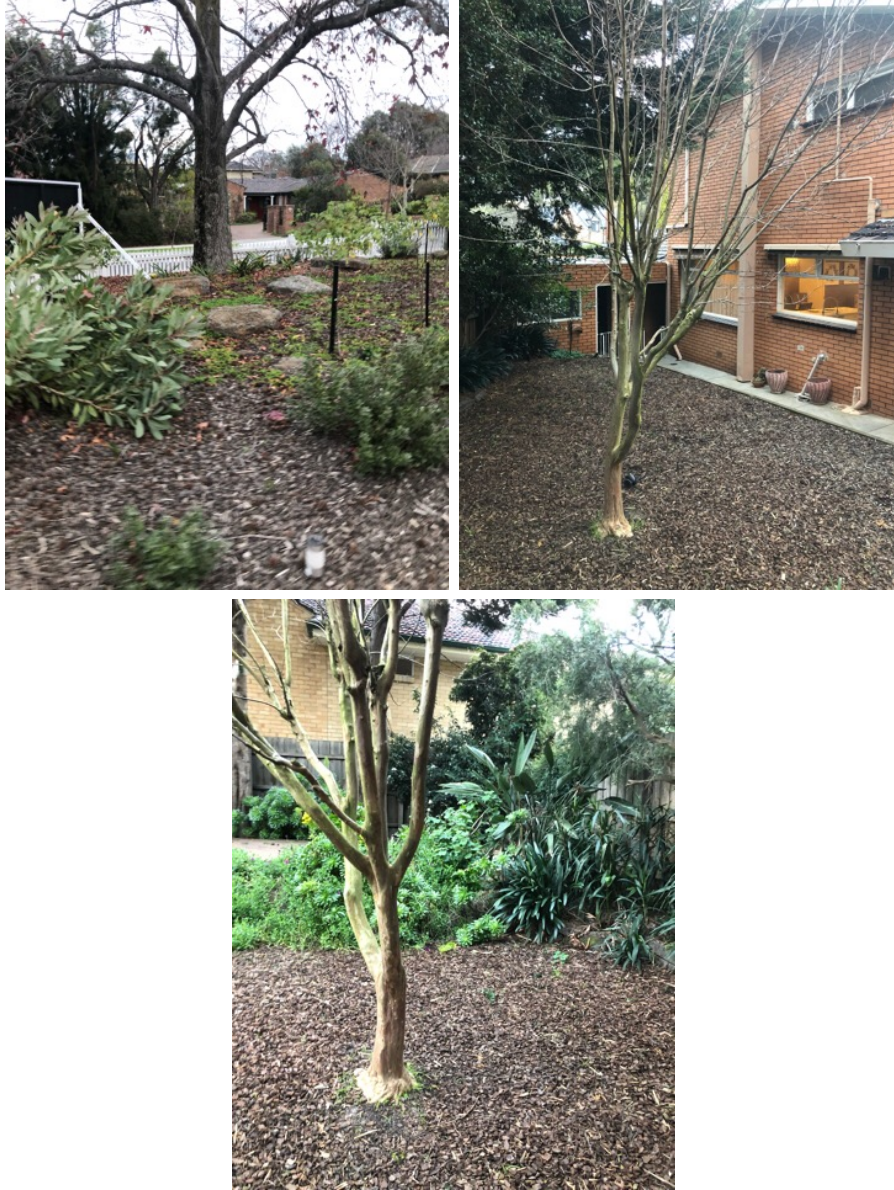
Tree Findings

Trees are close to the dwelling. These currently do not appear to have caused any defects/wall cracking.
Recommendations: Engage a qualified arborist to carry out an assessment on potential issues.

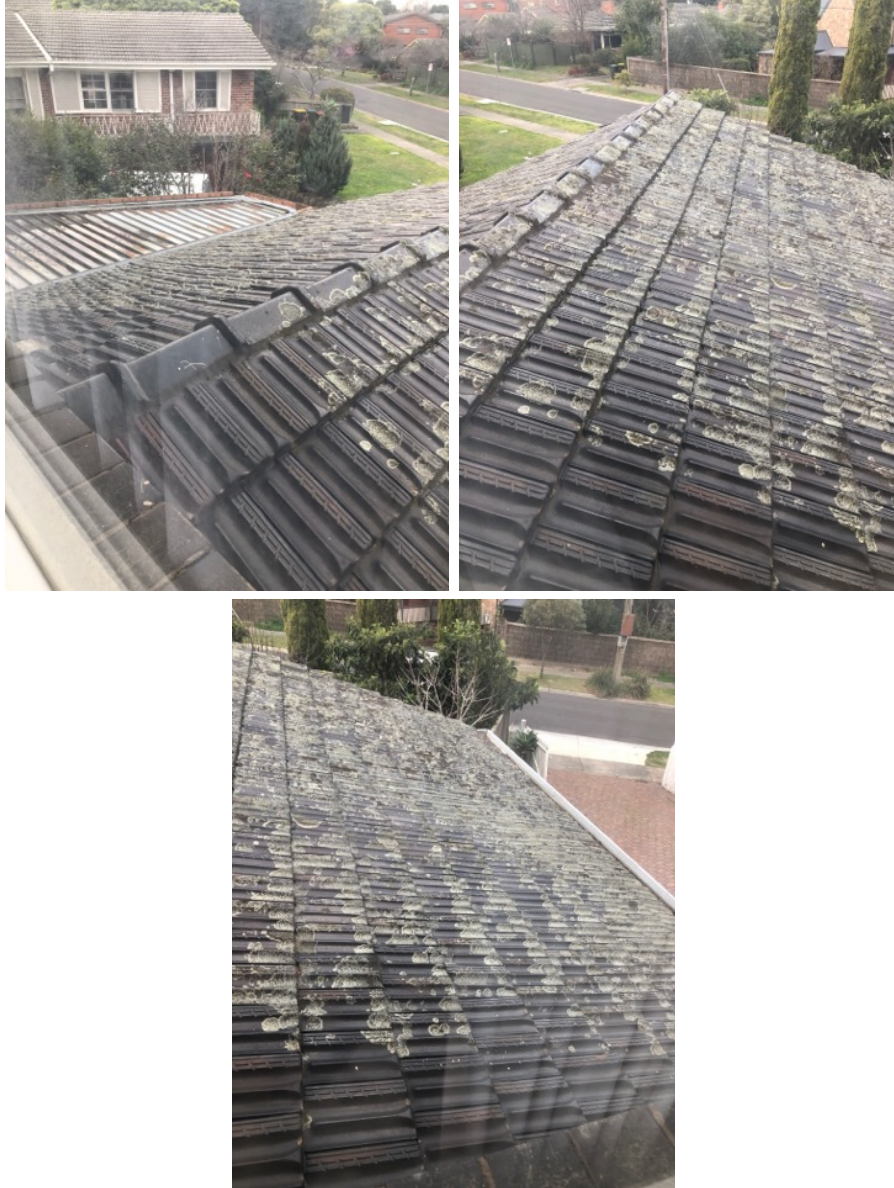
Overall Condition

Of the visible areas, the general condition of the roof is in serviceable condition for the age.

Note: In the absence of rainfall there is no guarantee that the roof won't leak.

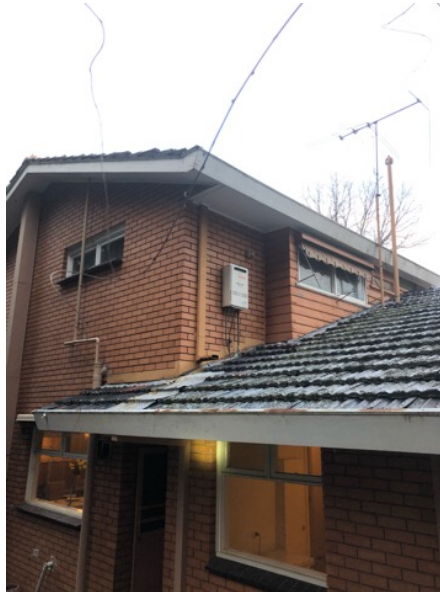
Debris in guttering areas- this requires cleaning out to prevent blocking of down pipes and leaking into eaves and fascia. Recommendations: Have gutters cleaned and assessed by a plumber for adequate fall. Also regularly clean to prevent ponding. Ponding water will contribute to rust.

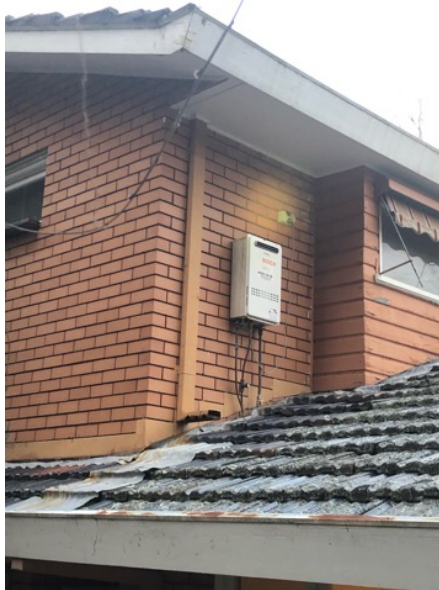
The hot water system appears to be in a serviceable condition. No specific tests other than running the hot water from a tap was carried out. No determination has been made as to the suitability or adequacy of the hot water system in relation to capacity or otherwise.

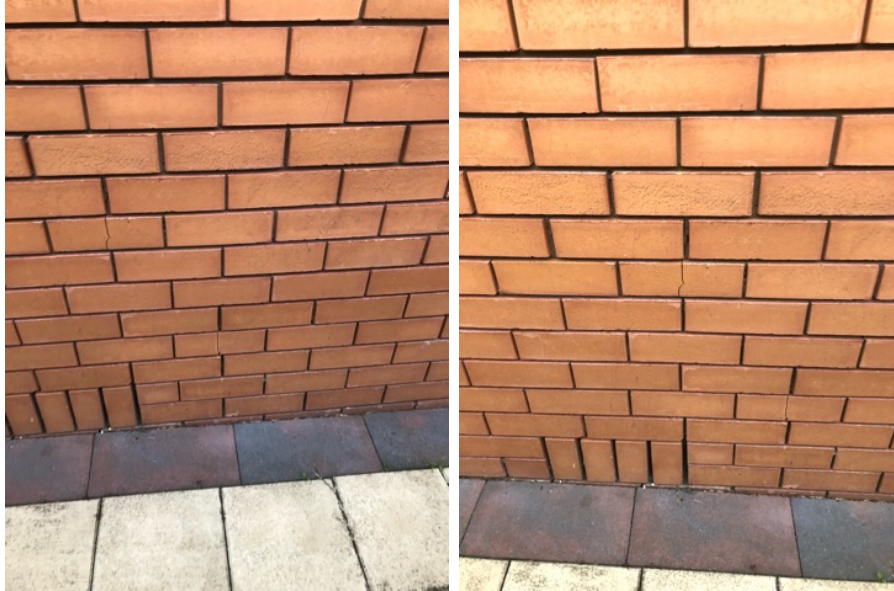
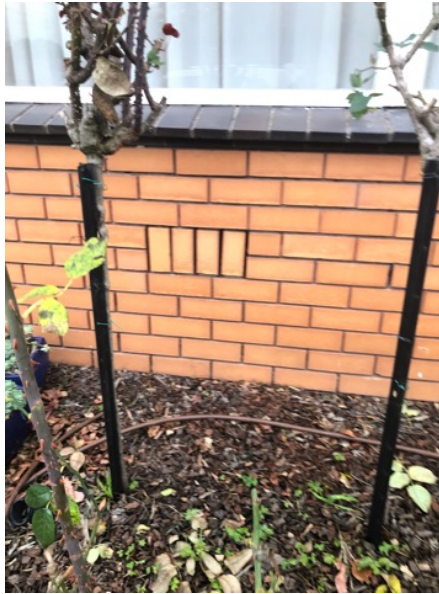
Findings

The vents are unobstructed.

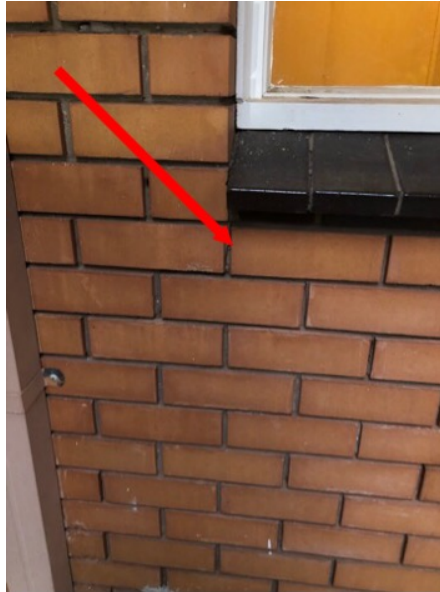
There appears to have been some settlement in the building which has caused some cracking to the walls. These cracks are categorized as 0 to 2 <5mm. This can also cause some doors to bind or be out of square. In the inspectors opinion these cracks are due to settlement, usually due to ground movement and subsequent movement to building materials can be expected. Any cracks should be monitored and if cracks increase in size, further investigation should be carried out by a structural engineer.

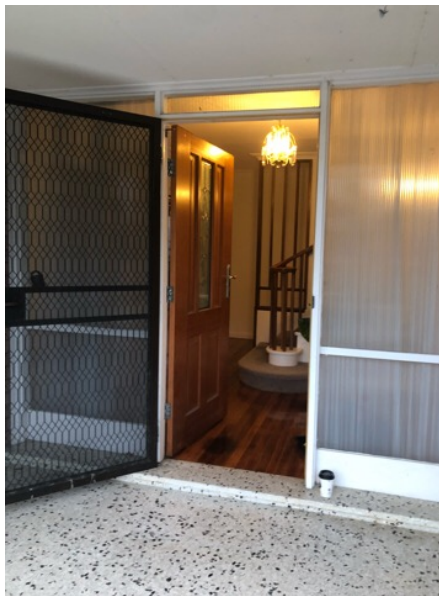
The entry porch serviceable or in reasonable or condition for the age of this dwelling.

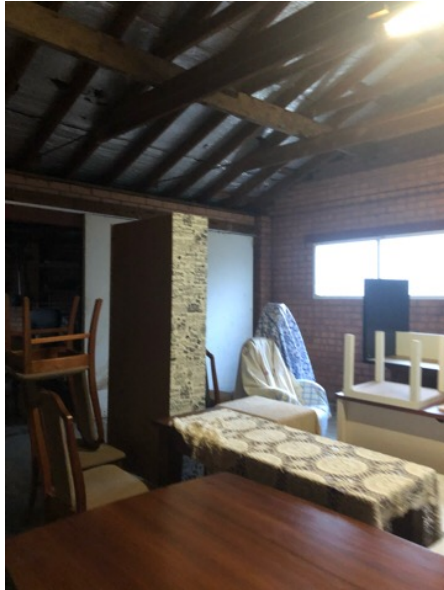
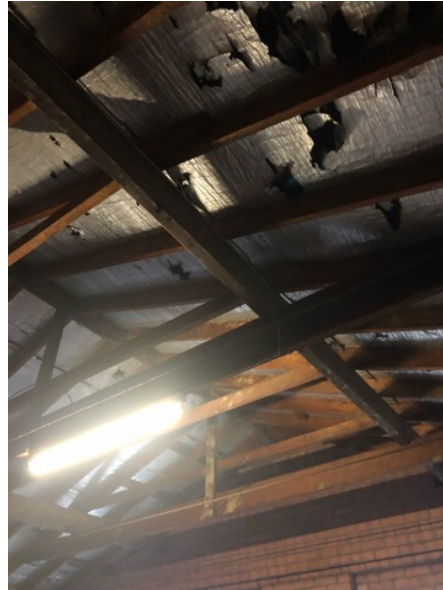
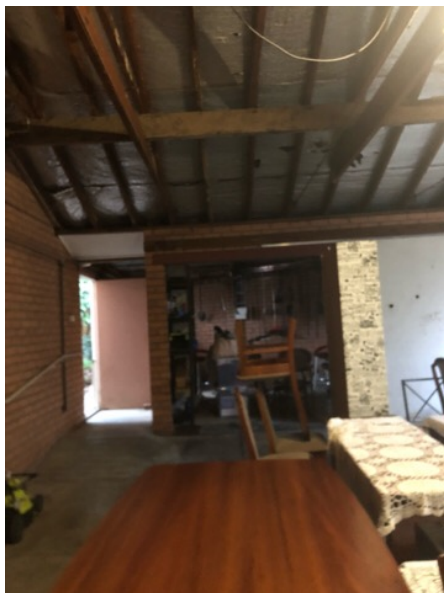
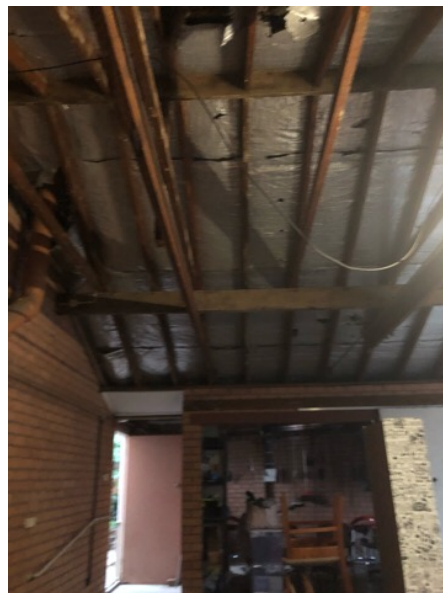
From the visible and accessible areas, the garage appears to be in a serviceable condition for the age of the property with no notable structural defects sighted.

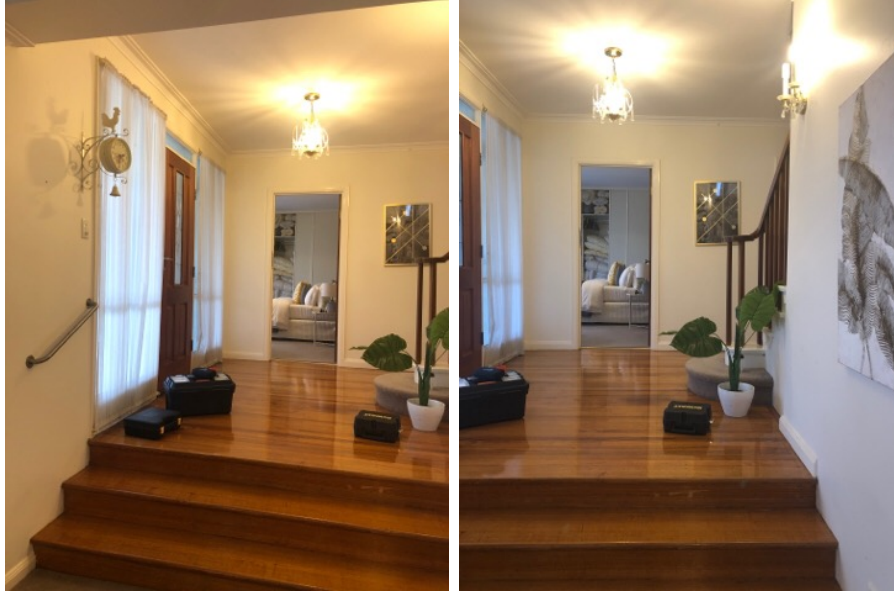
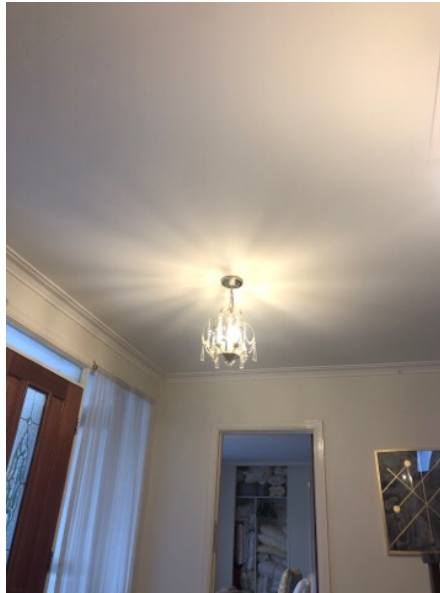
From the visible and accessible areas, the entry/Hallways appears to be in a serviceable condition for the age of the property with no notable structural defects sighted.

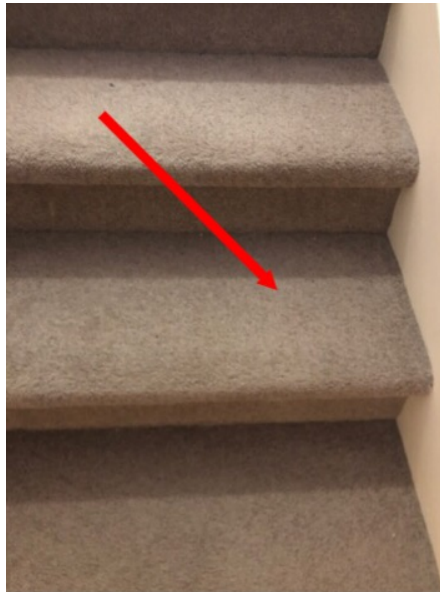
Internal Stair Case

The internal stair case is in a serviceable condition for the age with no notable defects sighted. Settlement cracks noted to the wall. These are typical and generally patch and paint will suffice, however we recommend monitor these cracks and if become wider or longer, you will need to contact a structural engineers to assess.

Squeaky floor at landing noted. Re-fixing the floor boards may fix this issue.

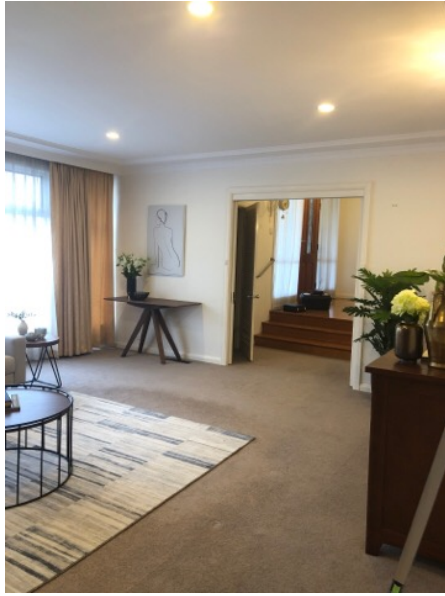
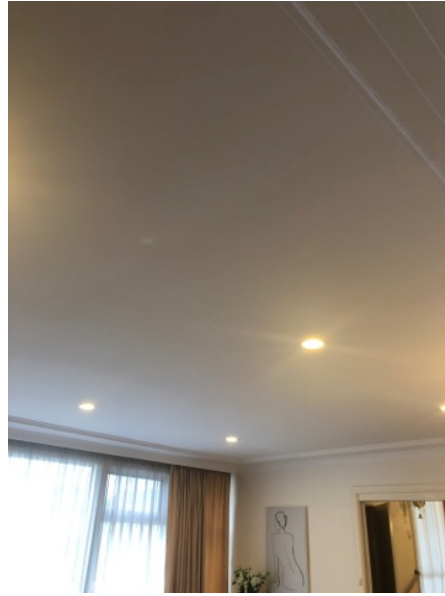
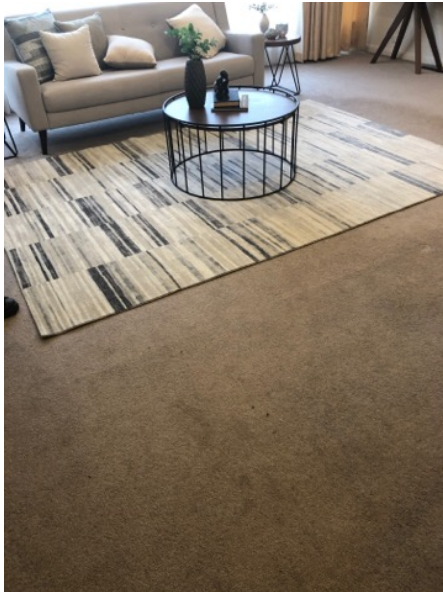
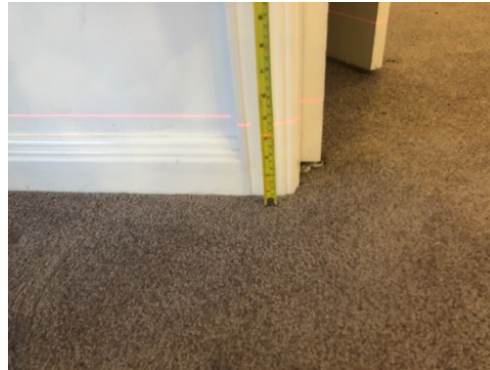
Lounge Room

From the visible and accessible areas, the entry/Hallways appears to be in a serviceable condition for the age of the property with no notable structural defects sighted.

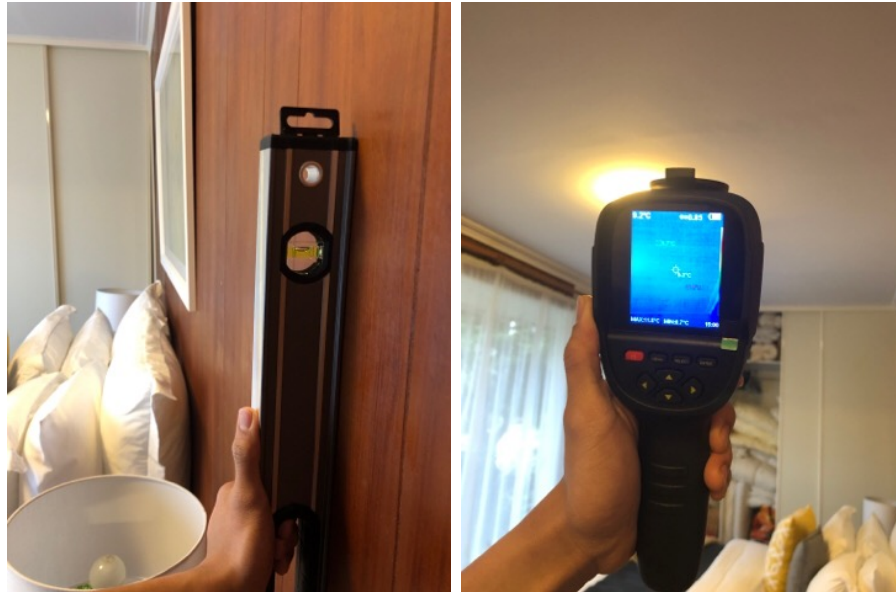
The wall is in serviceable condition.

There appears to have been some settlement in the building which has caused some cracking to the walls. These cracks are categorized as 0 to 2 <5mm. This can also cause some doors to bind or be out of square. In the inspector's opinion these cracks are due to settlement, usually due to ground movement and subsequent movement to building materials can be expected. Any cracks should be monitored and if cracks increase in size, further investigation should be carried out by a structural engineer.

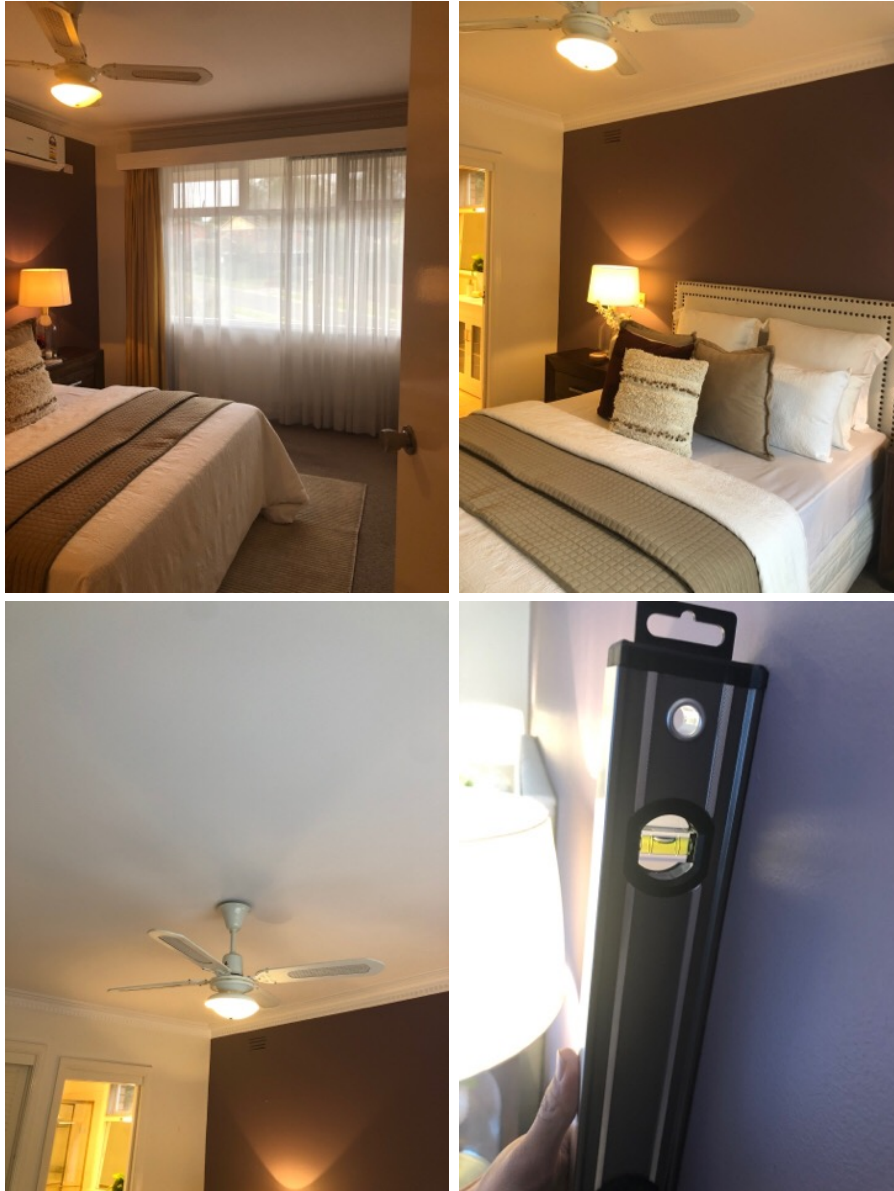
The flooring evenness has minor deviation of less than 20mm. There appears to have been some settlement in the building which has caused some unevenness to the floor. This can also cause some doors to bind or be out of square. In the inspector's opinion these deviations are due to settlement, usually due to ground movement and subsequent movement to building materials can be expected. Any cracks caused should be monitored if unevenness increases in magnitude.

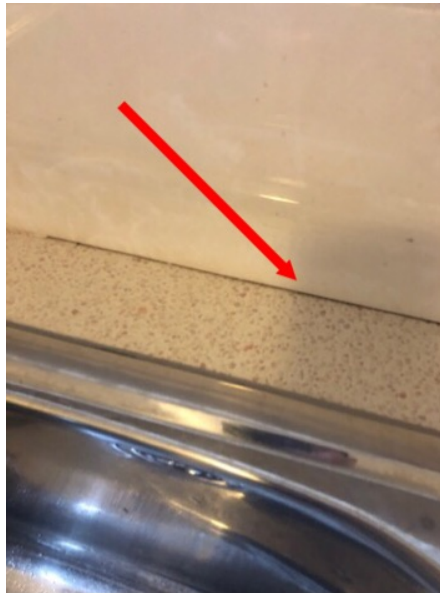
Bench top and splash back junction sealing deteriorated / missing - Recommendations: Re-sealing by a plumber or general maintenance contractor is recommended to prevent water access behind the bench.

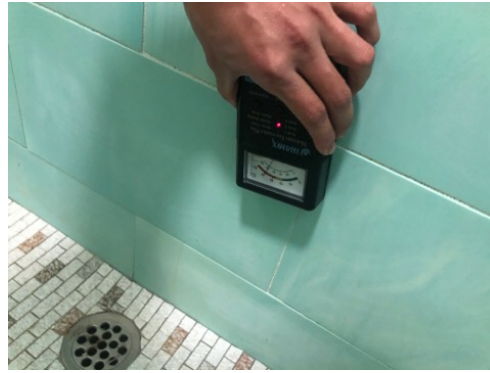
Walls

Excess moisture readings were obtained on the wall linings adjacent bathroom/shower. This may be related to the shower recess/plumbing in wall cavity leaking or failed waterproofing membrane to the wet area.

There appears to have been some settlement in the building which has caused some cracking to the walls. These cracks are categorized as 0 to 2 <5mm. This can also cause some doors to bind or be out of square. In the inspectors opinion these cracks are due to settlement, usually due to ground movement and subsequent movement to building materials can be expected. Any cracks should be monitored and if cracks increase in size, further investigation should be carried out by a structural engineer.

Cracked tile/s noted. A qualified tiler should be engaged for advice and recommendations.

Recommendations: Engage a plumber and a licensed waterproofer for advice and recommendations.

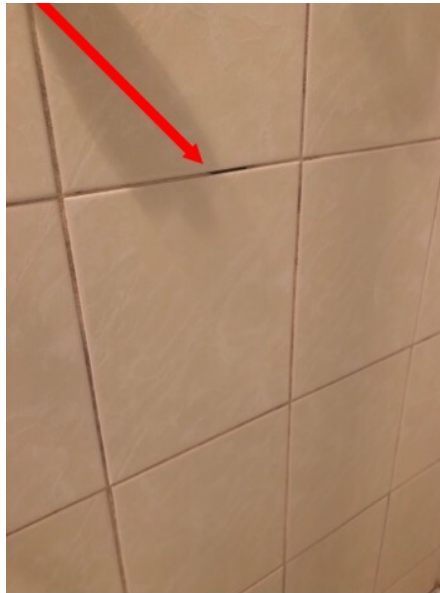
Tile grout deterioration. Re-grout / seal the shower tiles and screen junctions. A qualified plumber should be engaged for advice and recommendations.

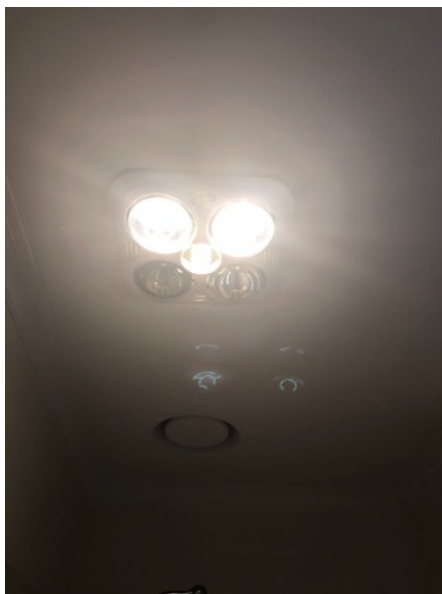
Lighting and Ceiling Heater

Component(s) of the ceiling heating light is not working. May require replacement of suitable light bulbs.

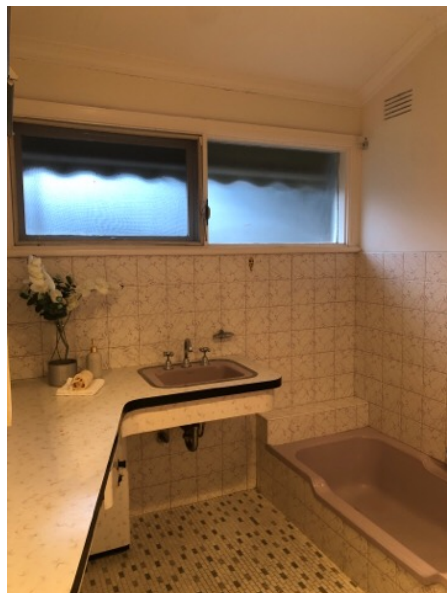
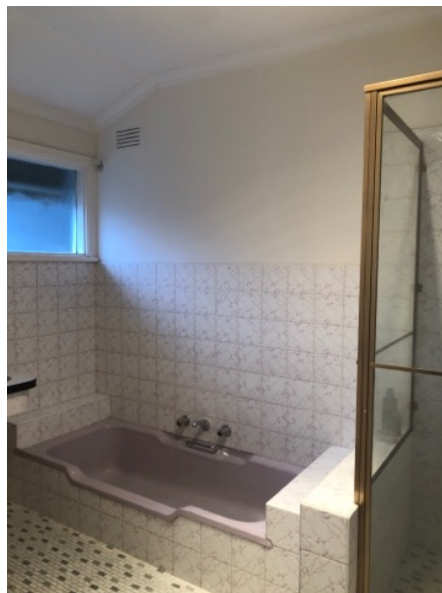
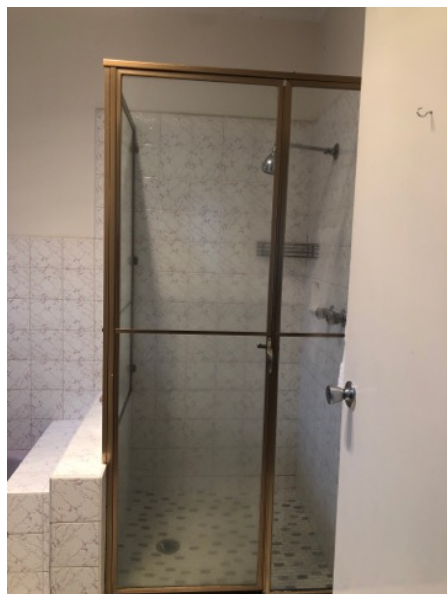
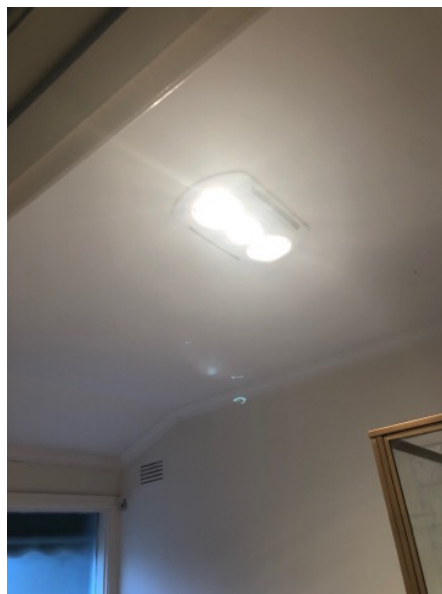
Ceiling

There appears to have been some settlement in the building which has caused some cracking to the ceiling. These cracks are categorized as 0 to 2 <5mm. This can also cause some doors to bind or be out of square. In the inspector's opinion these cracks are due to settlement, usually due to ground movement and subsequent movement to building materials can be expected. Any cracks should be monitored and if cracks increase in size, further investigation should be carried out by a structural engineer.

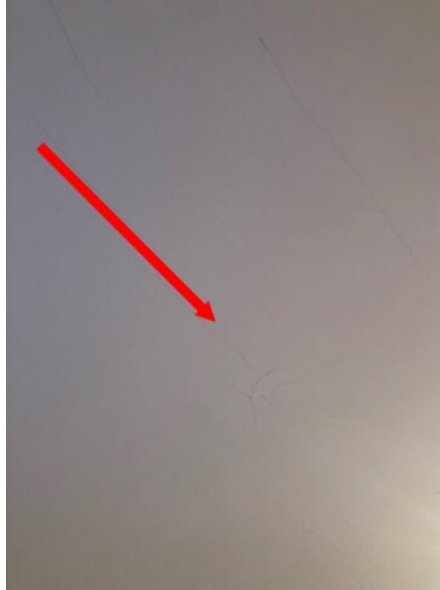
Walls

Excess moisture readings were obtained on the wall linings adjacent bathroom/shower. This may be related to the shower recess/plumbing in wall cavity leaking or failed waterproofing membrane to the wet area.

Recommendations: Engage a plumber and a licensed waterproofer for advice and recommendations.

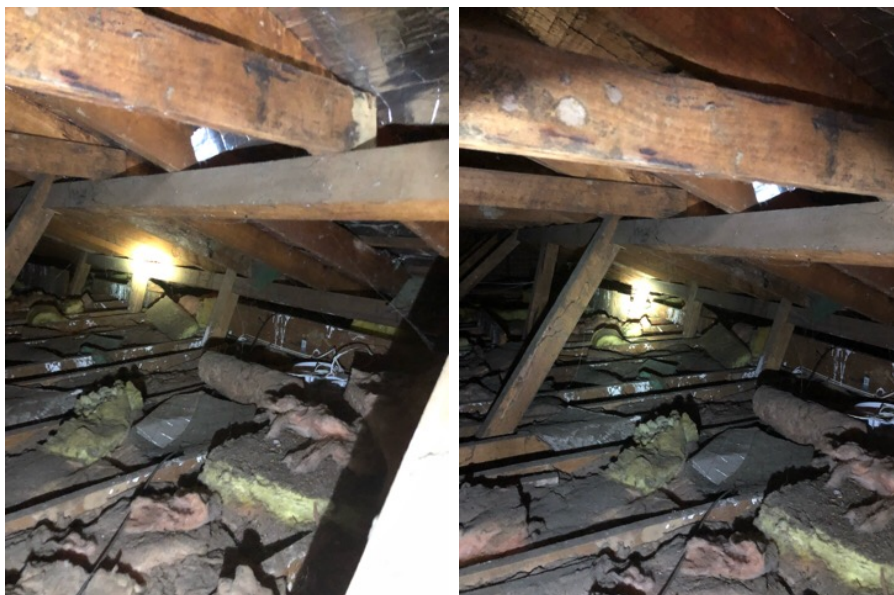
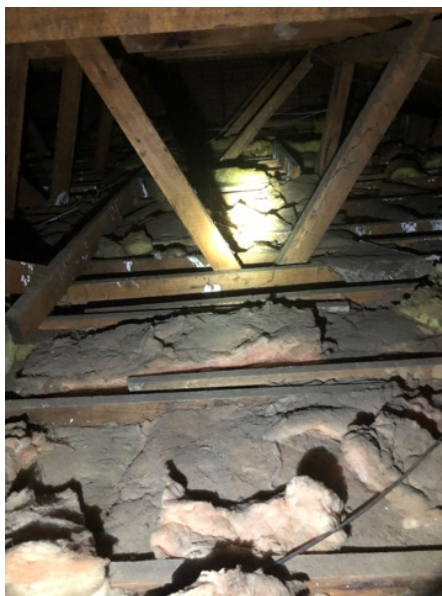
Where visible and accessible, the insulation appears to be in a serviceable condition.

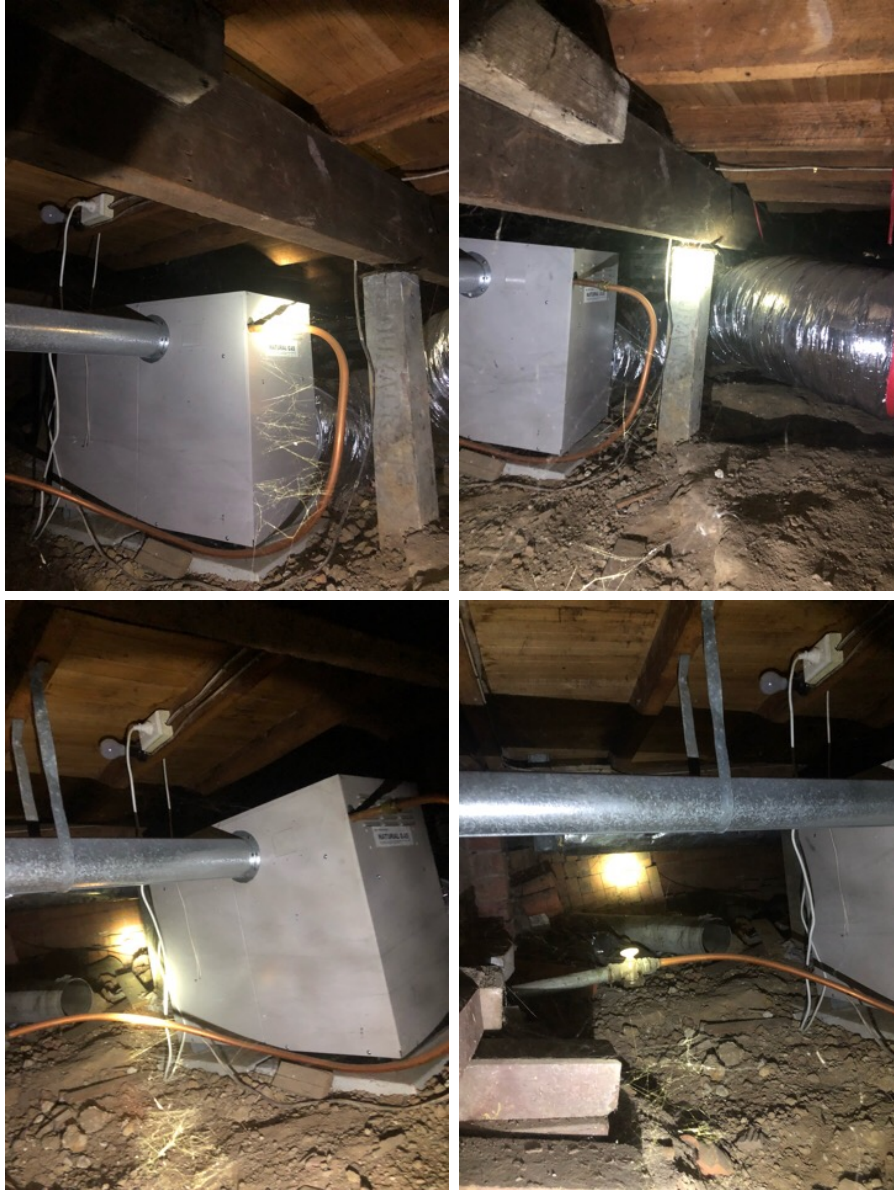
Of areas accessible and visible, the subfloor and components appeared to be in a serviceable condition.
