Building Inspection Report

FANGS BUILDING INSPECTIONS

Lotxx Hutchence Drive, Point Cook, VIC, 3030

Inspection Date: 28 Feb 2019

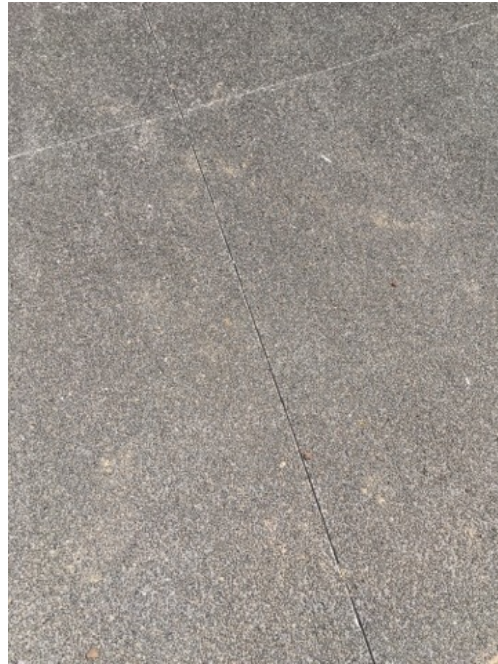
Driveway Condition

On visual inspection, the general condition of the driveway is in a serviceable condition.

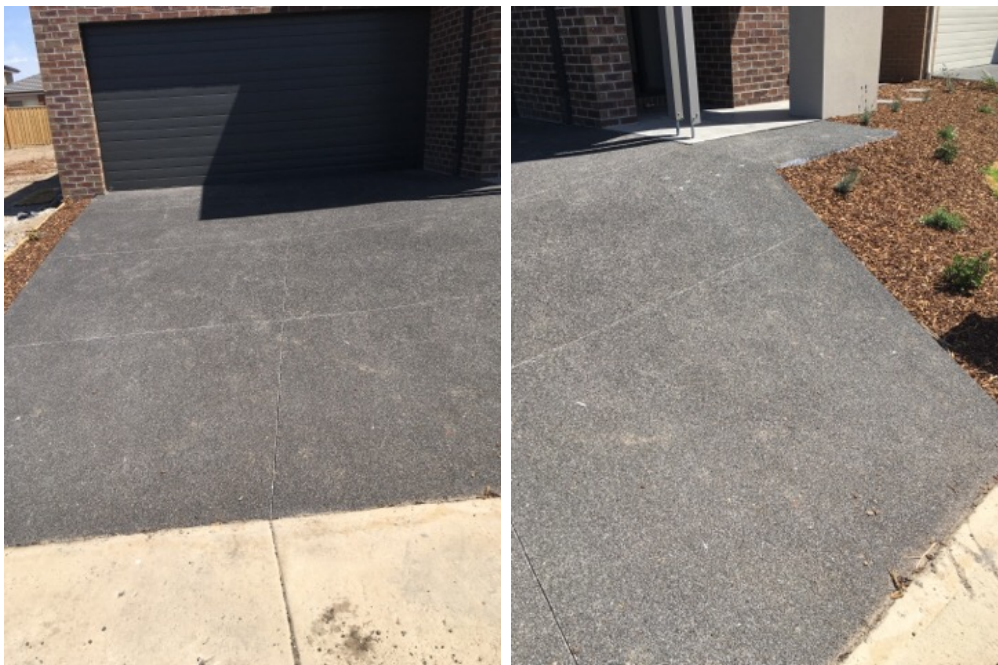
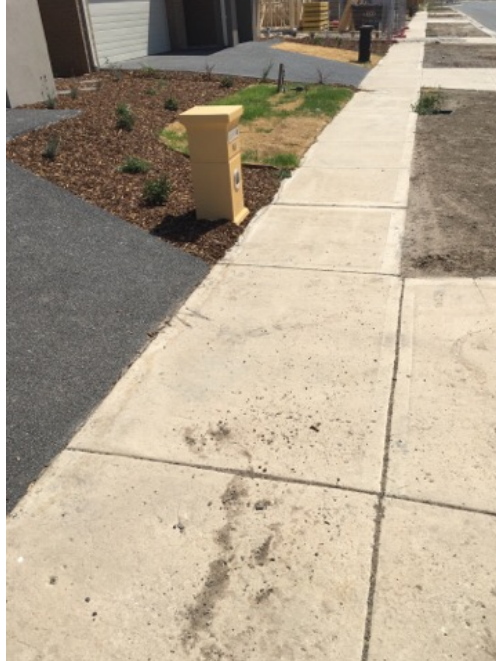
Pathways Condition

The paths around the home are in a serviceable condition for the age of this dwelling with no major defects visible.

Good condition

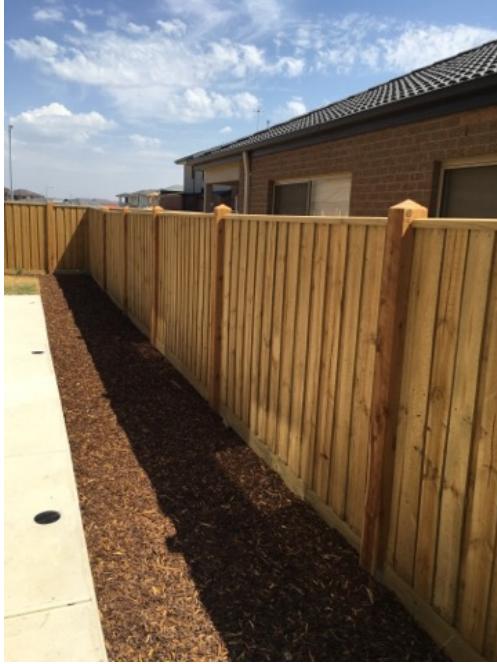
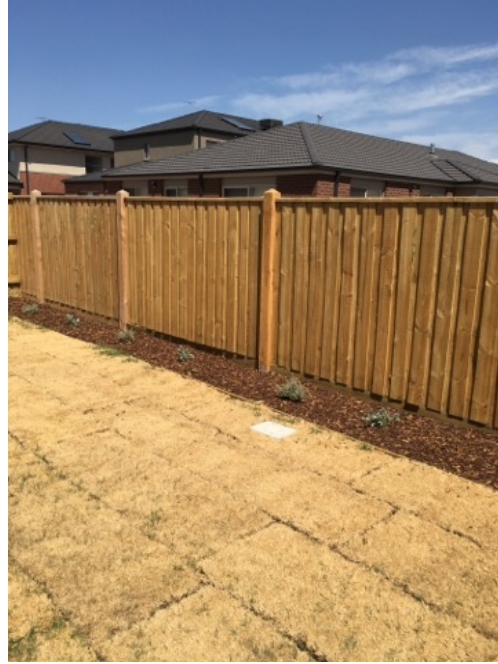
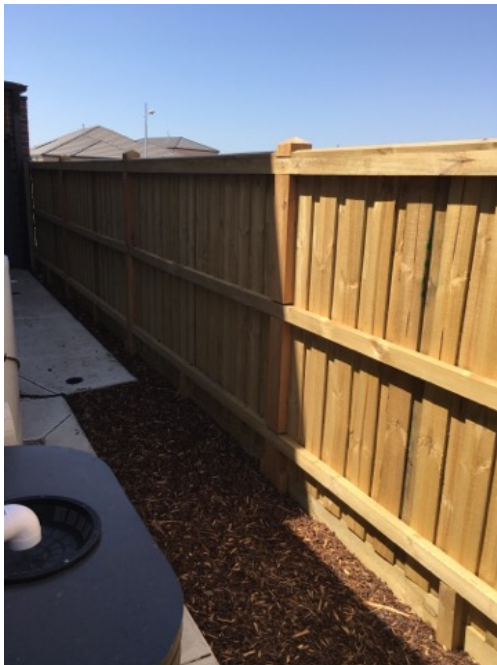
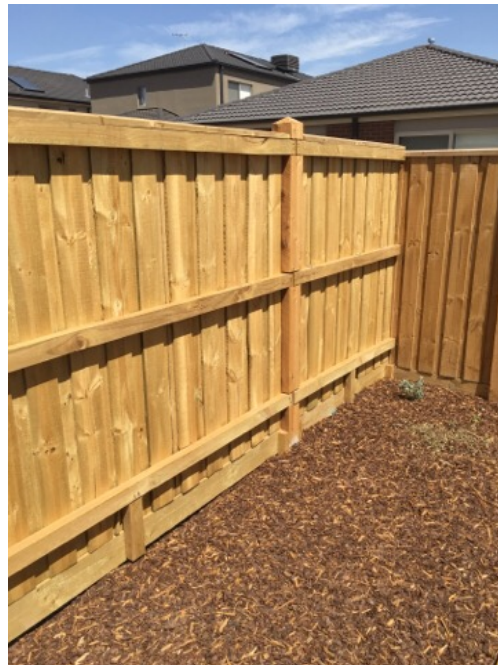
Fence installation completed and displays good workmanship

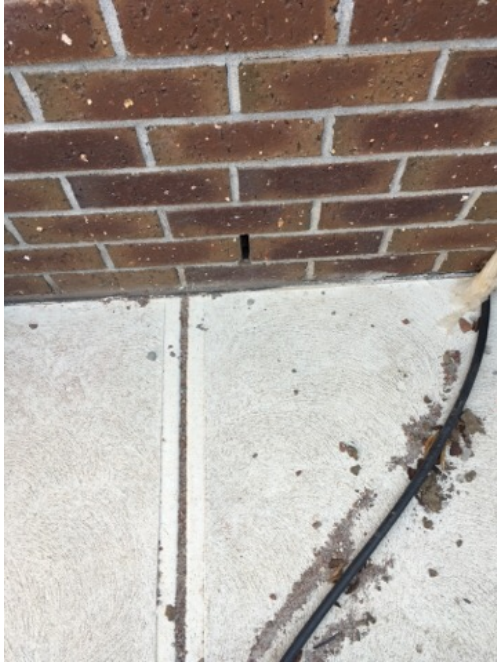
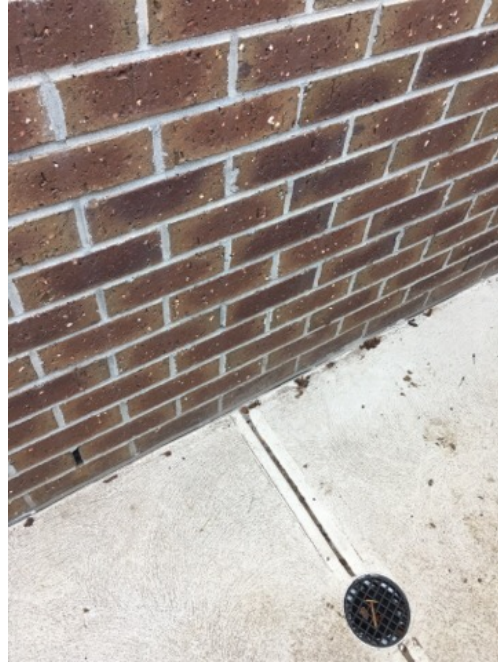
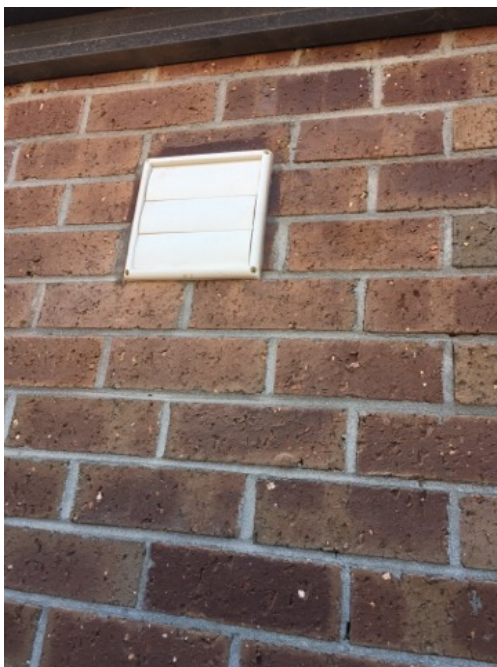
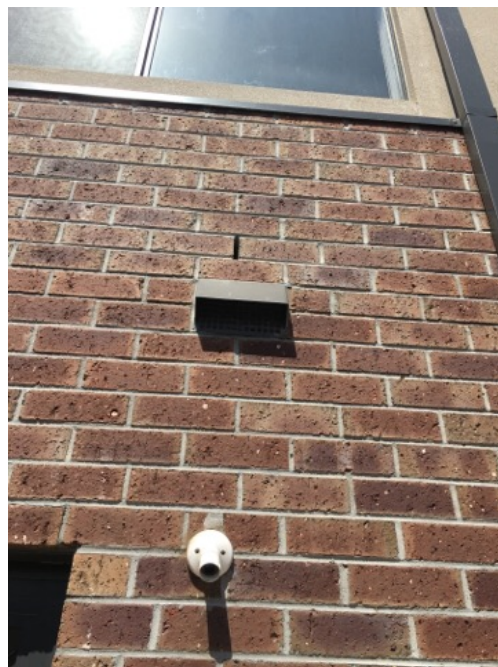
Weep Holes and Ventilation

The weep holes are unobstructed .

The vents are unobstructed.

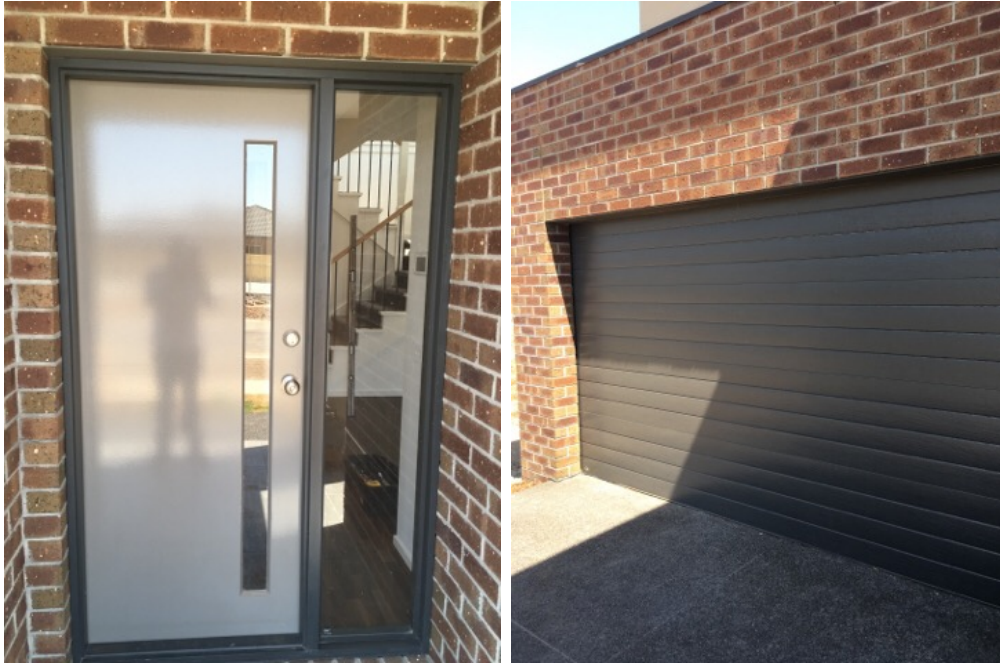
Door / Security Gate Findings

On Visual Inspection the external condition of the doors is serviceable.

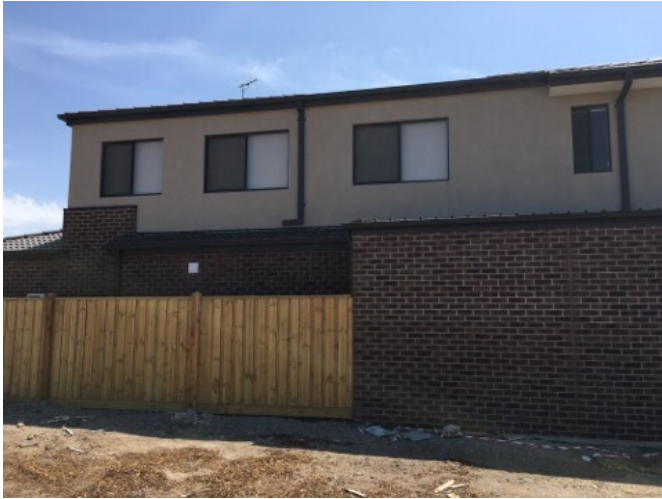
Condition

Poor laying or repair of brick work noted. We recommend you engage a brick layer for repairs.
Light glove missing

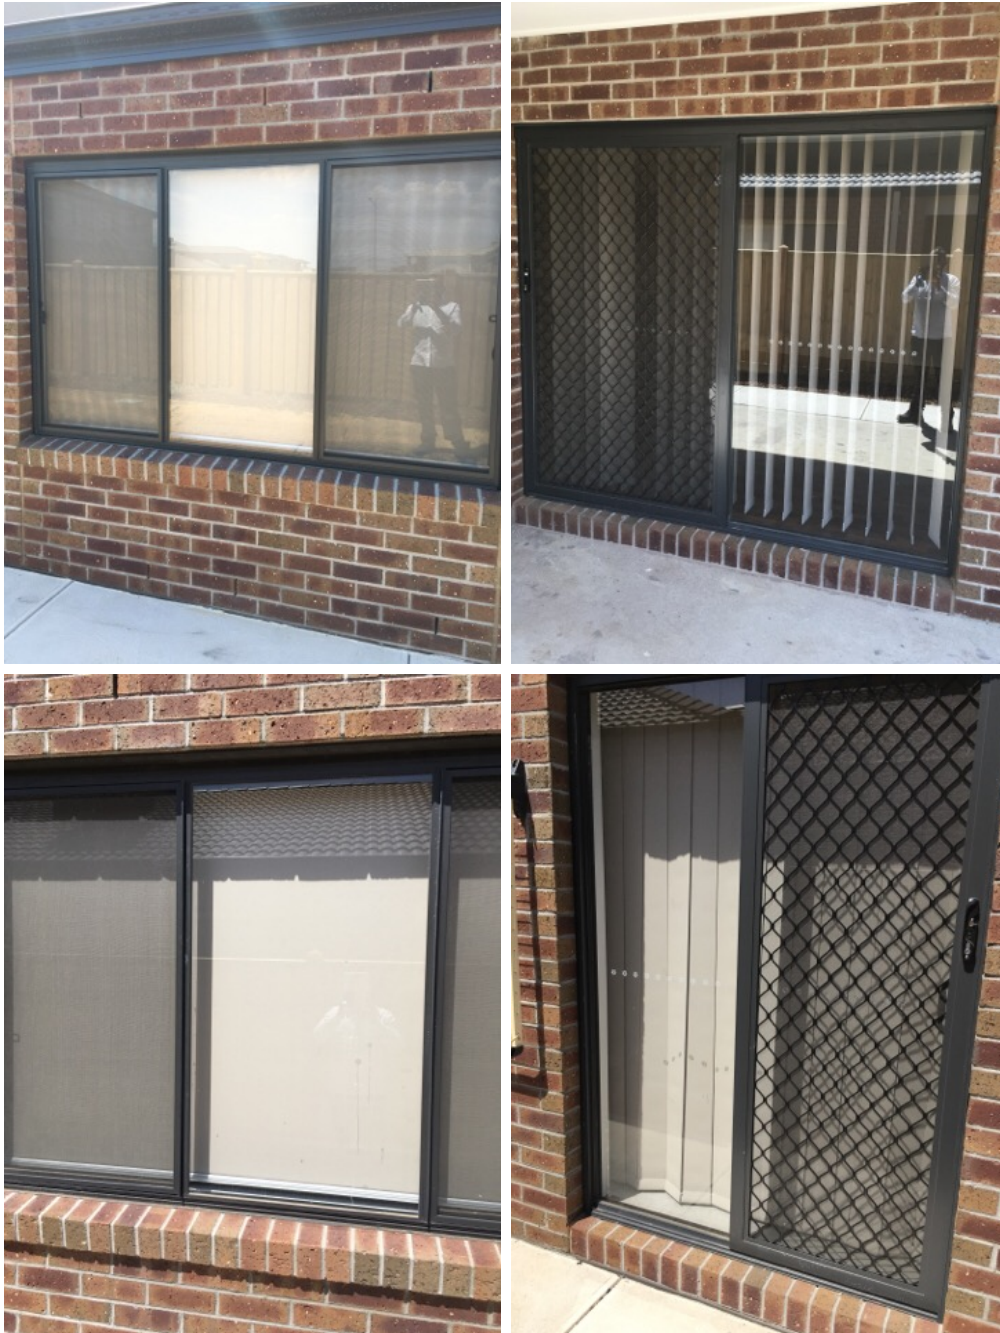
Overall Condition

On visual inspection, the general condition of the windows area is serviceable for the age.

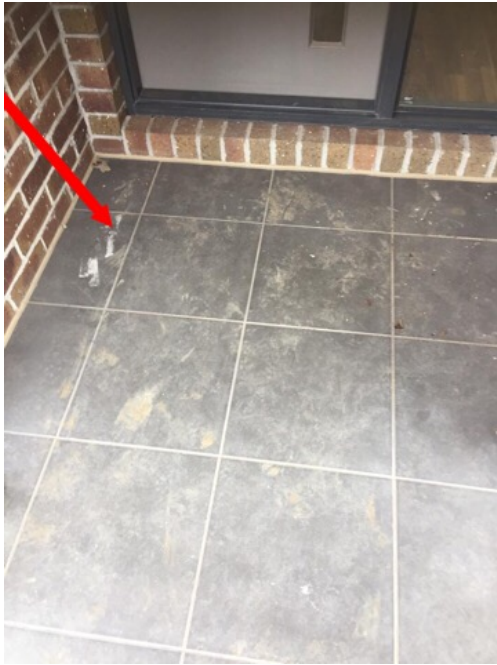
Base or Flooring Condition

Overpainted

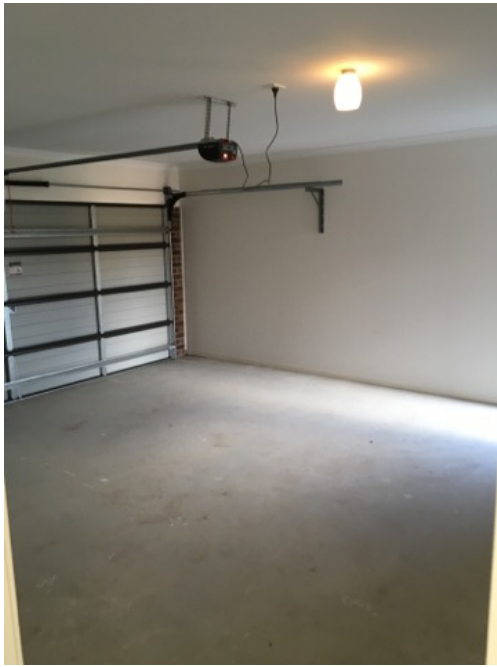
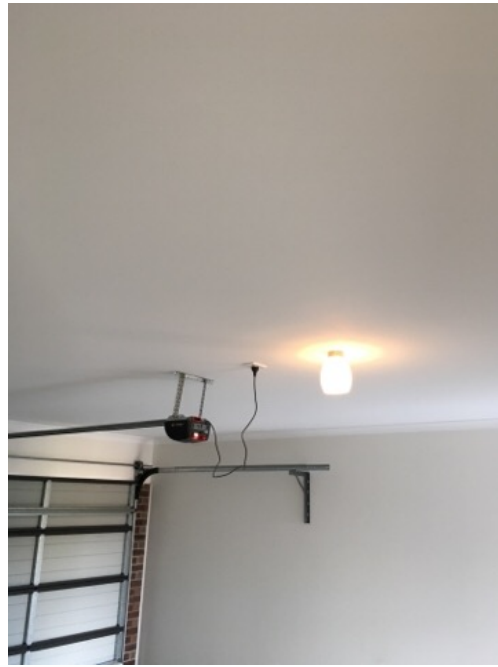
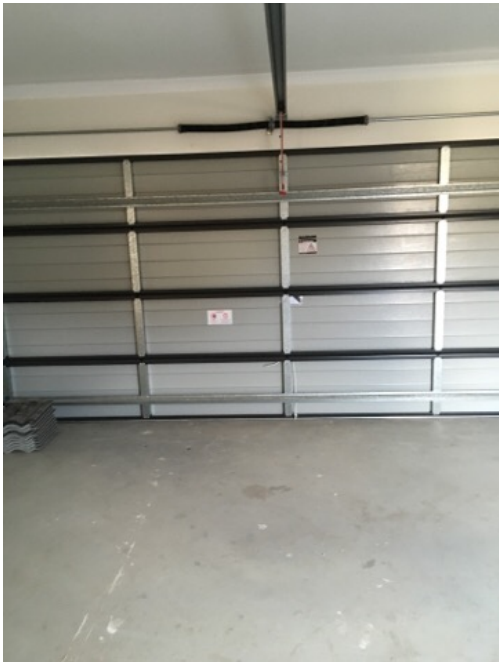
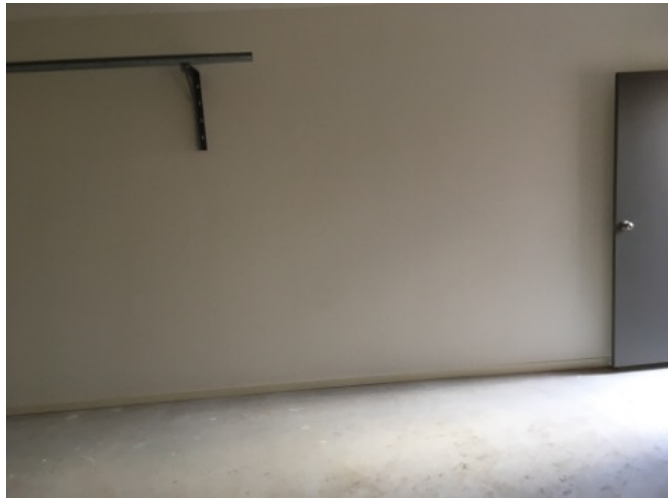
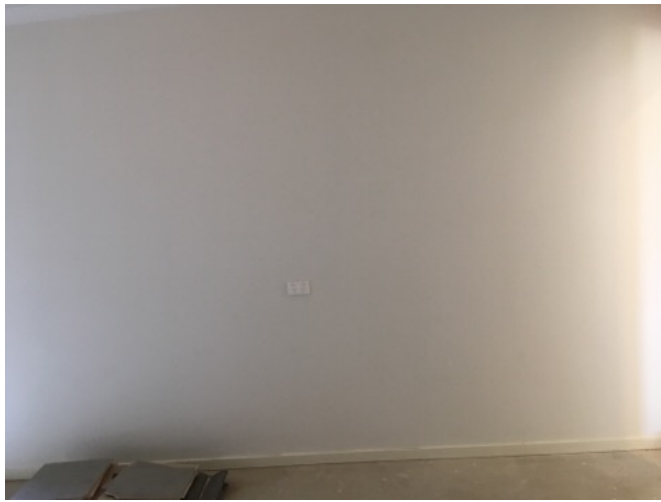
Overall Condition

From the visible and accessible areas, the garage appears to be in a serviceable condition for the age of the property with no notable structural defects sighted.

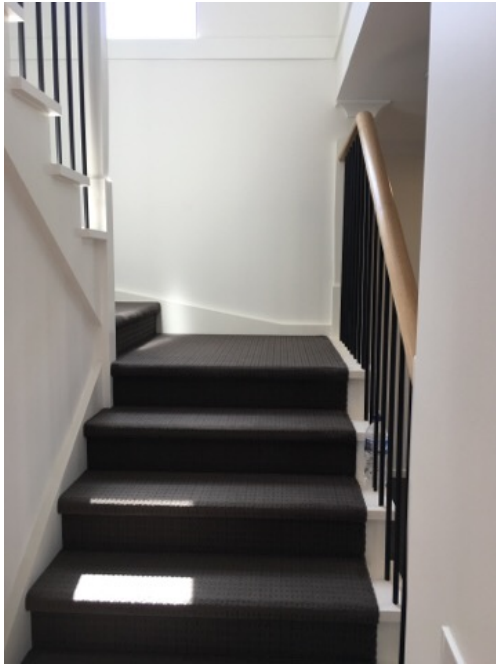
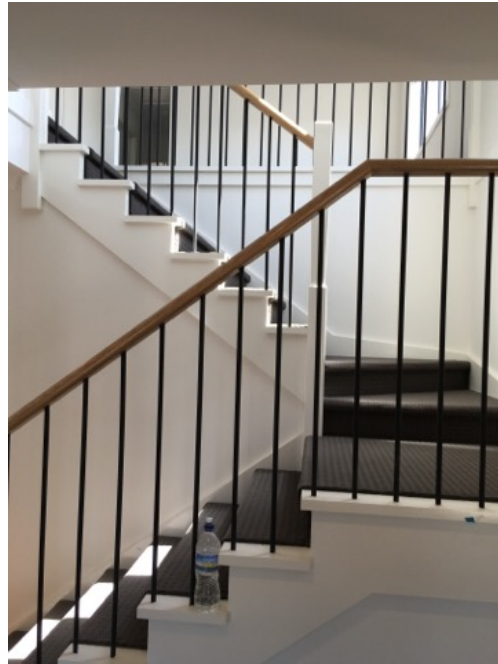
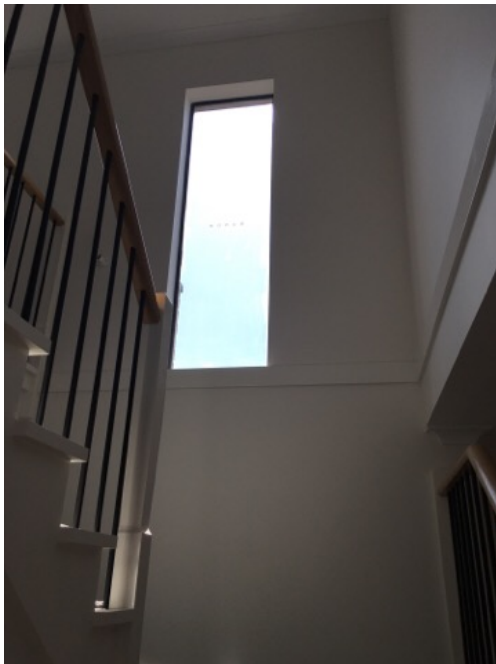
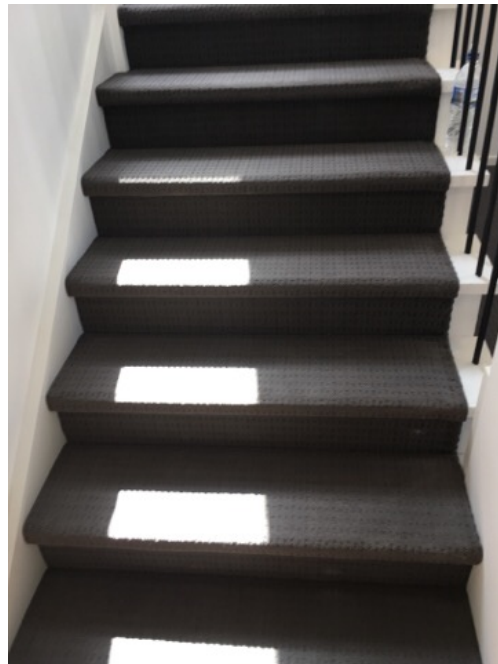
Stairs & Steps

The stairs/steps appear to be serviceable with no notable defects.

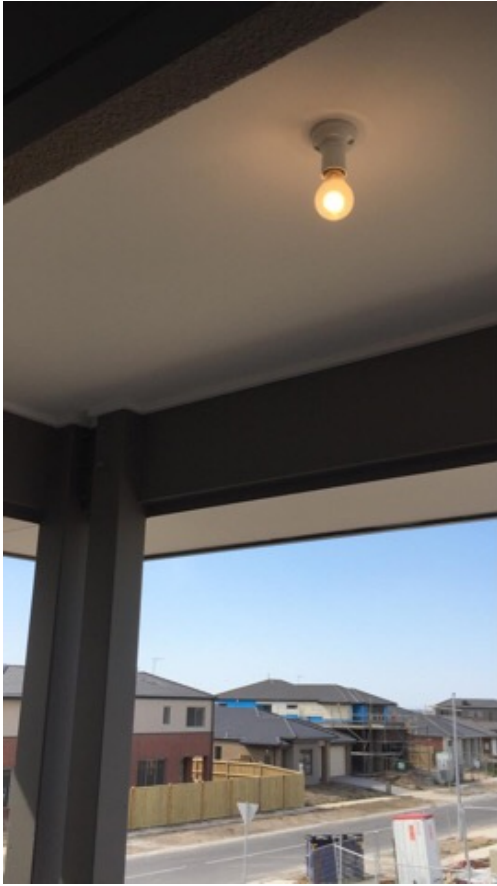
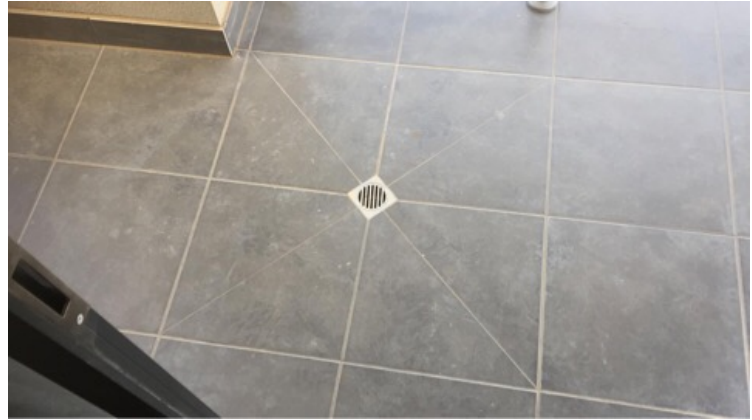
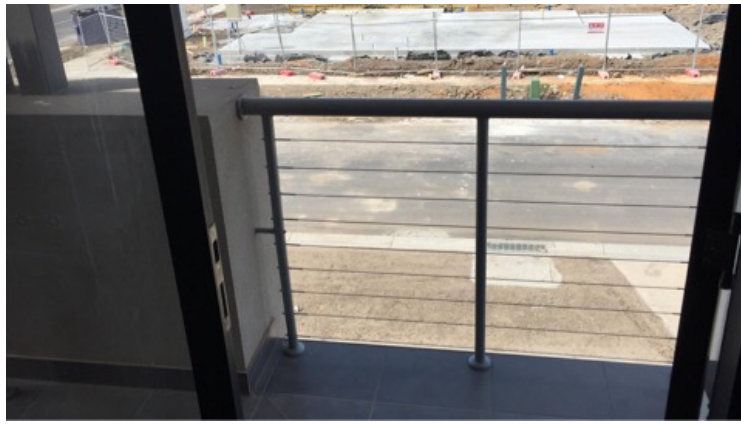
Balcony Findings

Though we are not structural engineers the balcony/s appear to be in a serviceable condition.

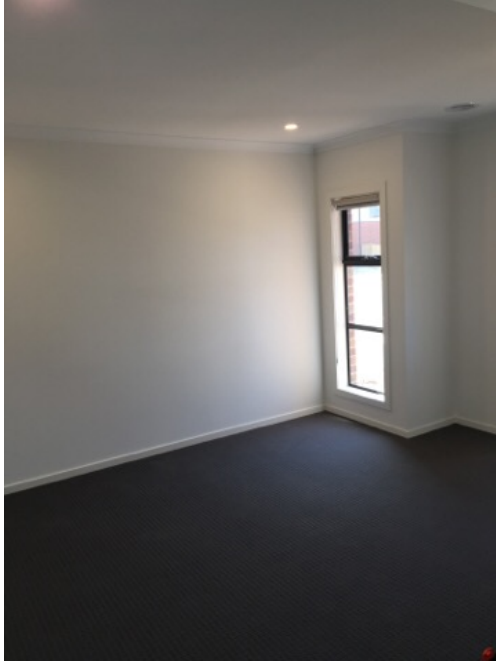
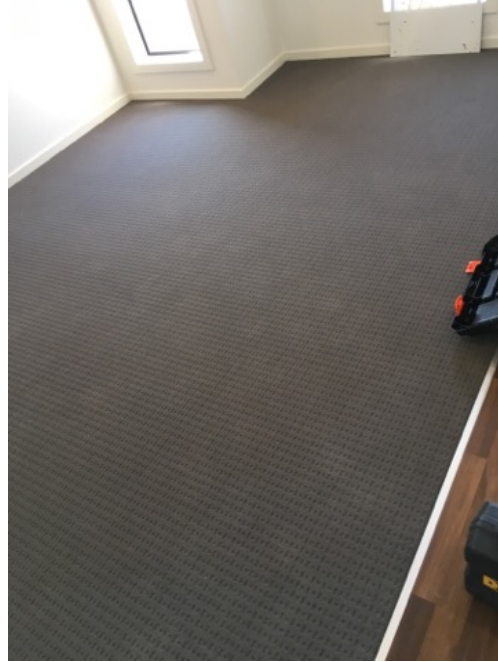
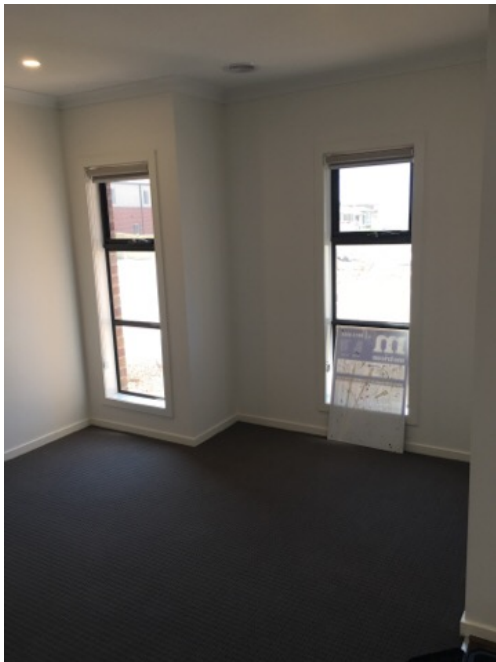
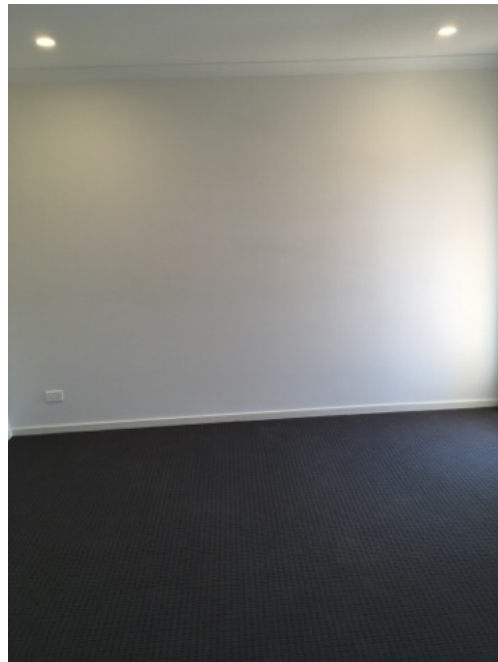
From the visible and accessible areas, the lounge room appears to be in a serviceable condition for the age of the property with no notable structural defects sighted.

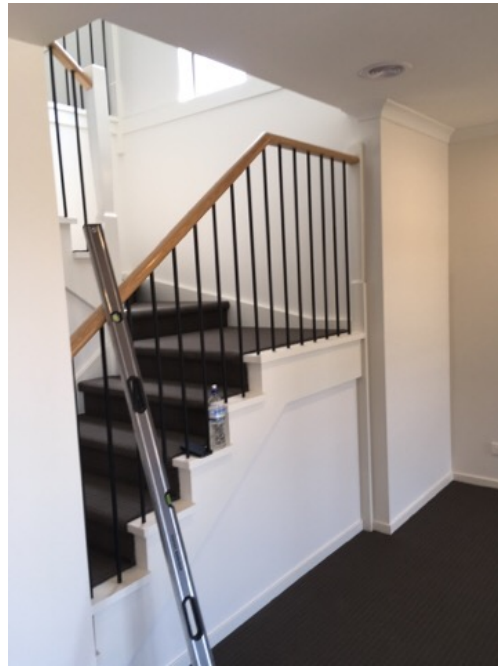
Walls

Paint Mark and Cracking Noted - Touch Up Will Satisfy

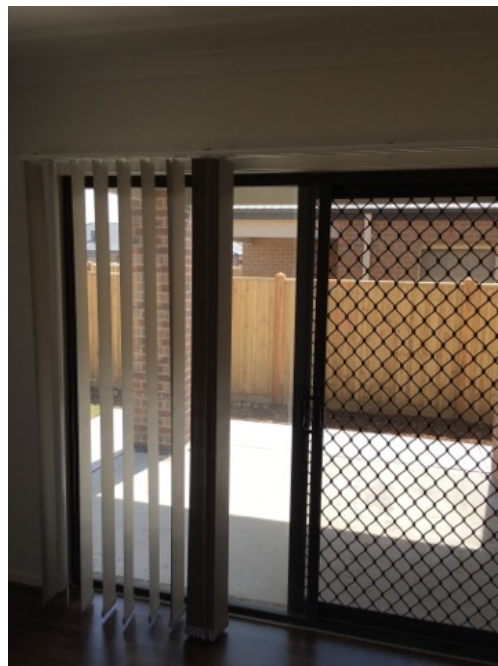
Walls

Minor Dent, Chips and Scratches Noted - Touch Up Will Satisfy

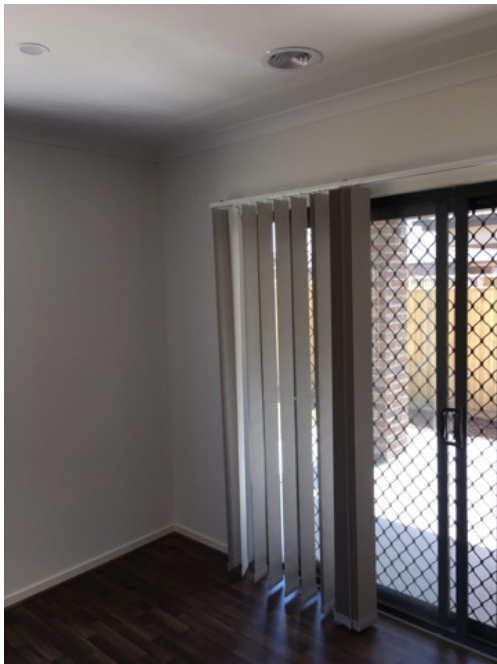
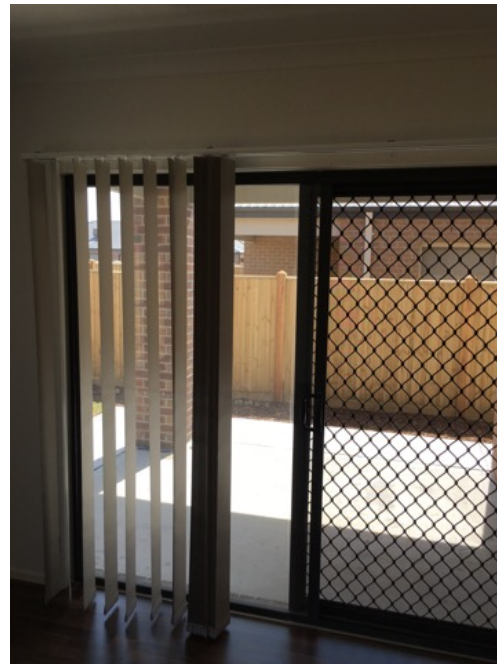
Walls

Paint Mark and Cracking Noted - Touch Up Will Satisfy

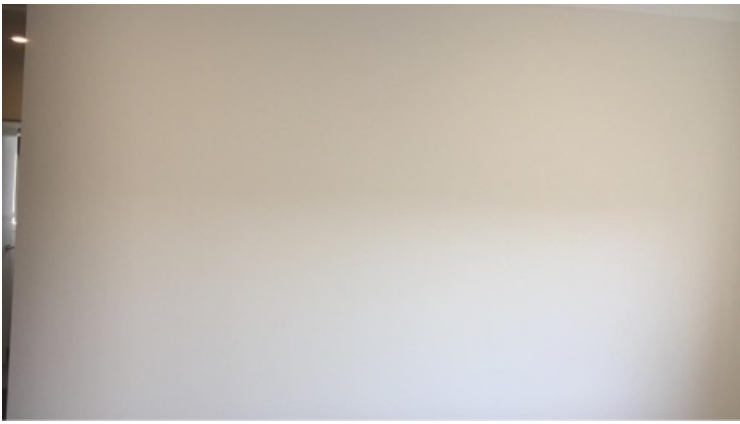
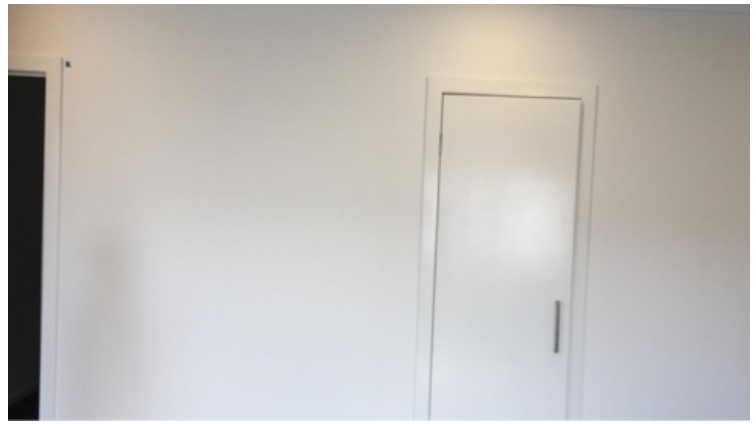
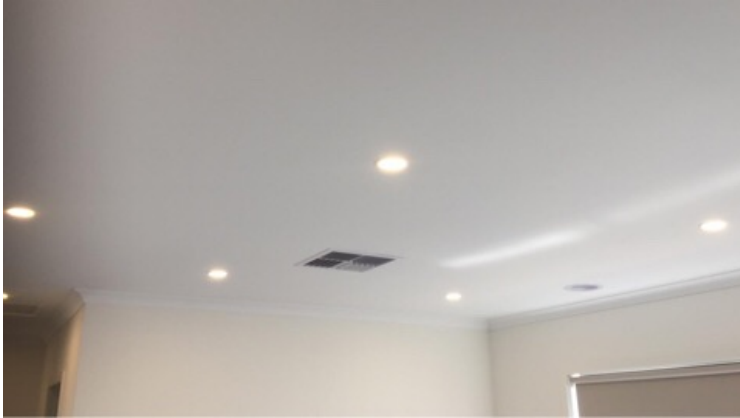
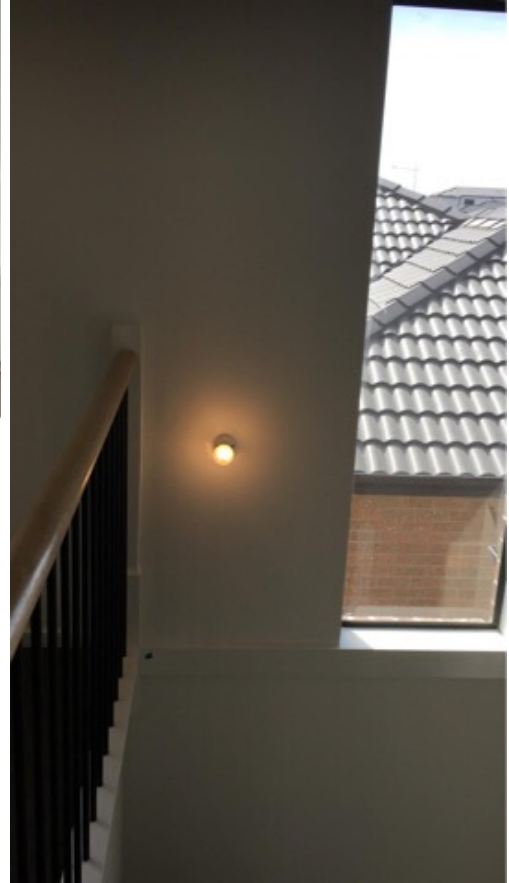
Walls

Minor Dent, Chips and Scratches Noted - Touch Up Will Satisfy

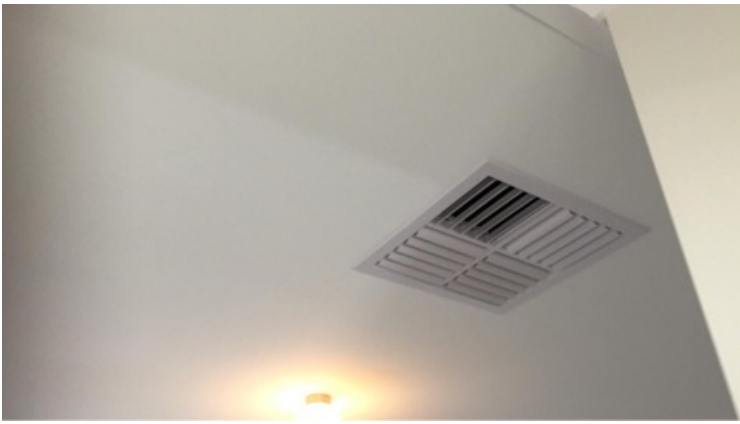
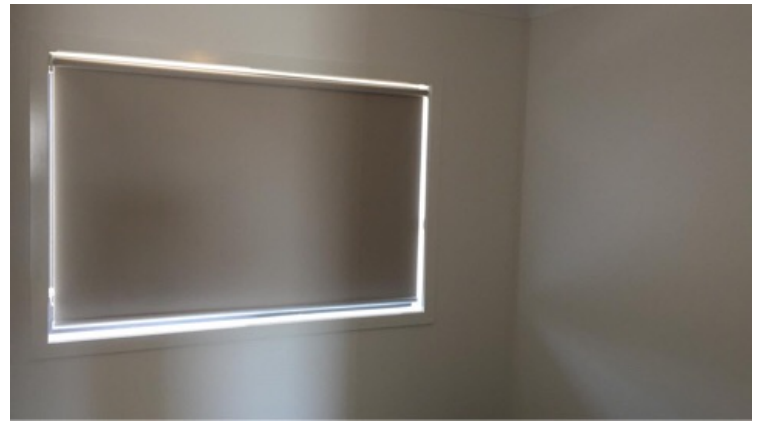
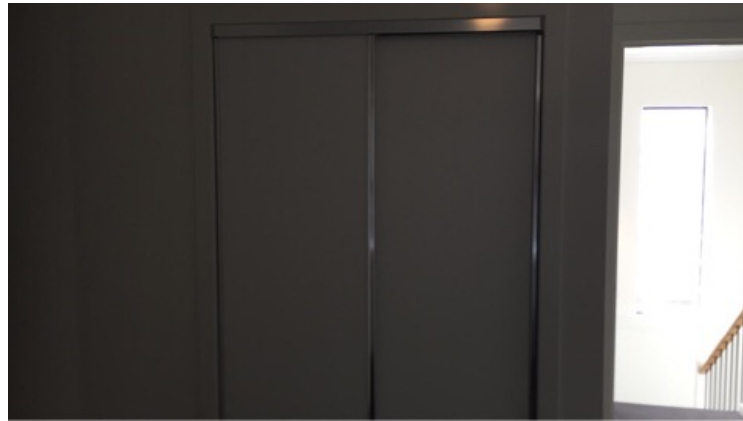
Walls

Minor Dent, Chips and Scratches Noted - Touch Up Will Satisfy

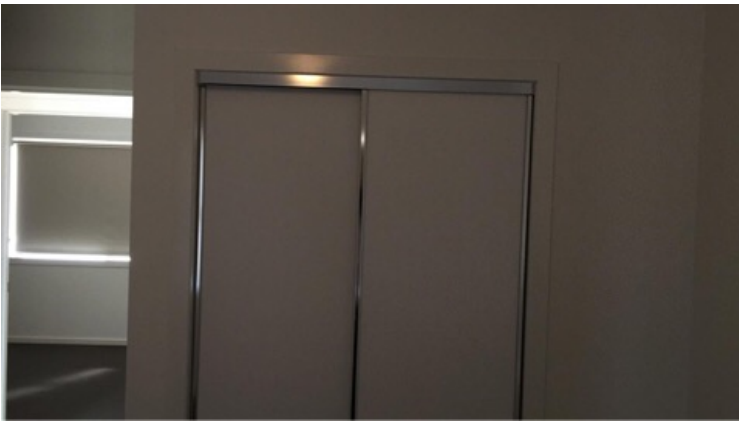
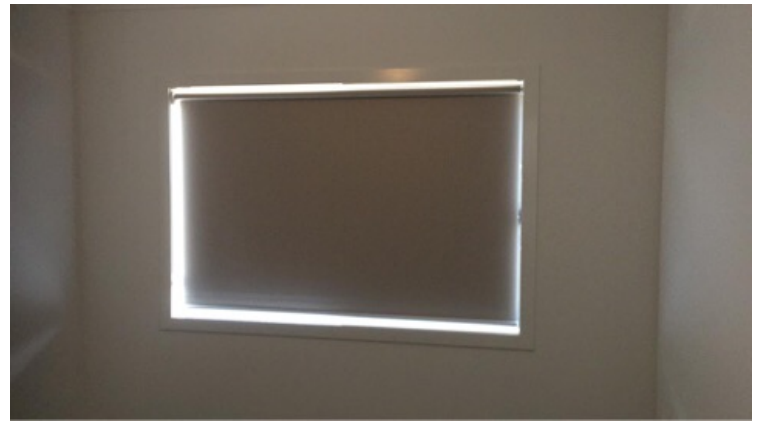
Walls

Minor Dent, Chips and Scratches Noted - Touch Up Will Satisfy

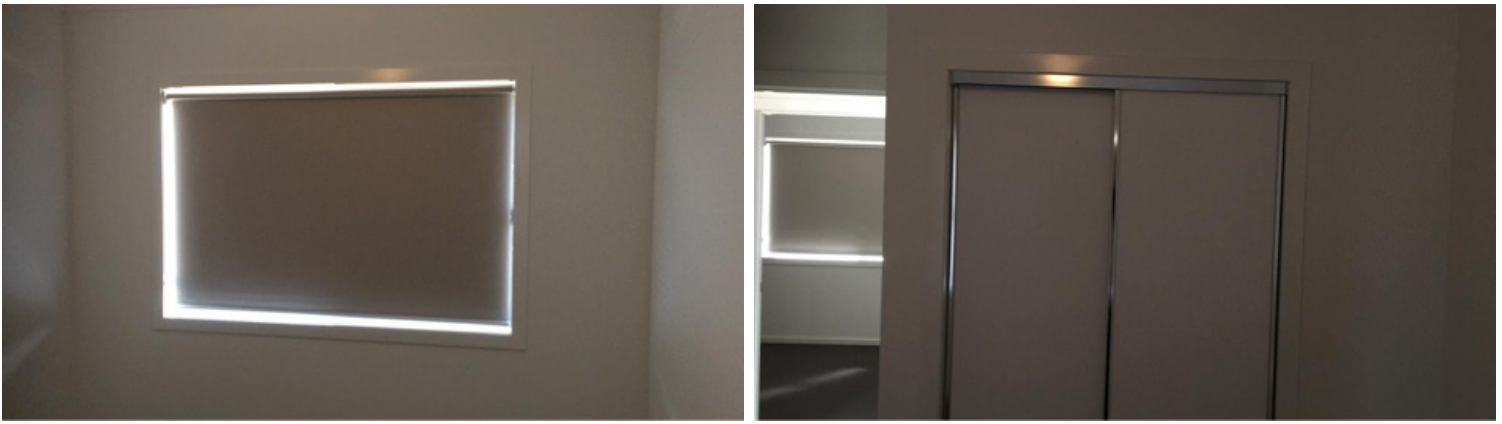
Walls

Paint Mark and Cracking Noted - Touch Up Will Satisfy

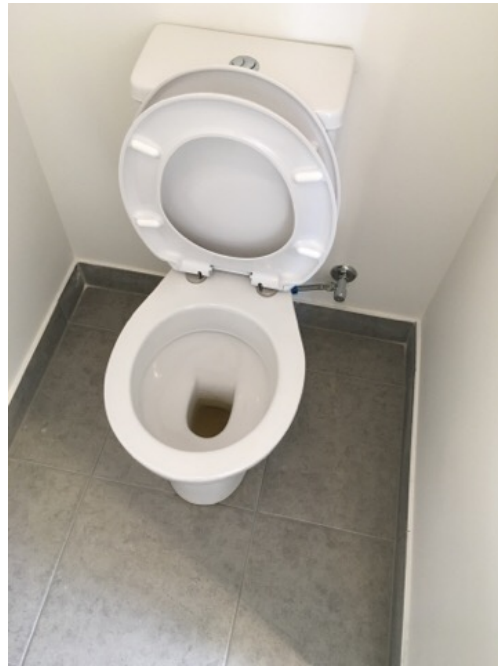
Pan is loose at the base. Contact a licensed plumber for repairs.
Toilet seat needs to be fixed

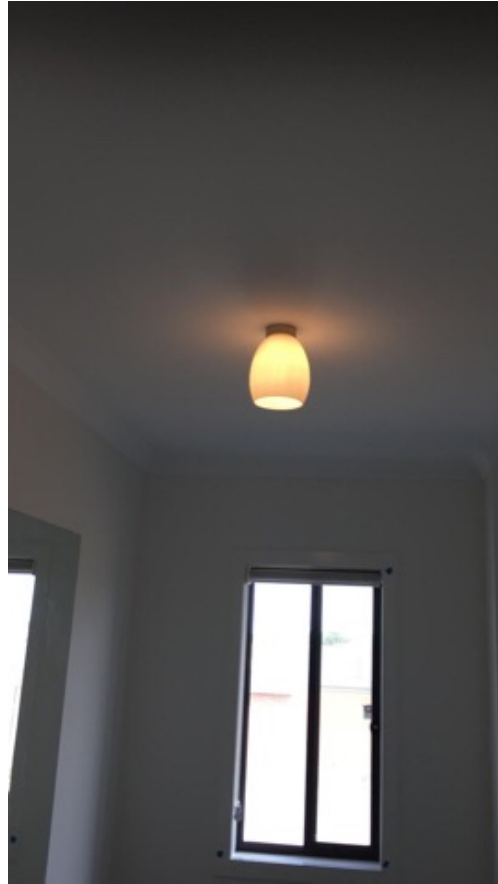
Walls

Minor Dent, Chips and Scratches Noted - Touch Up Will Satisfy

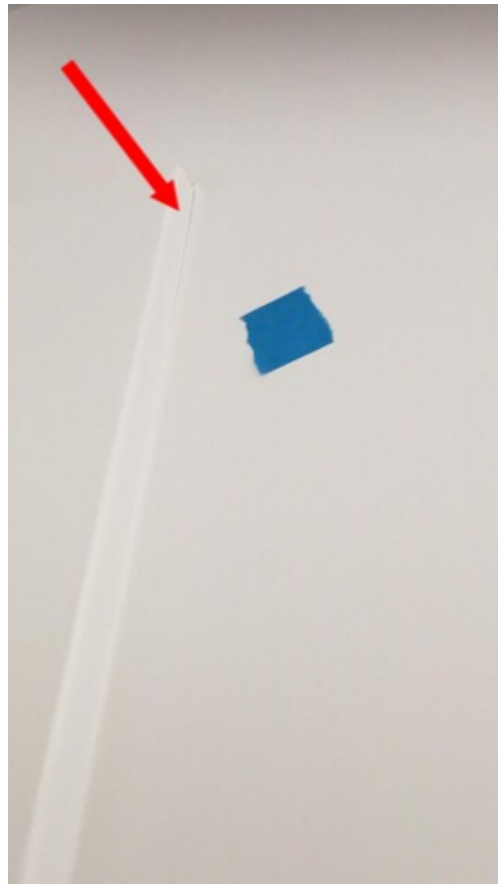
Window

Minor Dent, Chips and Scratches Noted - Touch Up Will Satisfy

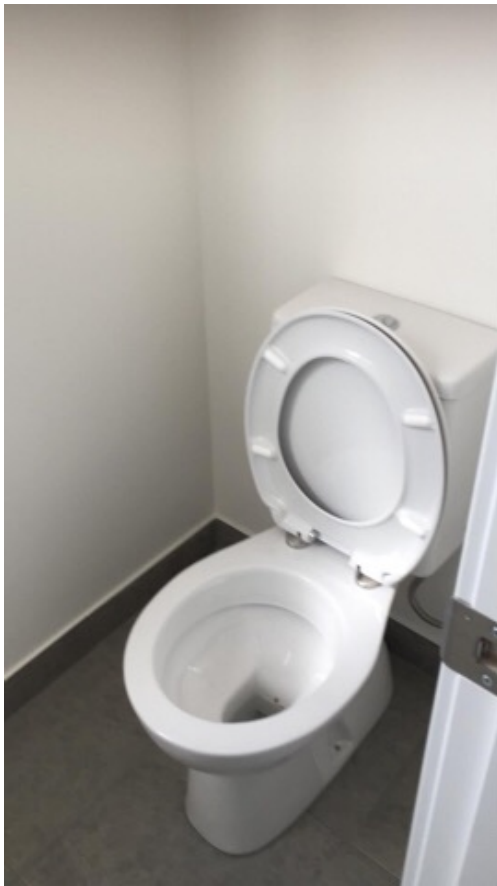
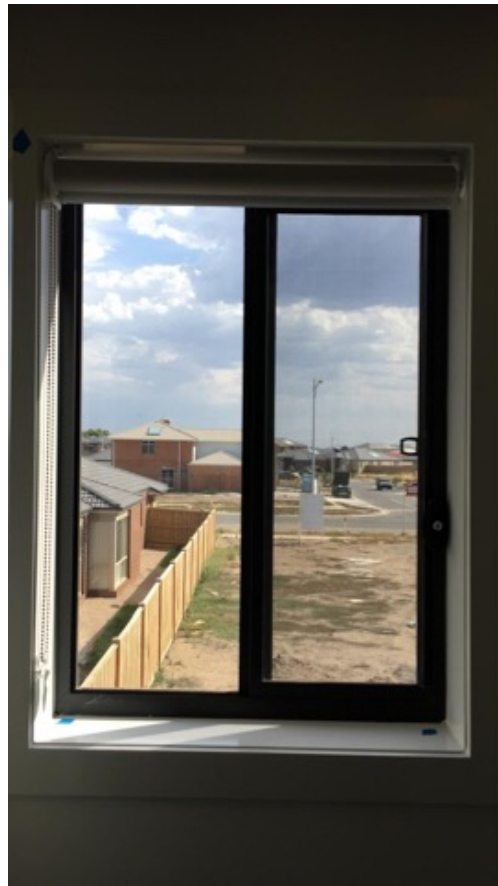
Window

Paint Mark and Cracking Noted (Include Skirting) - Touch Up Will Satisfy

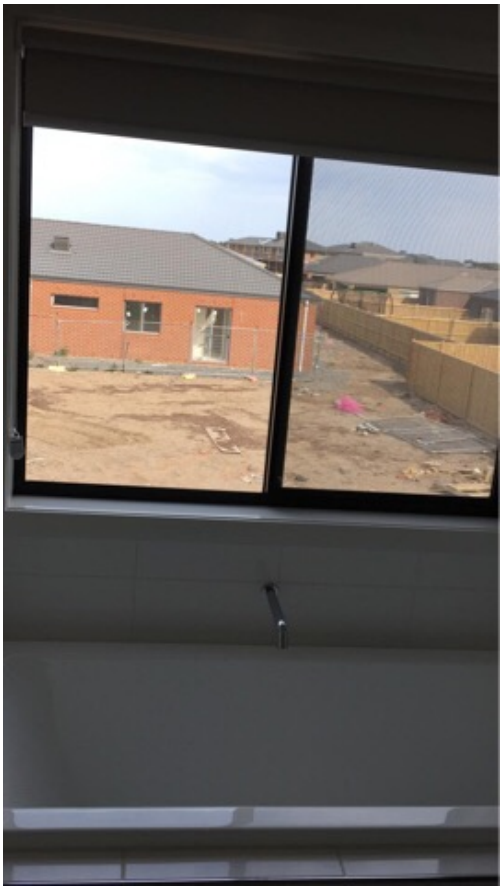
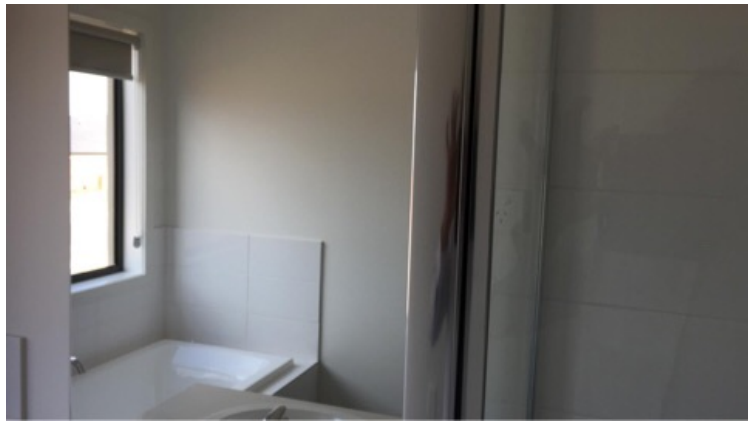
Window

Paint Mark and Cracking Noted (Include Skirting) - Touch Up Will Satisfy

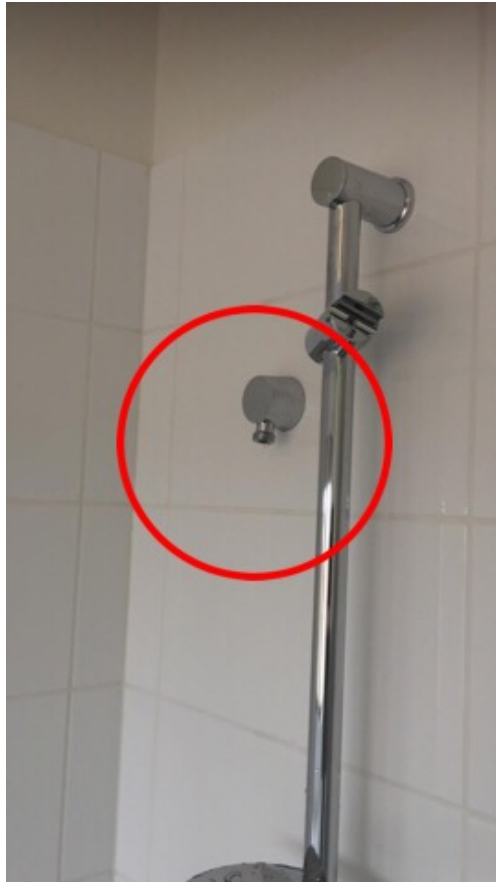
Shower And Bath

Shower head was not installed during the inspection

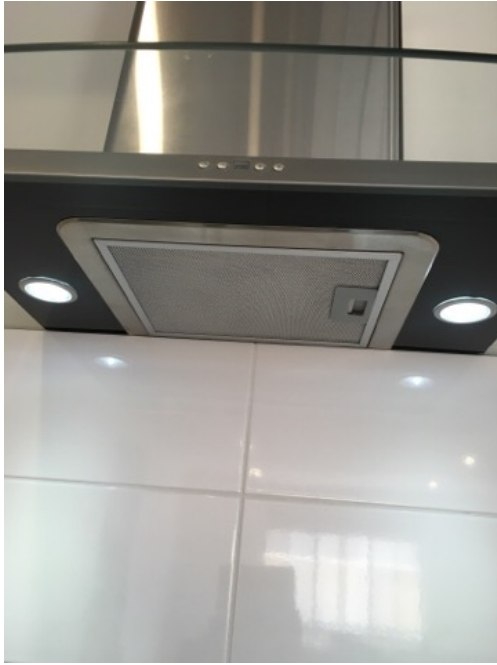
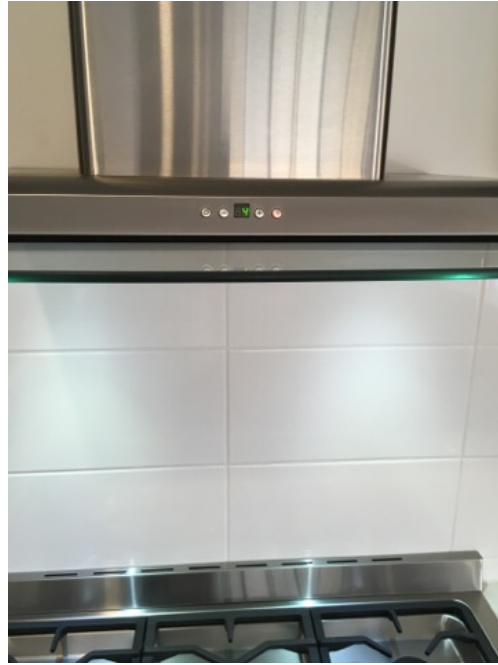
Rangehood

The rangehood is serviceable at the time of inspection

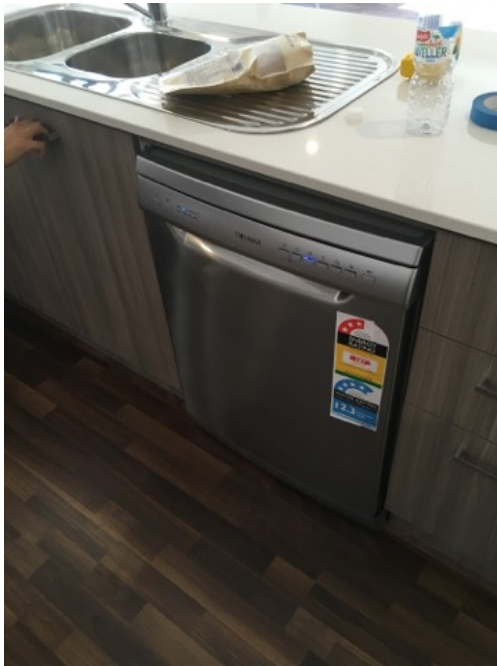
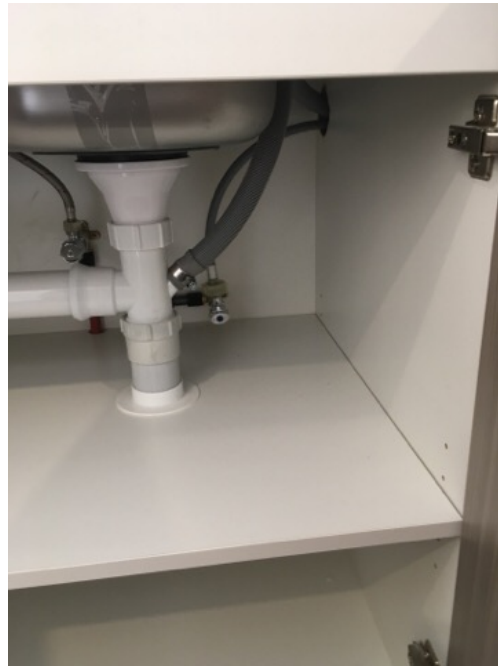
Dishwasher

The dishwasher is serviceable at the time of inspection

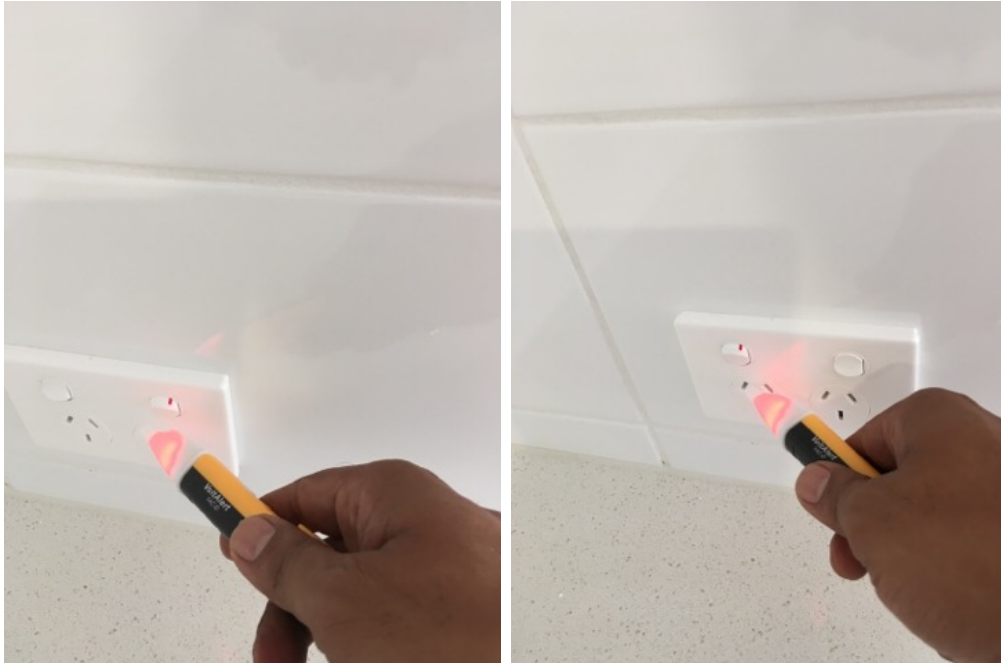
Electric Outlets

Electrical outlet(s) is serviceable
