Building Inspection Report

FANGS BUILDING INSPECTIONS

Lotxx Hutchence Drive, Point Cook, VIC, 3030

Inspection Date: 28 Feb 2019

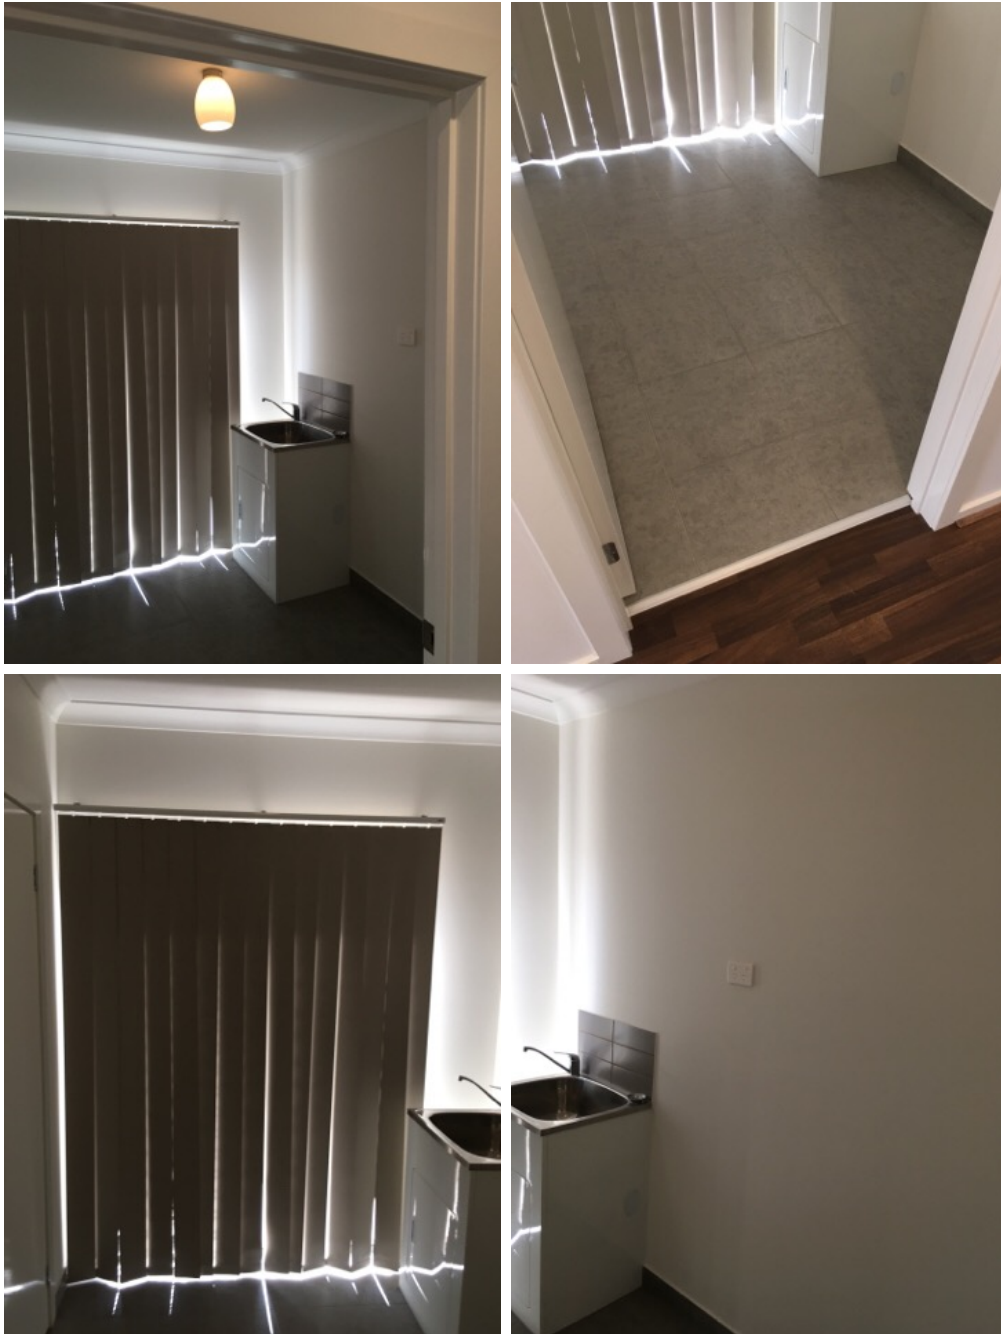
Of the visible areas, the general condition of the laundry is serviceable.

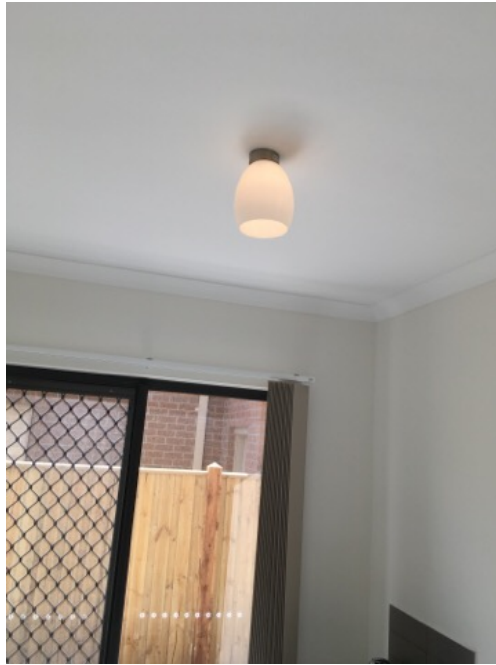
Lighting

All lighting in the area appears to be in serviceable condition during the time of inspection

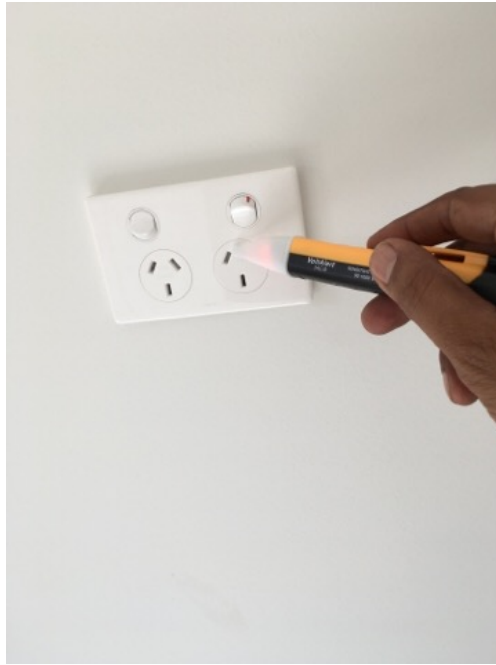
Electric Outlets

Electrical outlet(s) is serviceable

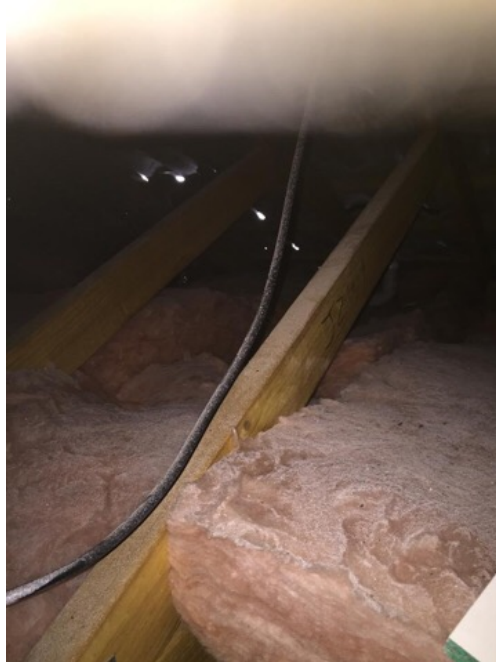
Visible sections of the roof void is in a serviceable condition for age of this dwelling.

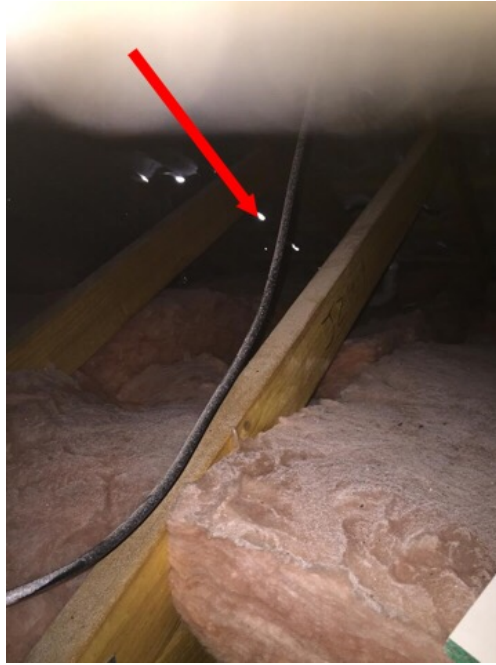
Roof Cladding

Dislodged tile section visible. Recommendations: A qualified roof tiler should be engaged for advice and recommendations.

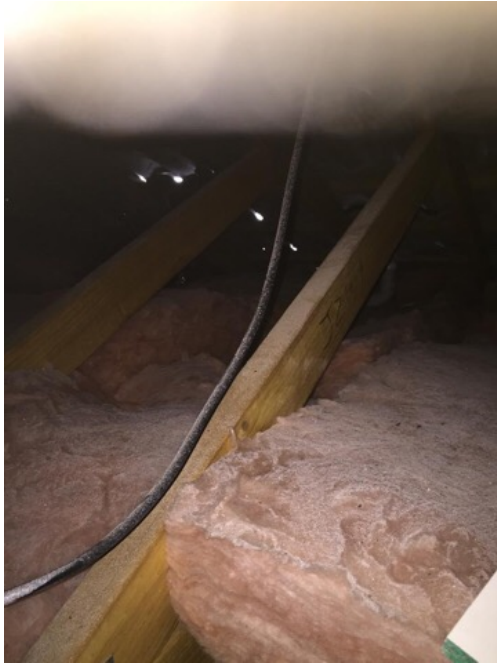
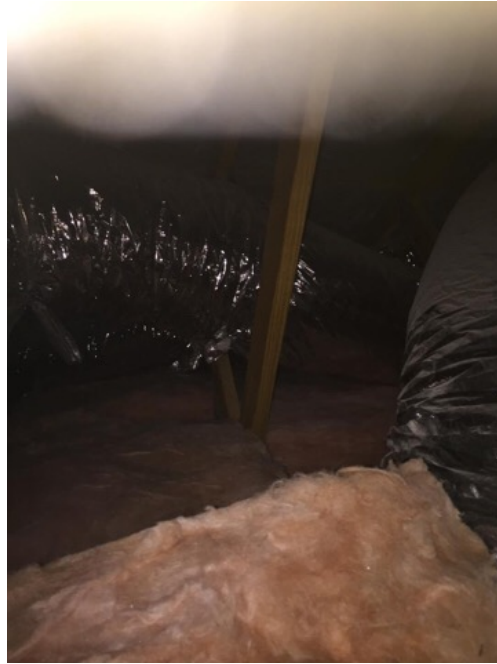
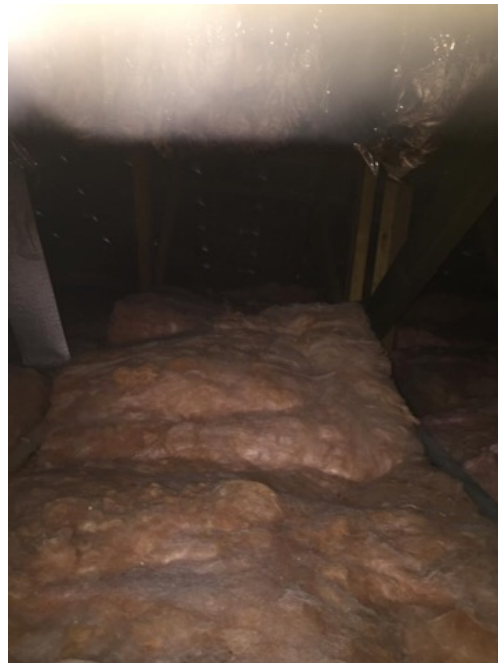
Insulation

Where visible and accessible, the insulation appears to be in a serviceable condition.
