Building Inspection Report

FANGS BUILDING INSPECTIONS

John St, Balwyn North, VIC, 3104

Report/Agreement # 22111905371251

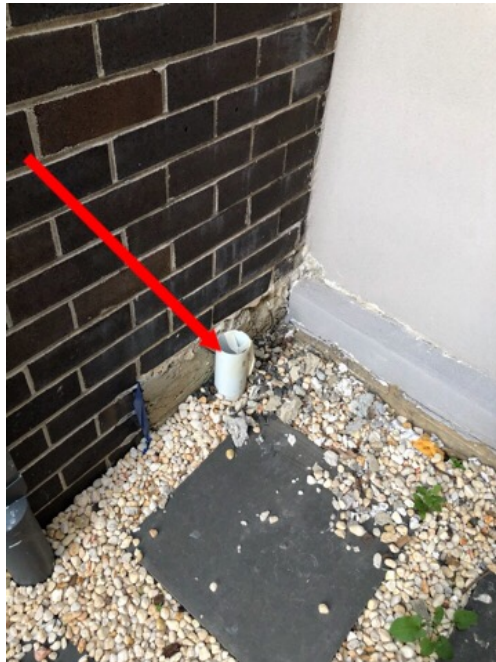
Drains

Lid needs to be installed to the pipe

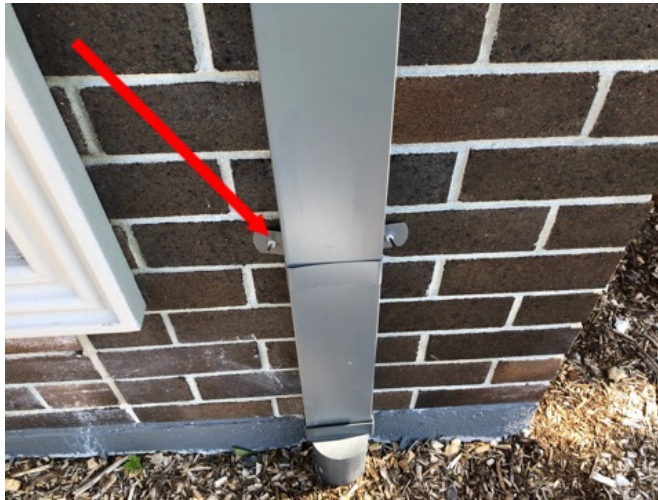
Down Pipe Findings

The down pipe/s wall clips is detached or missing. Recommendations: Although minor and easily rectifiable, we recommend a licensed roof plumber be engaged for repairs

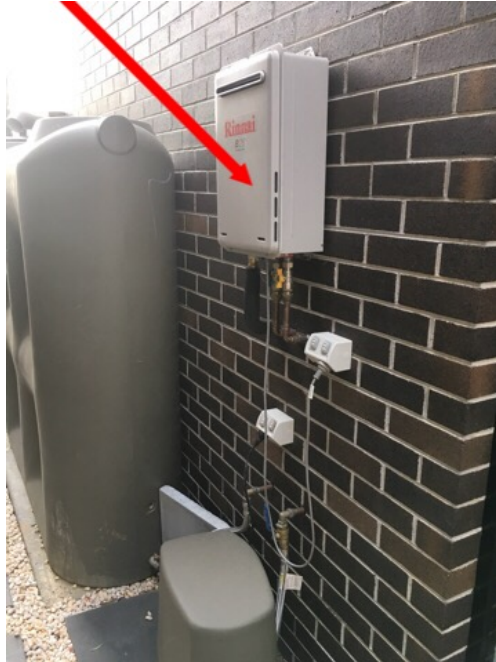
Hot Water Unit Findings

No hot water could be dispensed at the time of inspection. Contact a licensed plumber for further assessment.

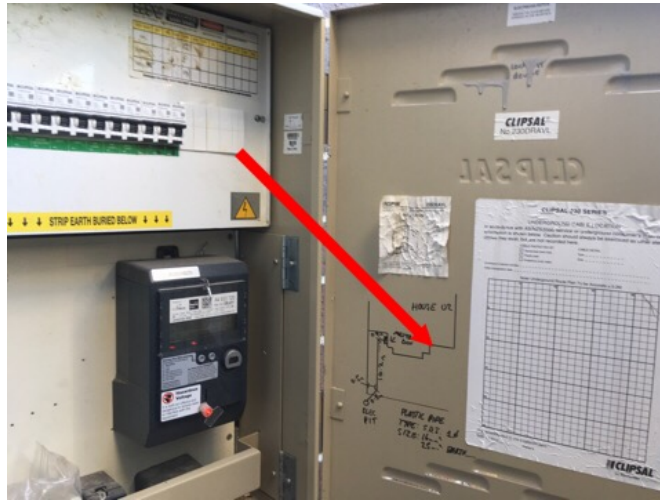
Durable Notice

Termite control durable notice missing, confirm with builder that termite treatment has been carried out.

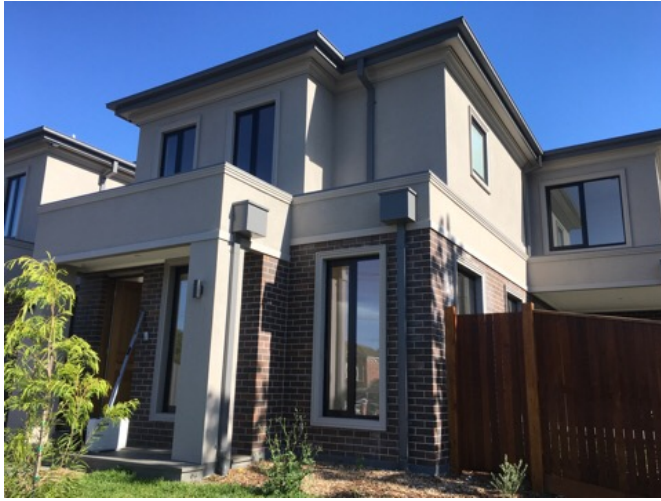
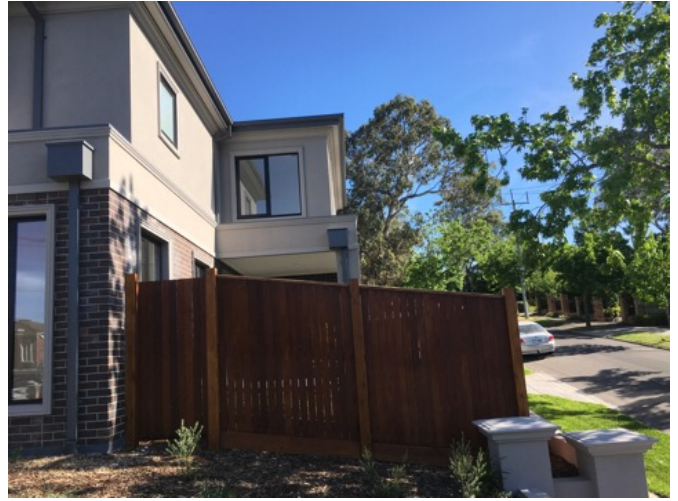
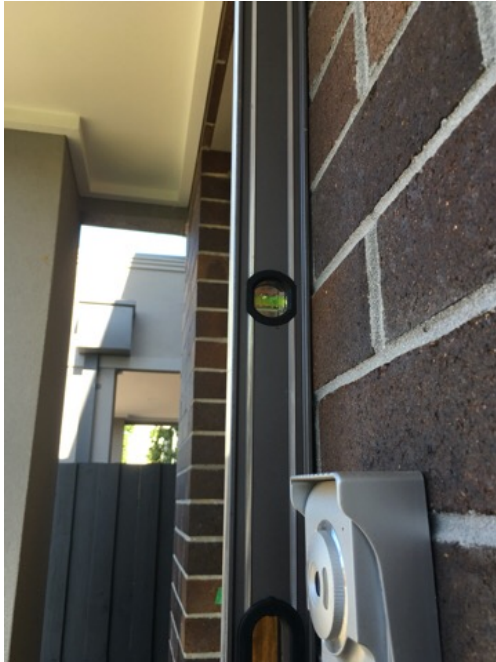
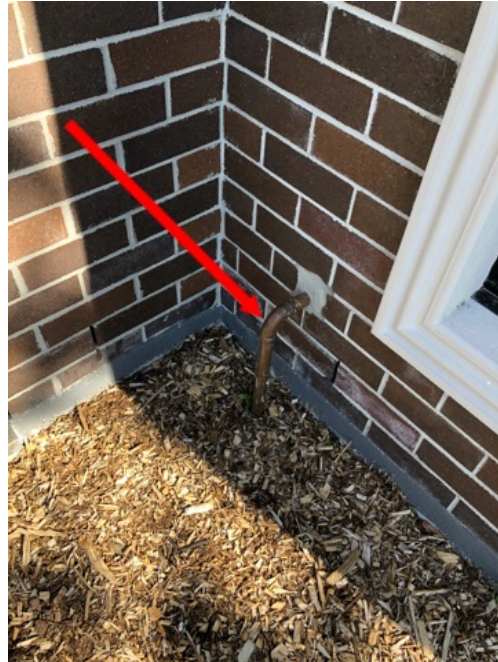
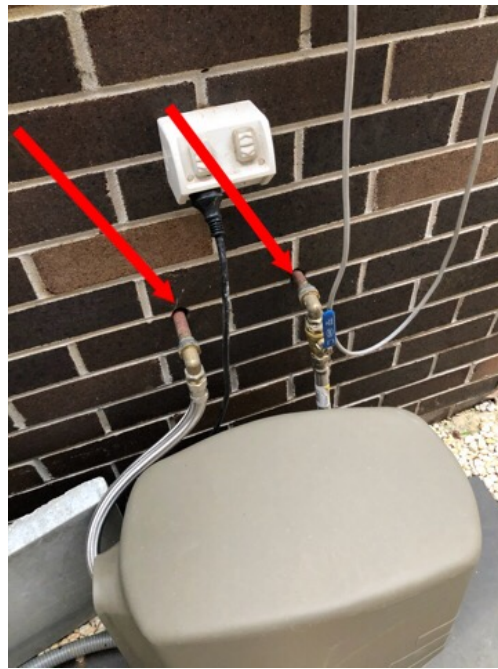
Confirm with the builder what this pipe is

Caulking required around the pipe and seal the gaps

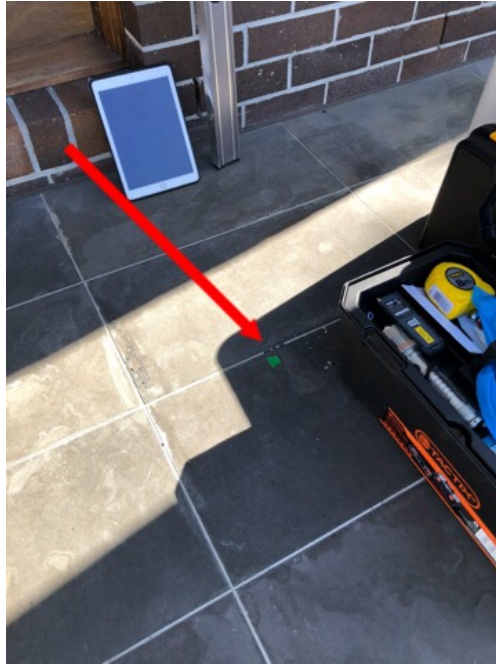
Base or Flooring Condition

Grout missing noted

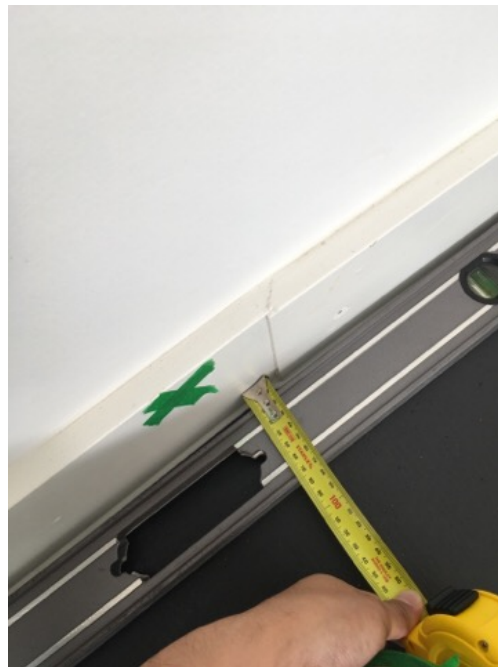
Internal Wall Findings

Internal wall deviation over standard and tolerance in the referred area.

The magnitude of the deviation is regarded as a major defect.

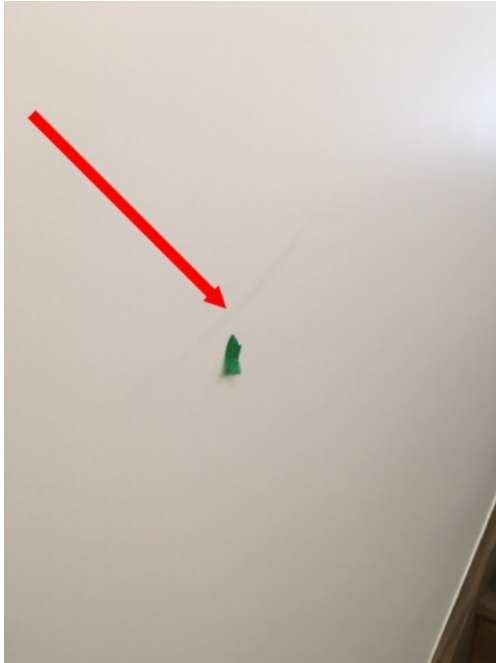
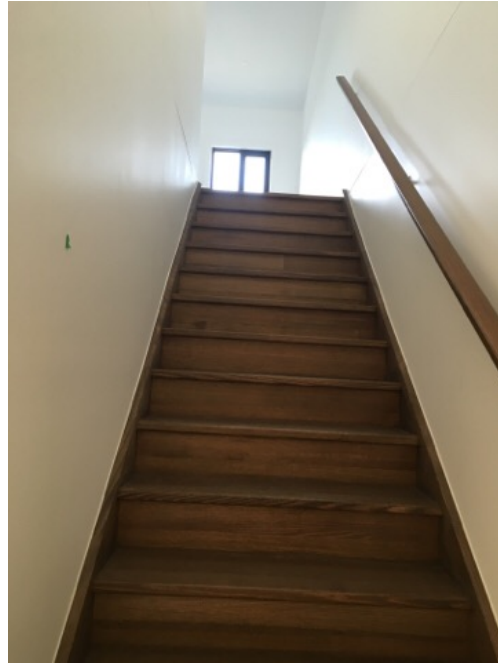
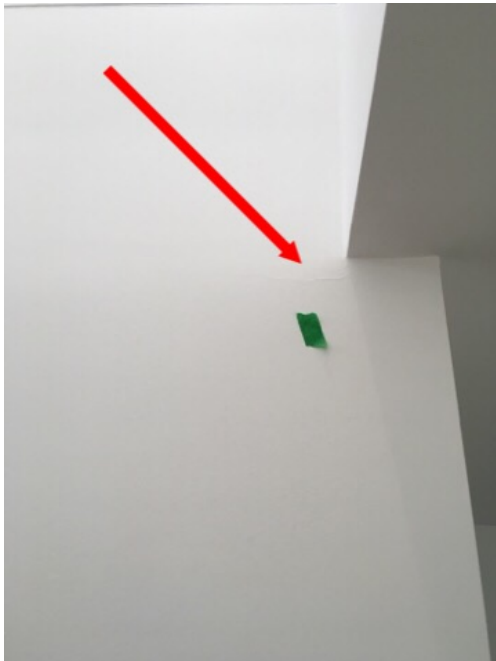
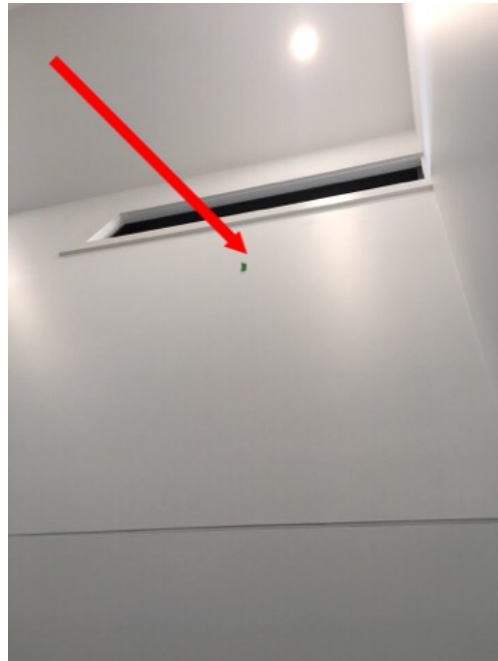
Internal Stair Case

Settlement cracks noted to the wall. These are typical and generally patch and paint will suffice, however we recommend monitor these cracks and if become wider or longer, you will need to contact a structural engineers to assess.

Minor touch ups will satisfy

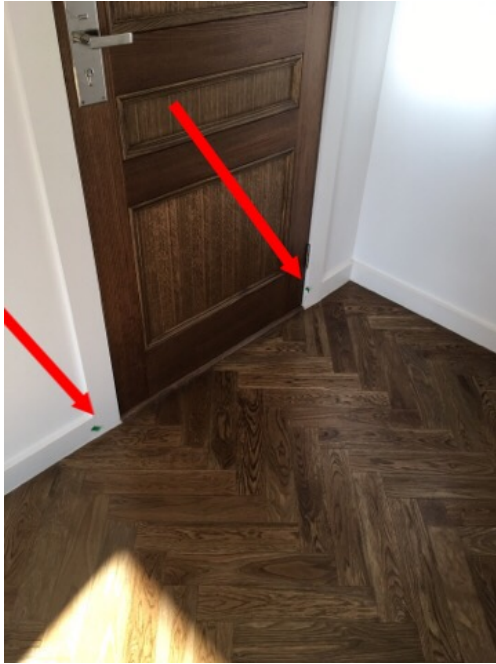
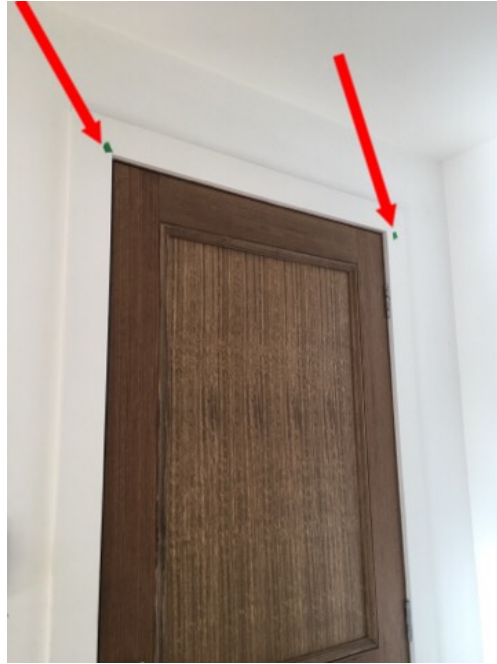
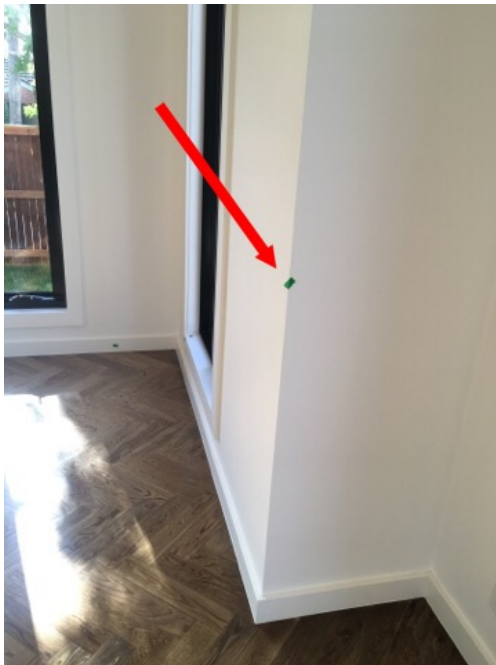
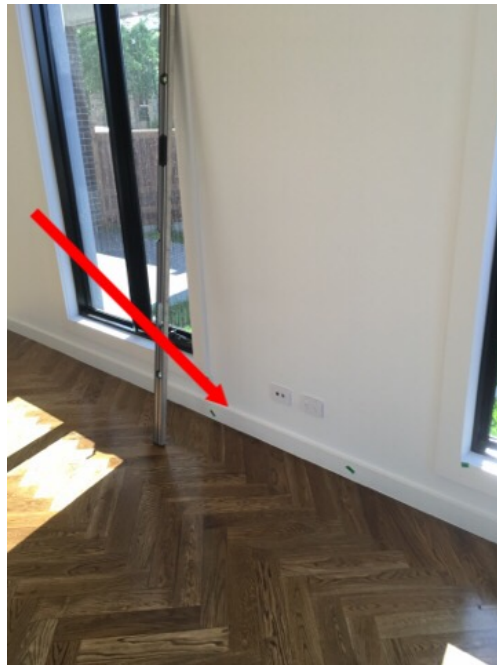
Minor cracking noted, touch up will satisfy.

Minor dents, chips and scratches noted, touch up will satisfy.

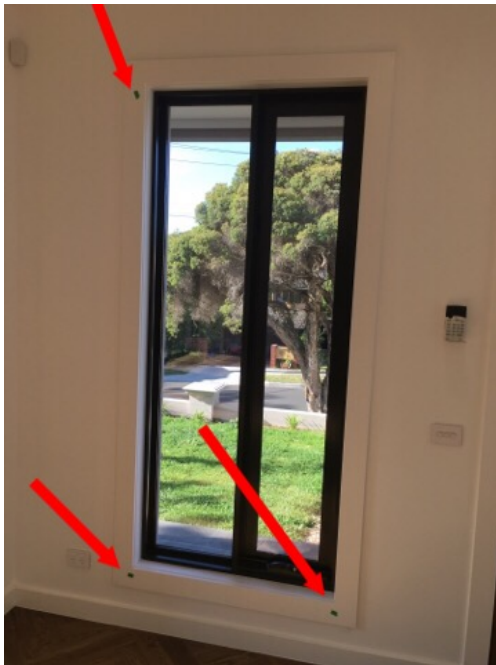
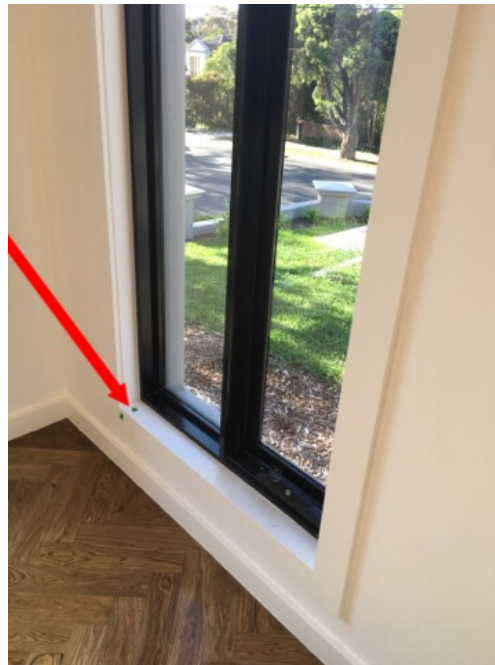
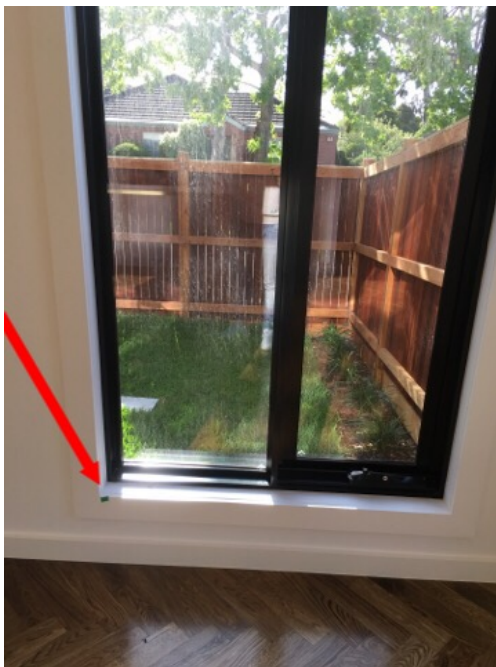
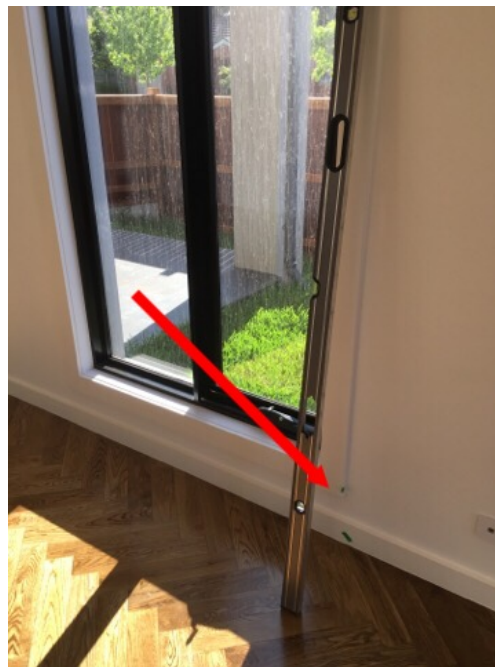
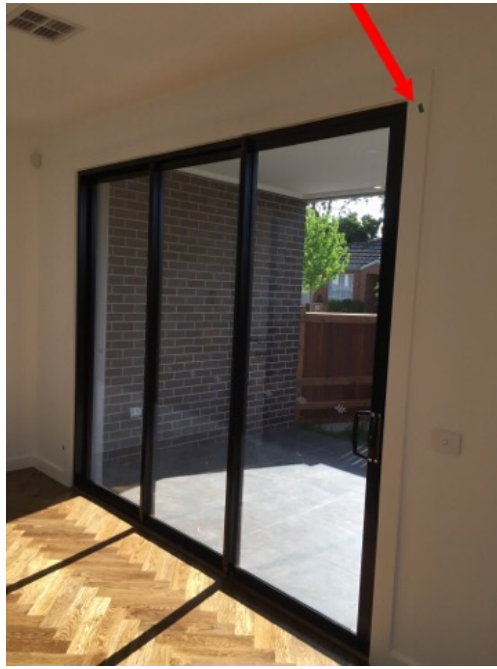
Minor dents, chips and scratches noted, touch up will satisfy.

Minor cracking noted, touch up will satisfy.

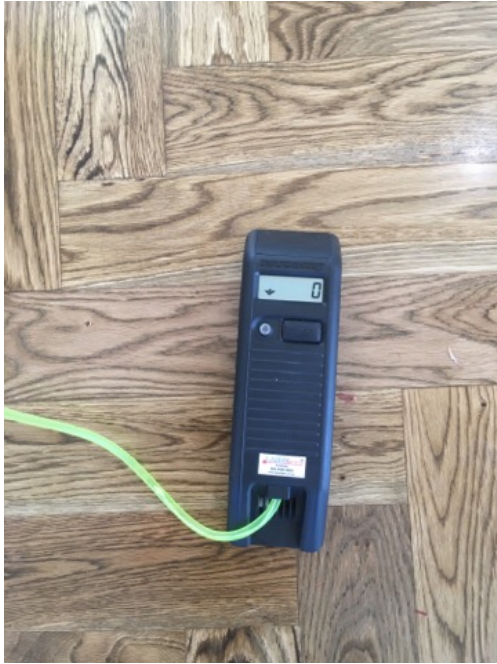
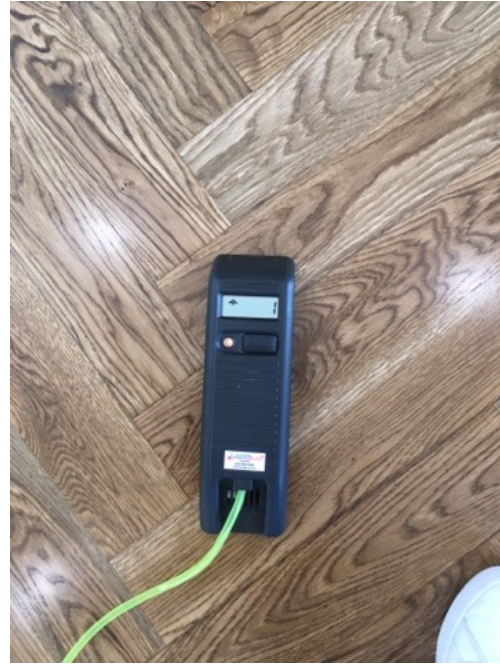
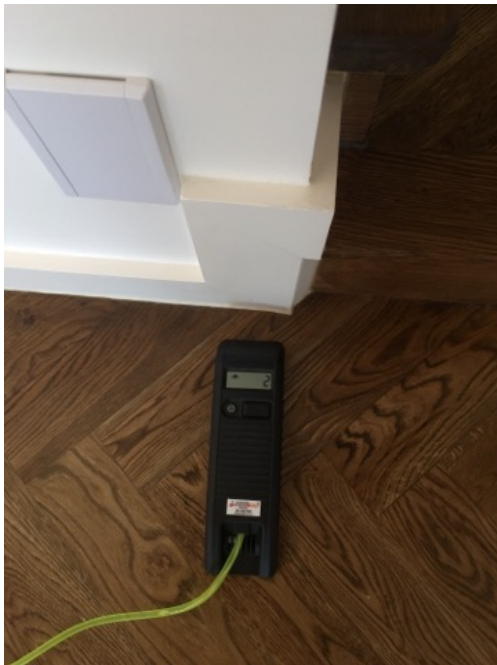
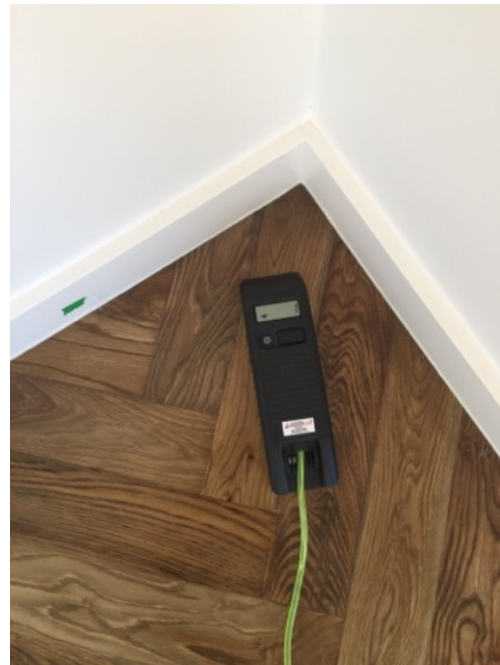
Flooring

The flooring is serviceable.

The floor is even or has deviation that is within standards and tolerance.

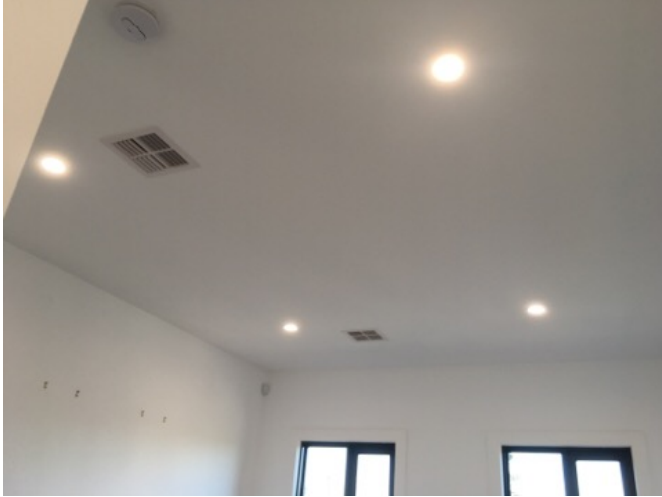
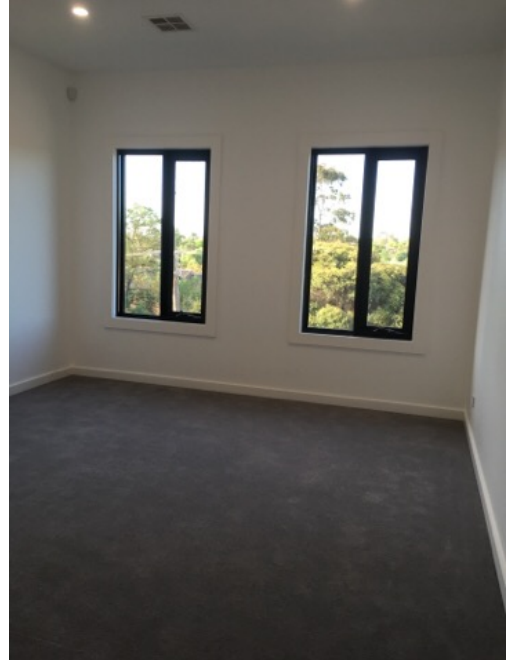
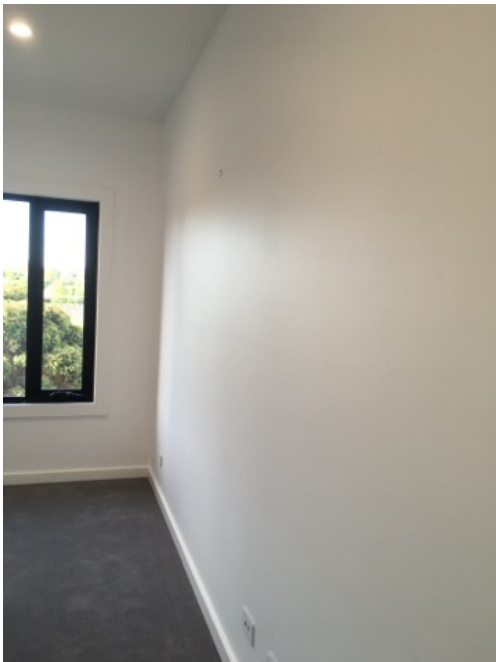
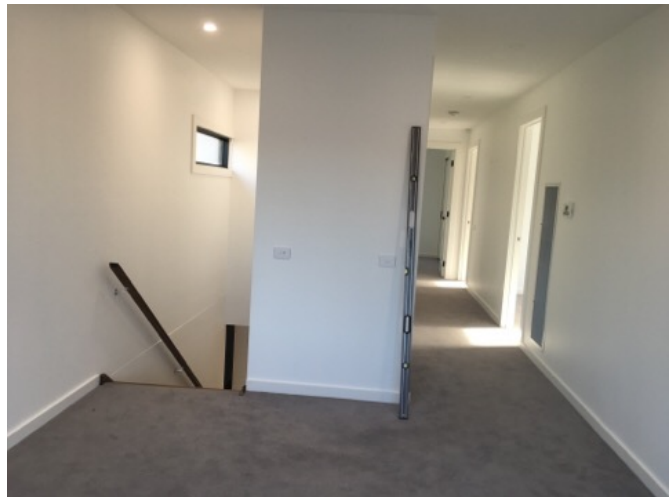
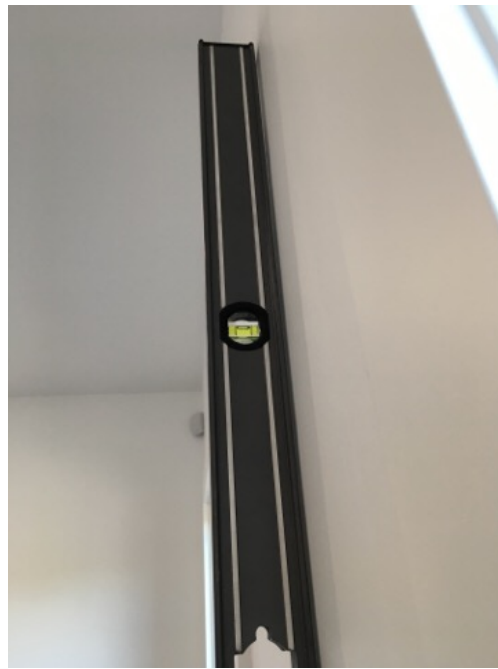
Rumpus Room

From the visible and accessible areas, the entry/Hallways appears to be in a serviceable condition for the age of the property with no notable structural defects sighted.

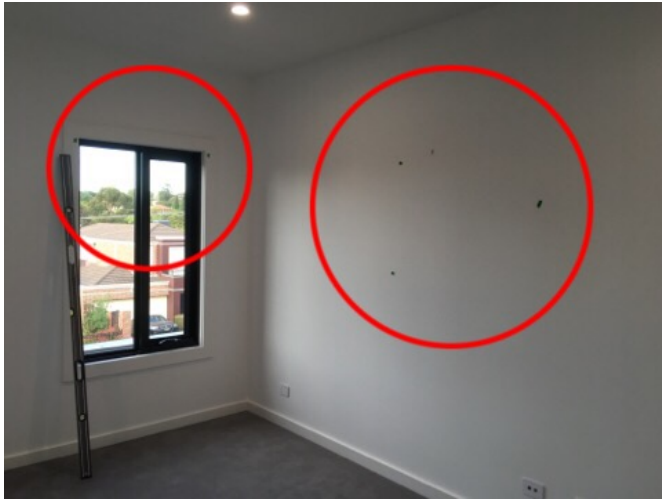
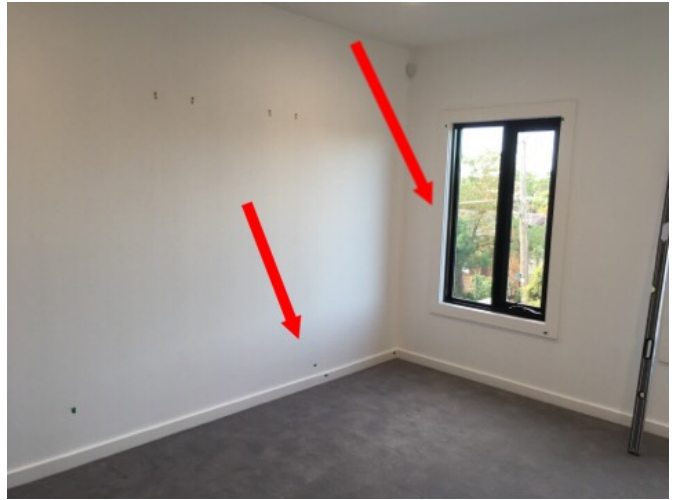
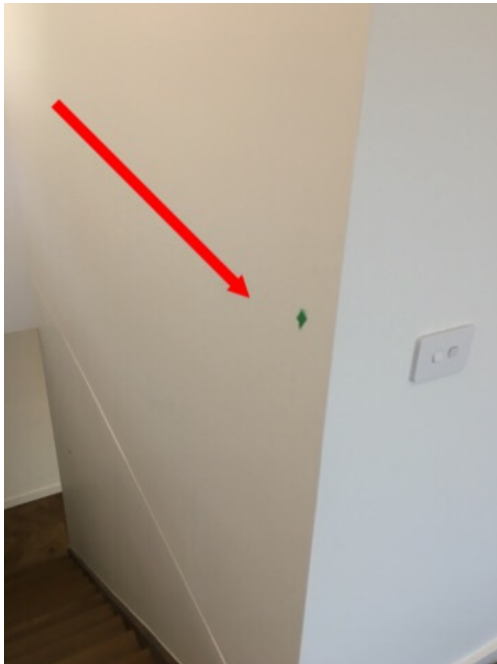
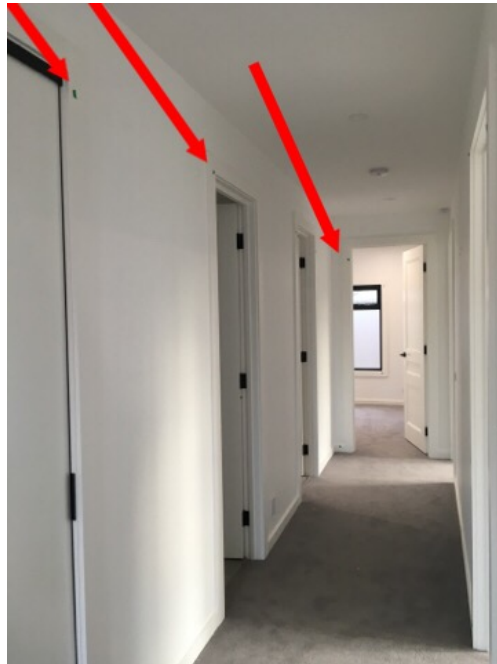
Walls

Minor dents, chips and scratches noted, touch up will satisfy.

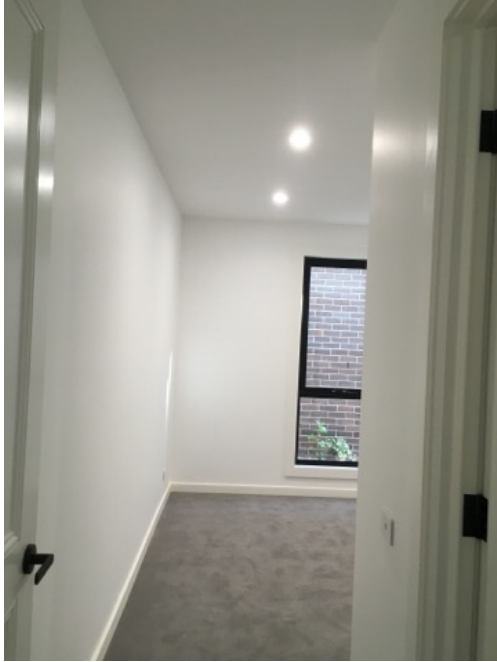
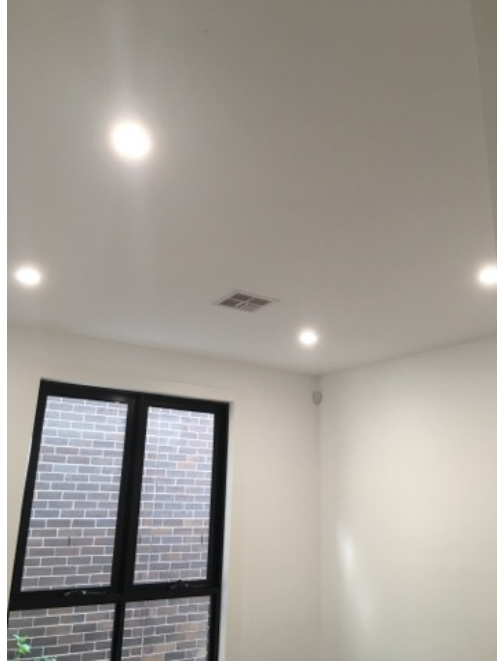
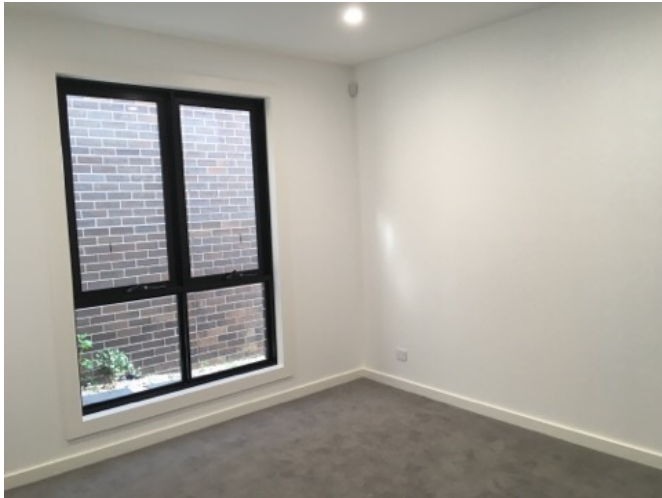
Bedroom 1

From the visible and accessible areas, the entry/Hallways appears to be in a serviceable condition for the age of the property with no notable structural defects sighted.

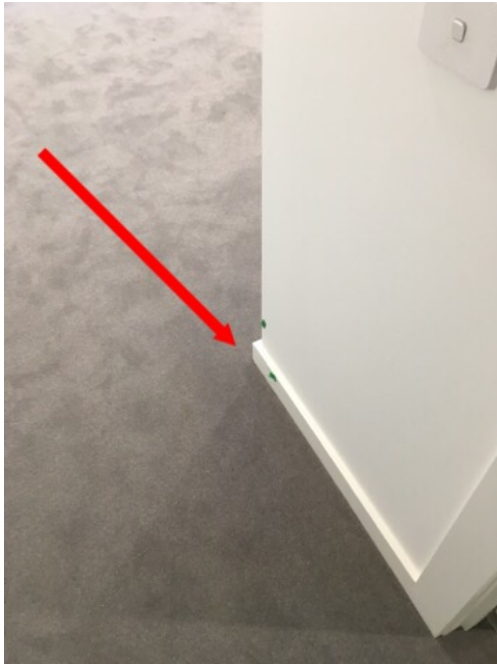
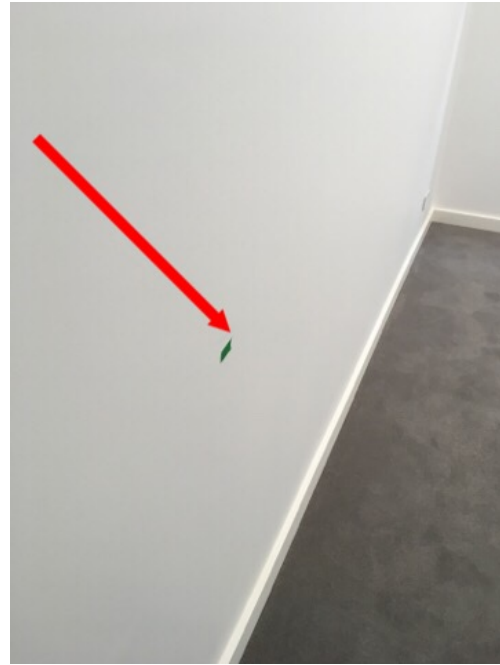
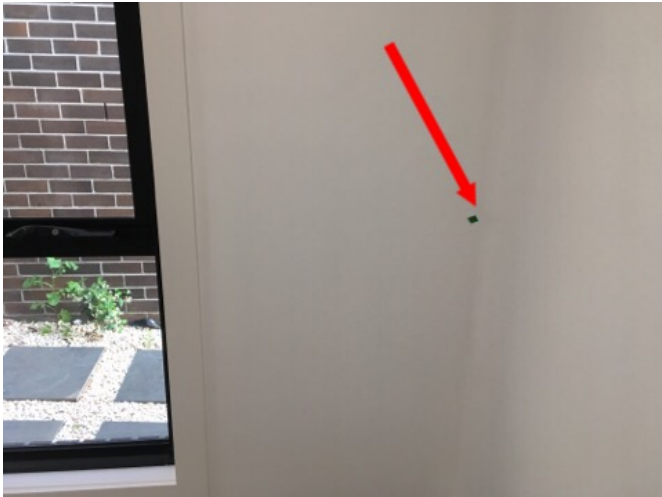
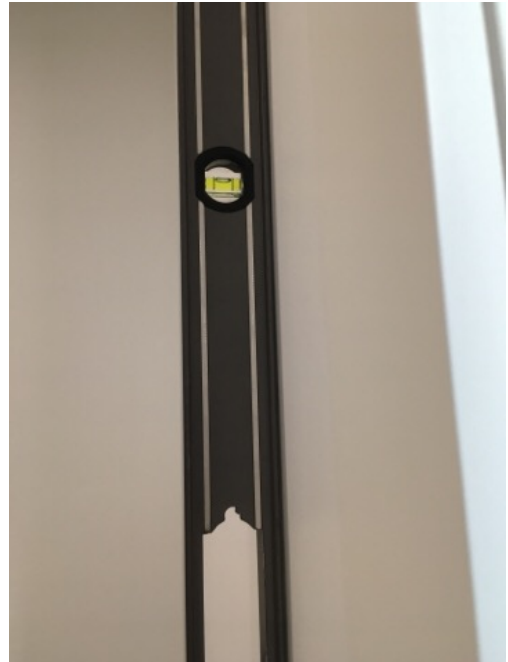
Walls

Minor dents, chips and scratches noted, touch up will satisfy.

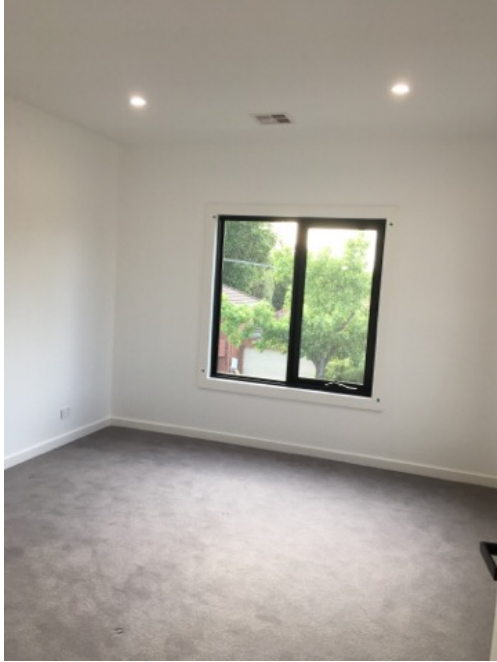
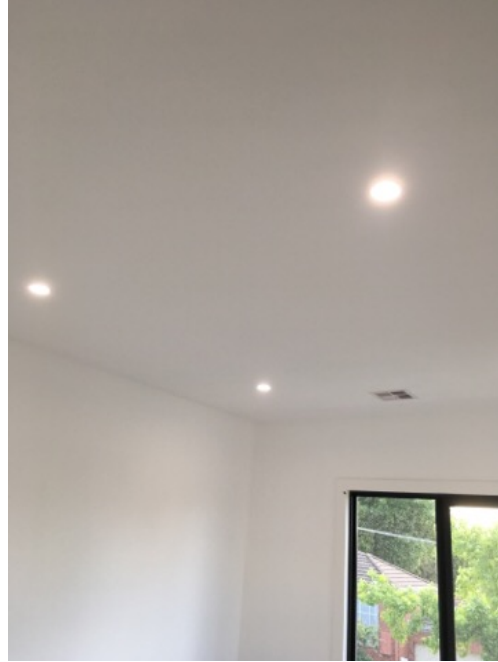
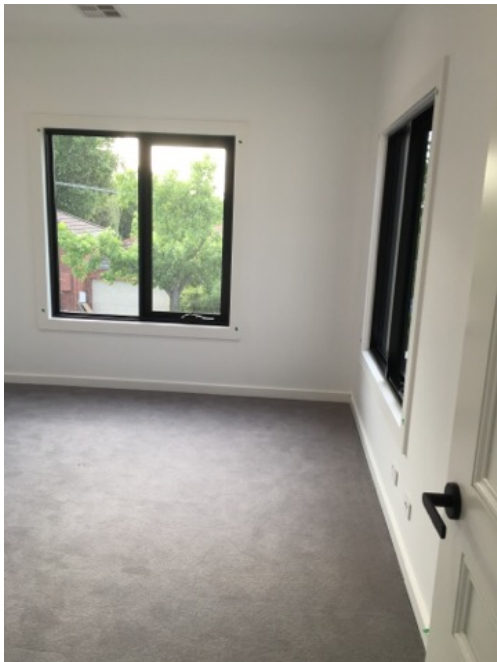
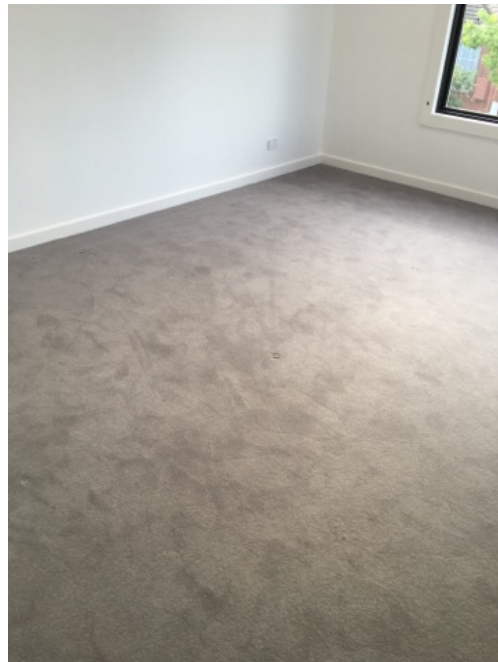
Bedroom 2

From the visible and accessible areas, the entry/Hallways appears to be in a serviceable condition for the age of the property with no notable structural defects sighted.

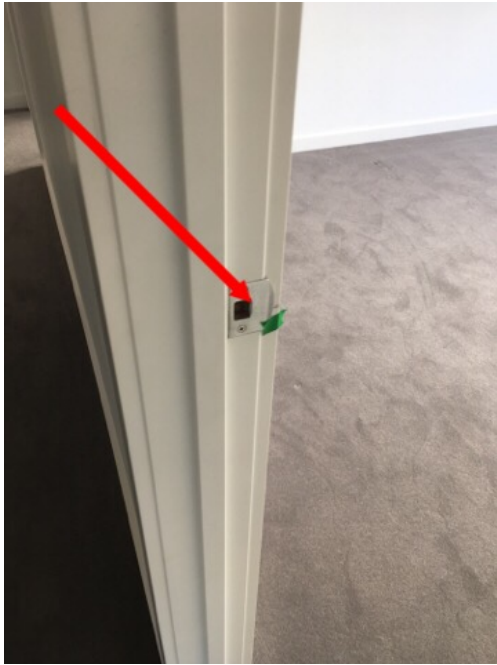
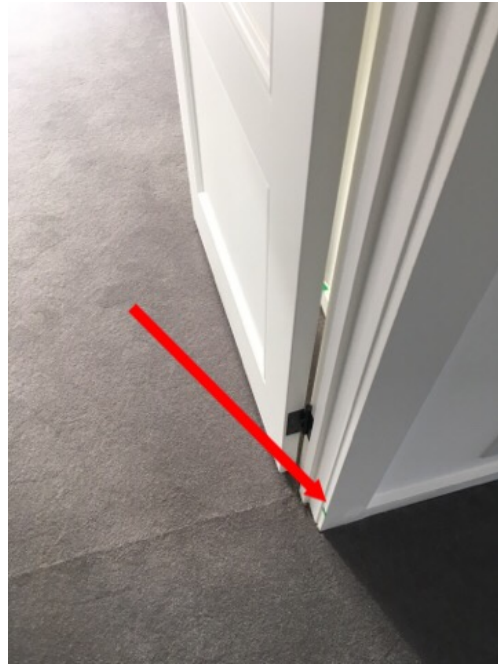
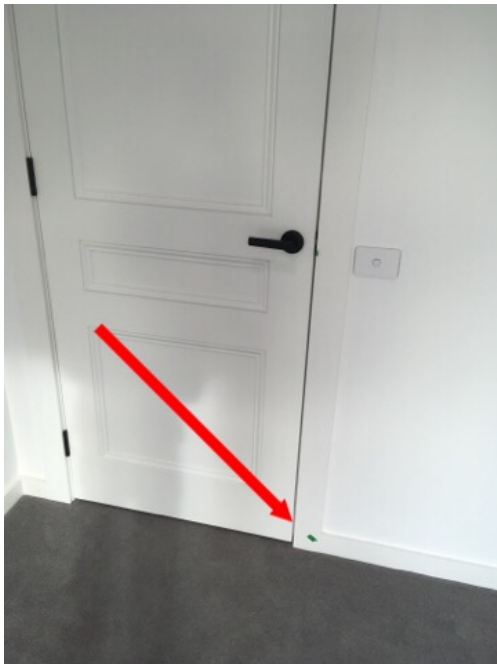
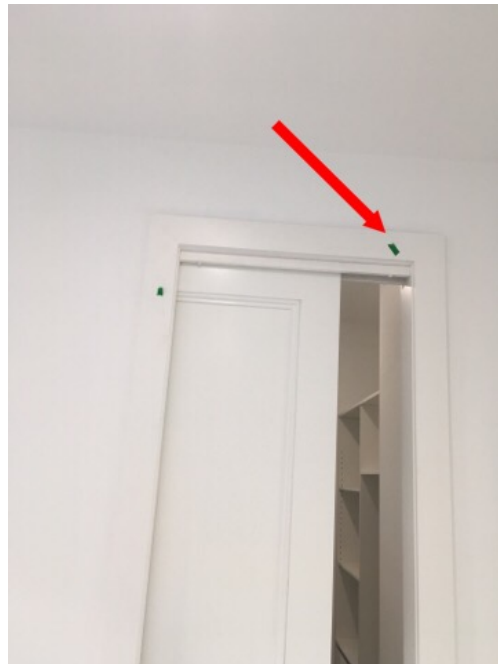
Door

Minor dents, chips and scratches noted - touch up will satisfy

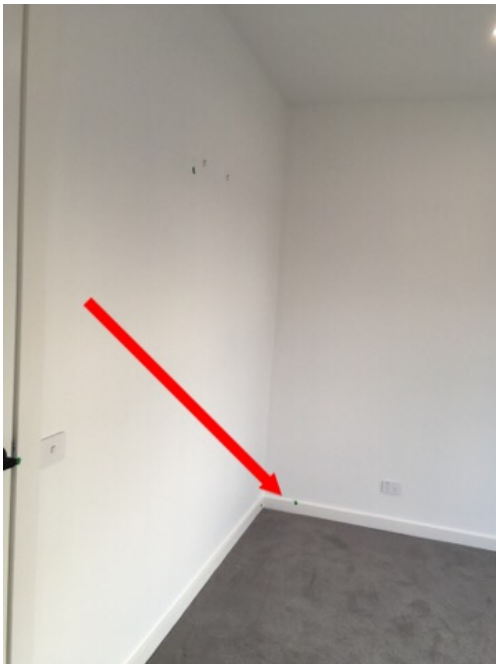
Walls

Minor dents, chips and scratches noted, touch up will satisfy.

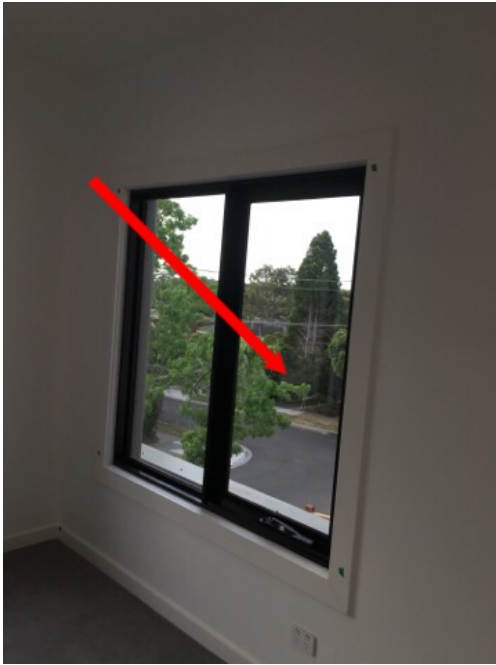
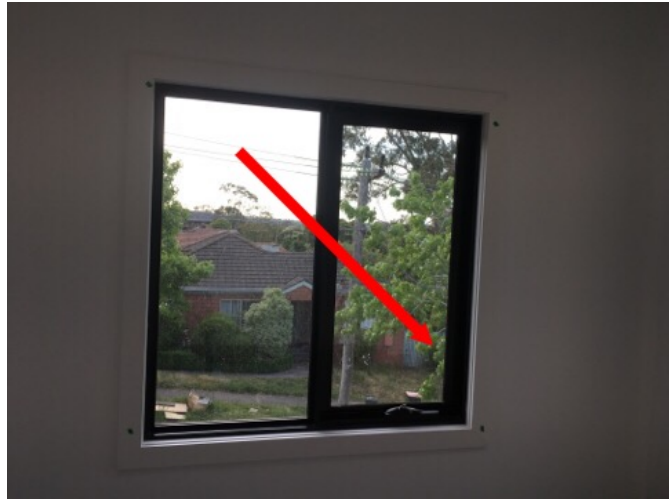
Windows

Minor cracking noted, touch up will satisfy.

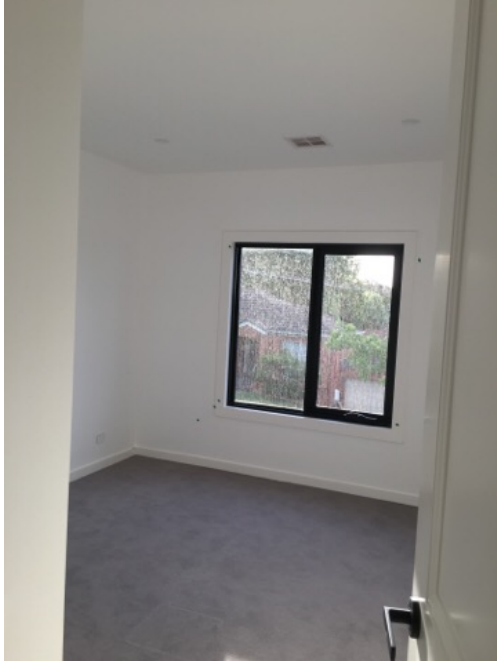
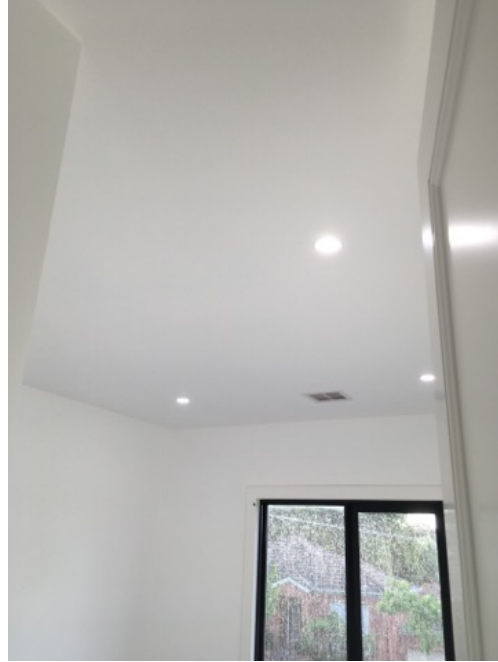
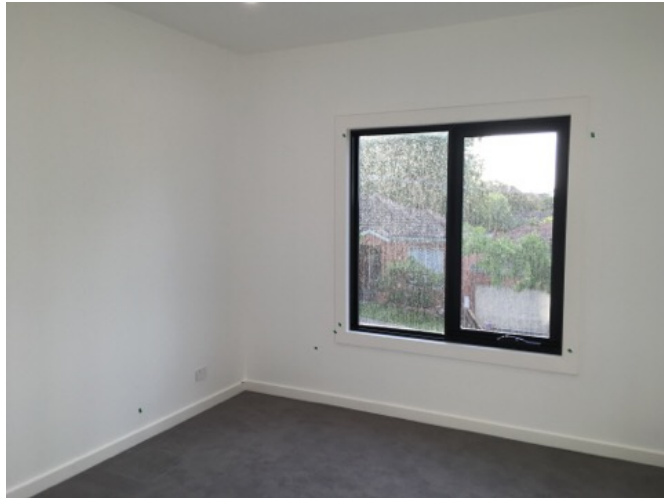
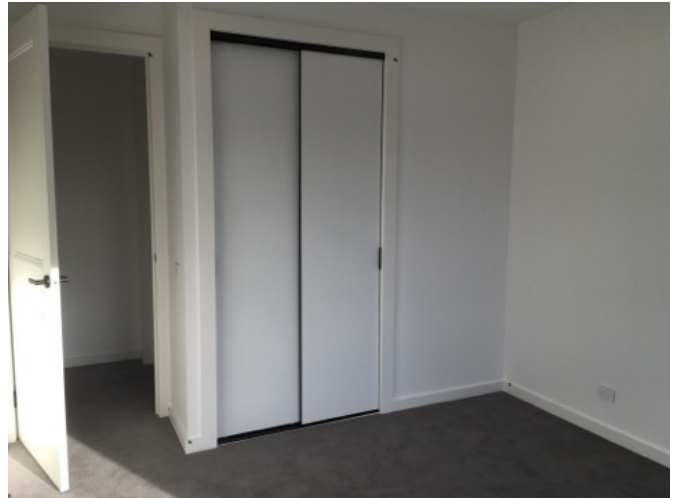
Bedroom 3

From the visible and accessible areas, the entry/Hallways appears to be in a serviceable condition for the age of the property with no notable structural defects sighted.

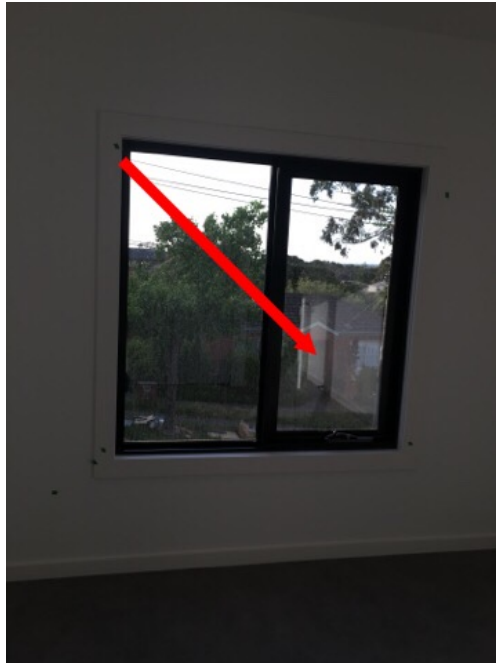
Windows

Minor cracking noted, touch up will satisfy.

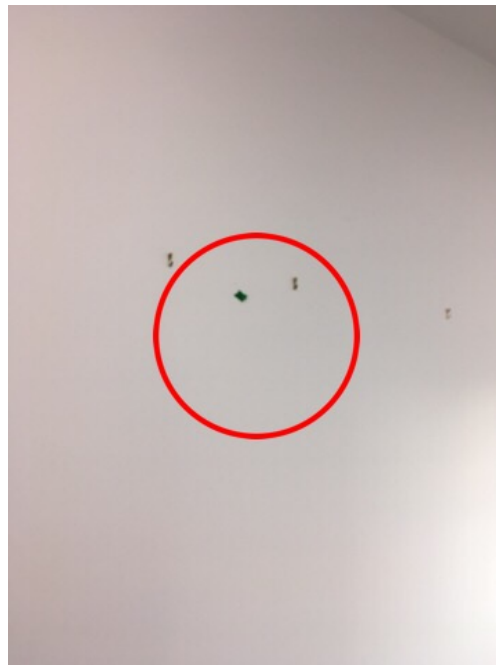
Walls

Minor dents, chips and scratches noted, touch up will satisfy.

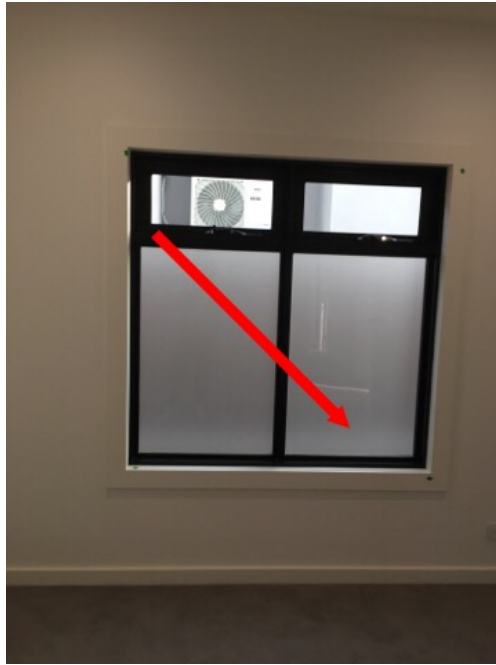
Windows

Minor cracking noted, touch up will satisfy.

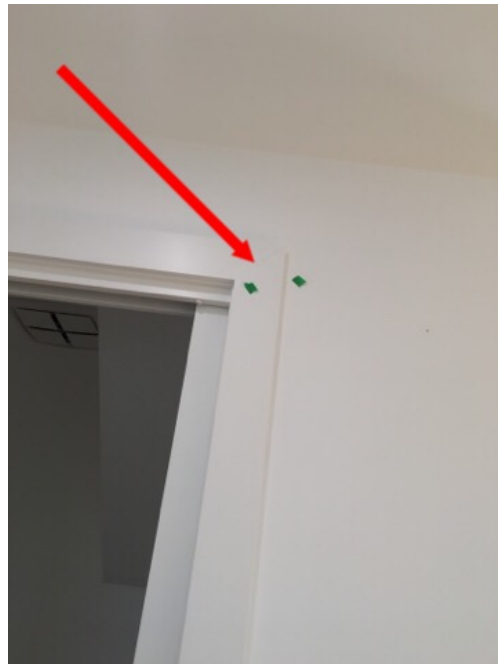
Door

Minor dents, chips and scratches noted - touch up will satisfy

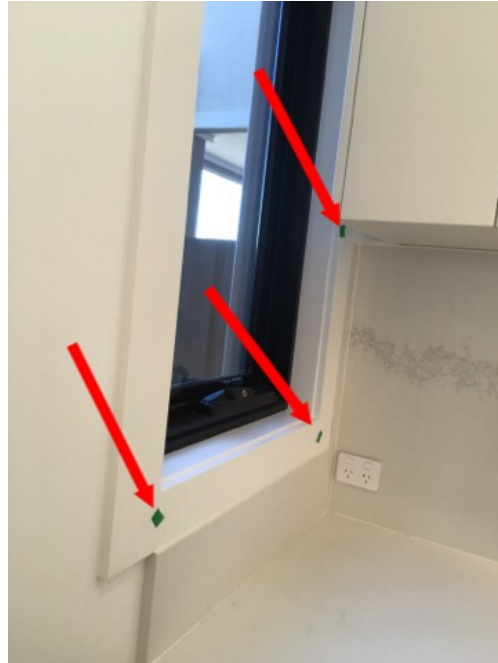
Window

Minor dents, chips and scratches noted, touch up will satisfy.

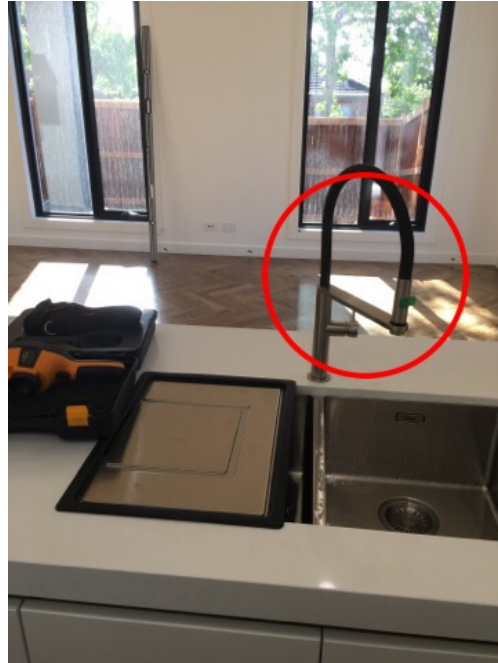
Sink and Taps

Poor water pressure from taps. Recommendations: A qualified plumber should be engaged for advice and recommendations.

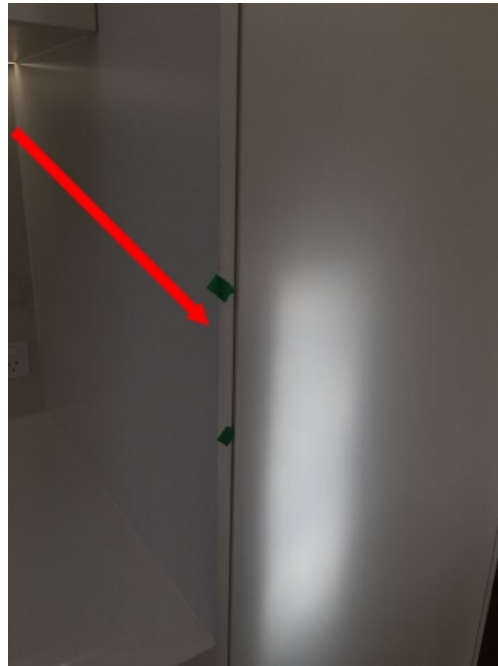
Cupboards And Bench Tops

Minor dents, chips and scratches noted - touch up will satisfy

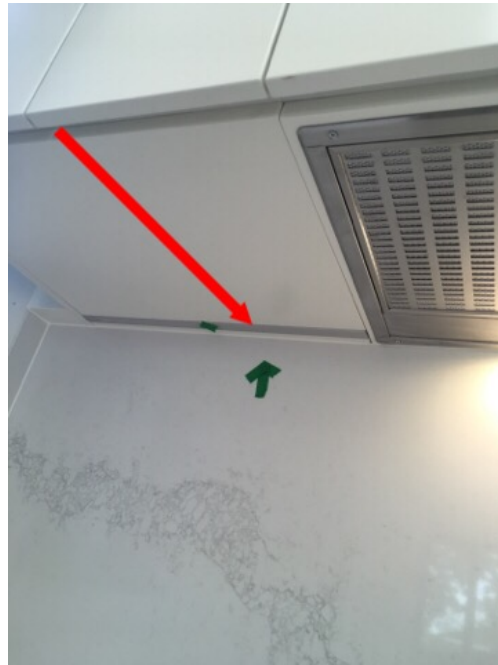
Lighting

Some / all of the lighting appears to be not working during the time of inspection
