Building Inspection Report

FANGS BUILDING INSPECTIONS

John St, Balwyn North, VIC, 3104

Report/Agreement # 22111905371251

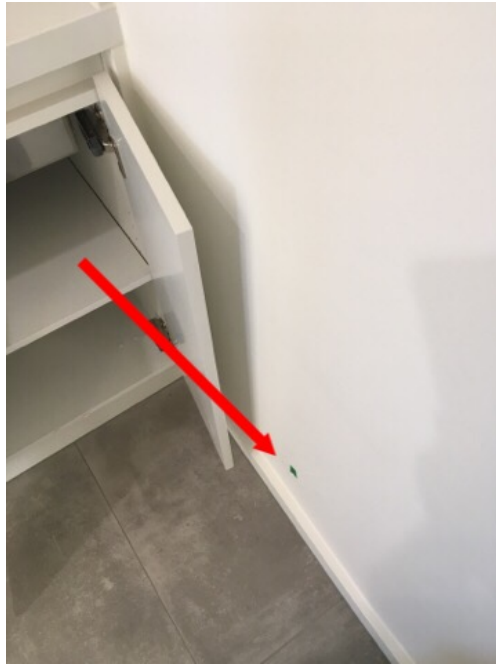
Walls

Minor dents, chips and scratches noted, touch up will satisfy.

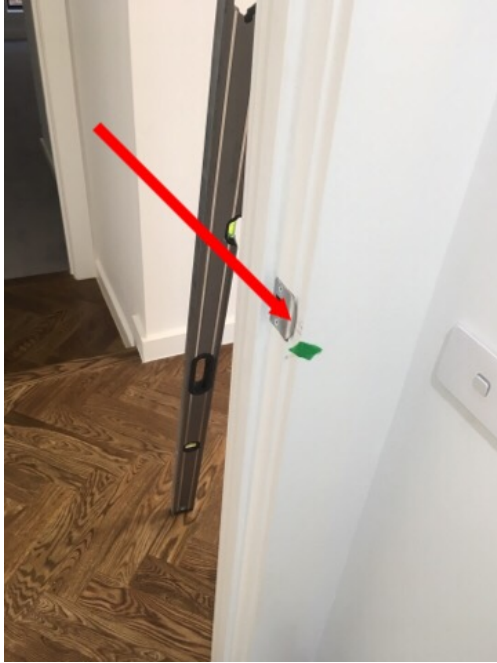
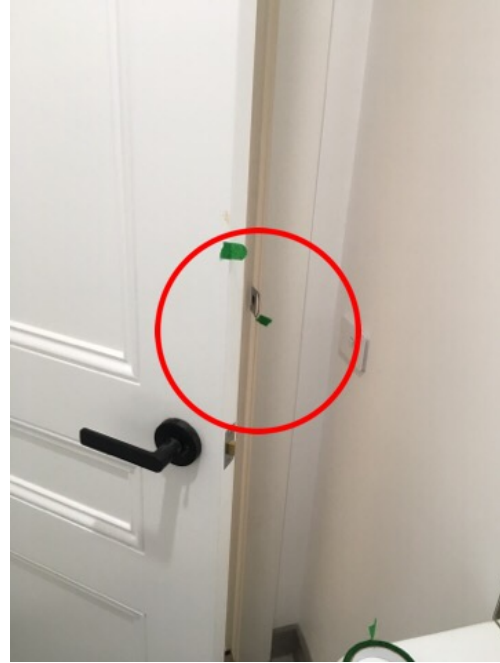
Door

Minor dents, chips and scratches noted - touch up will satisfy

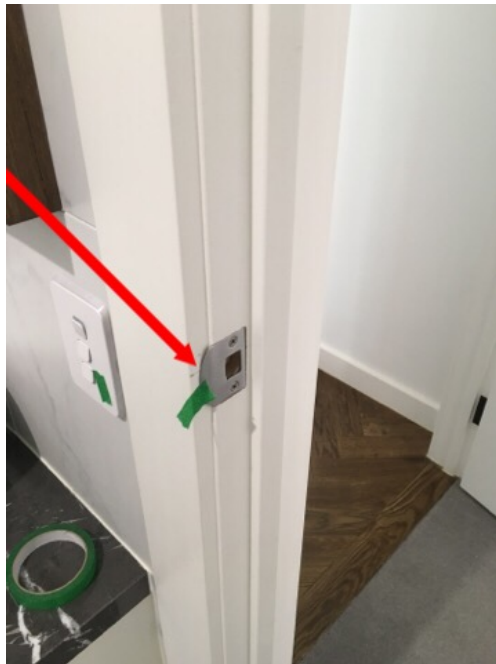
Door

Minor dents, chips and scratches noted - touch up will satisfy

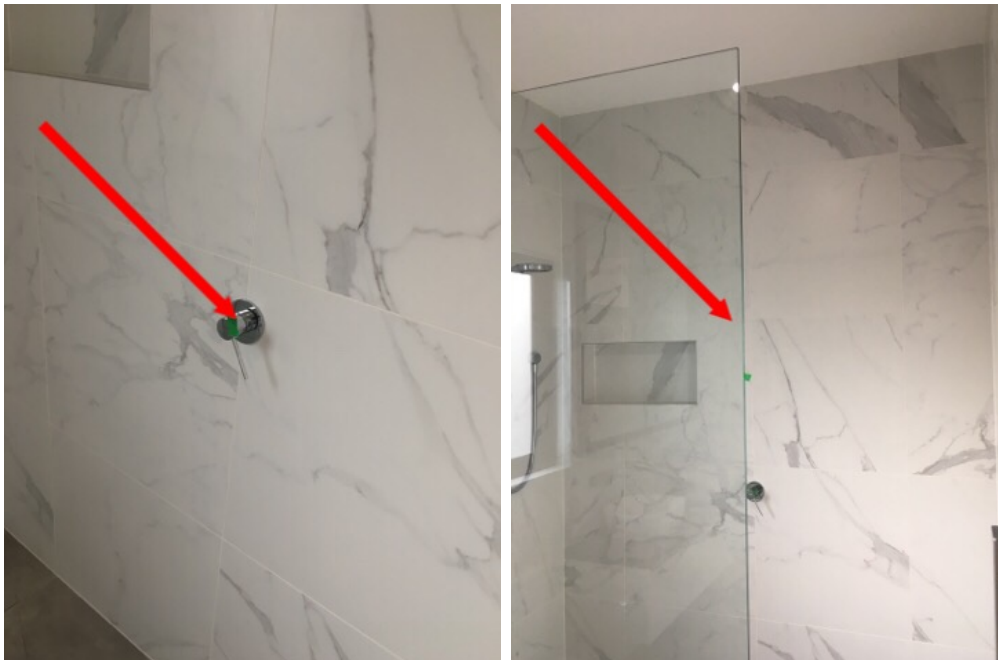
There is excessive pipe knocking or water hammer to the shower taps. Recommendations. Installing a Water Hammer Arrestor may resolve this, however speak with a licensed plumber for further recommendations.

Shower screen not secured, consider as a safety issue

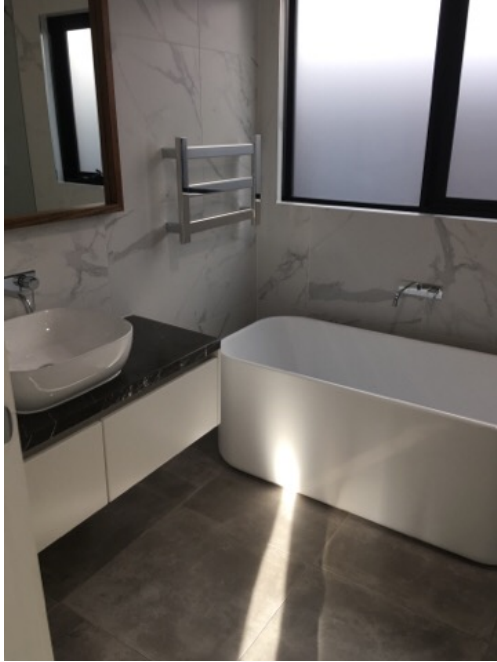
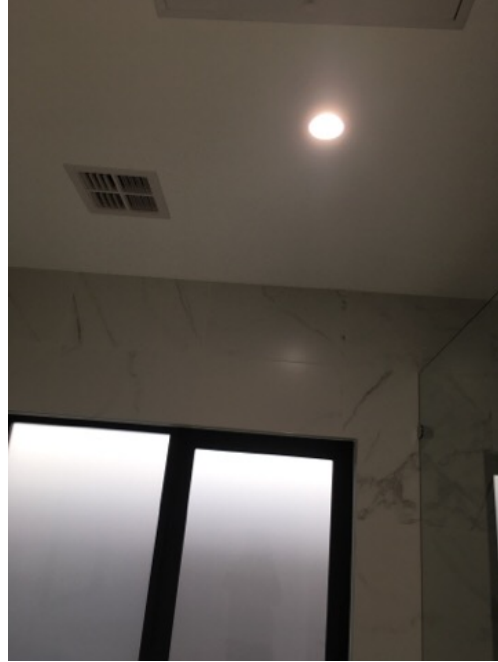
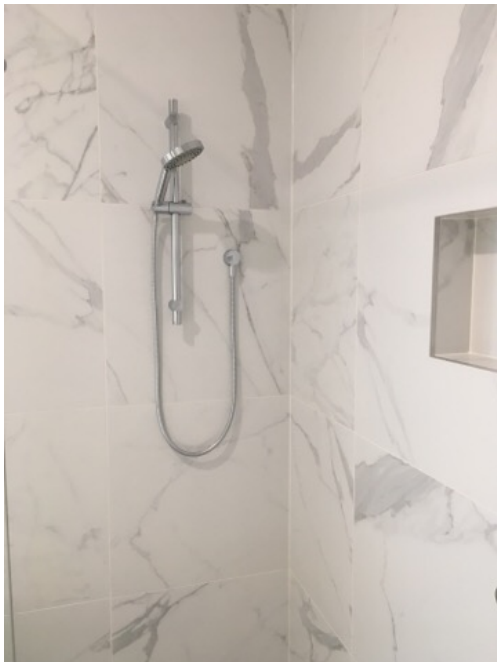
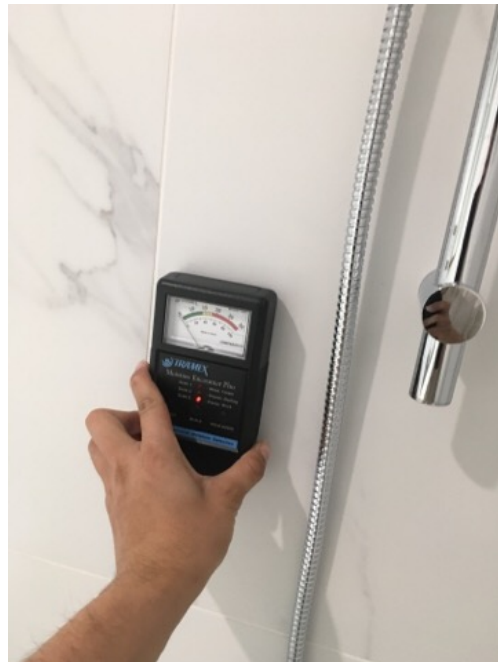
Shower

There is excessive pipe knocking or water hammer to the shower taps. Recommendations. Installing a Water Hammer Arrestor may resolve this, however speak with a licensed plumber for further recommendations.

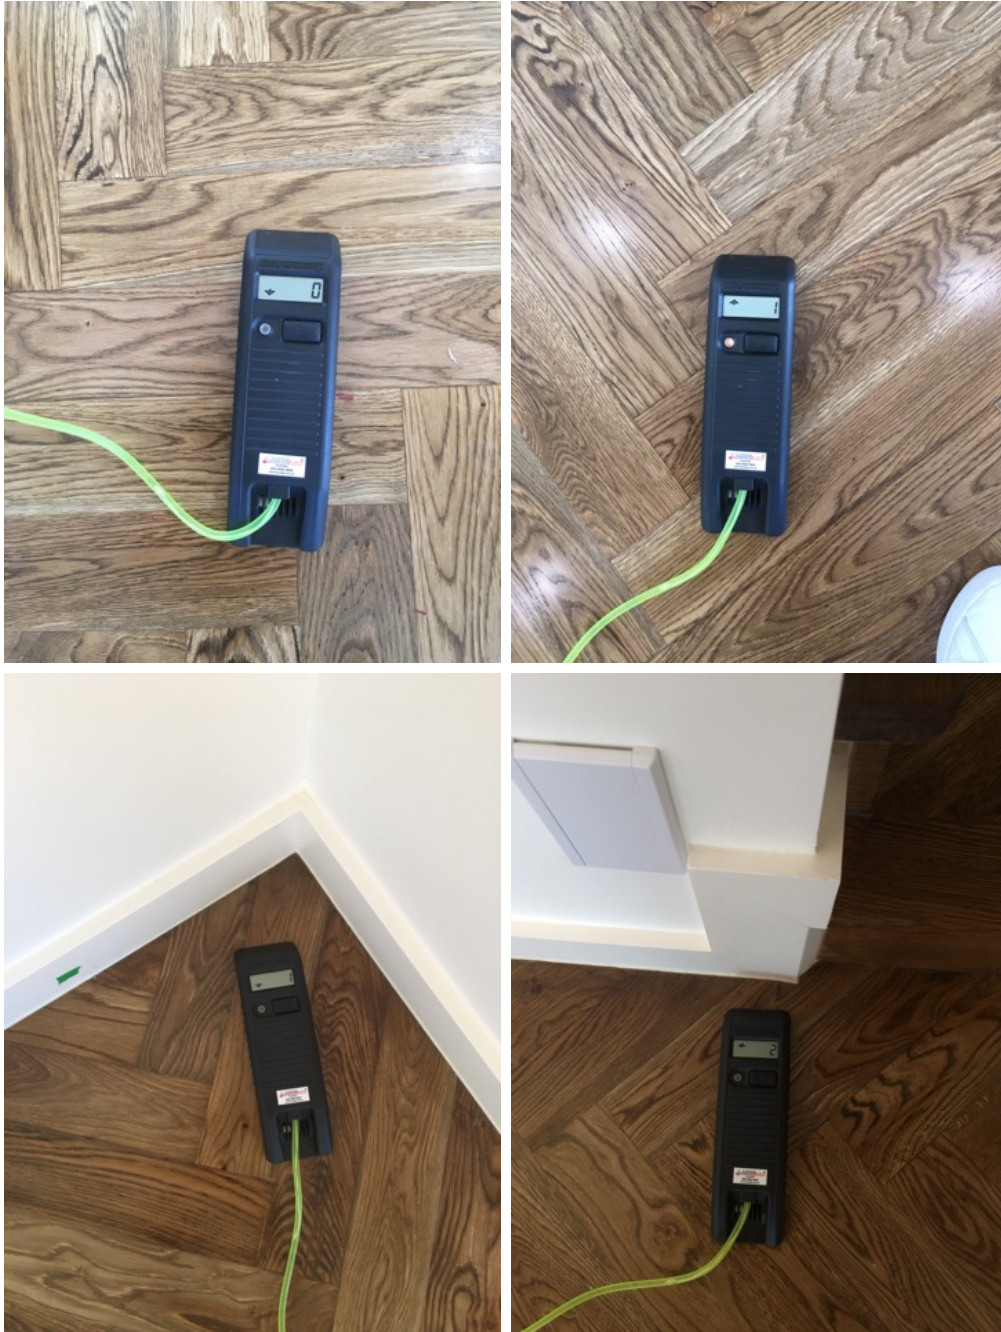
Floor Levelness

Floor Evenness Acceptable

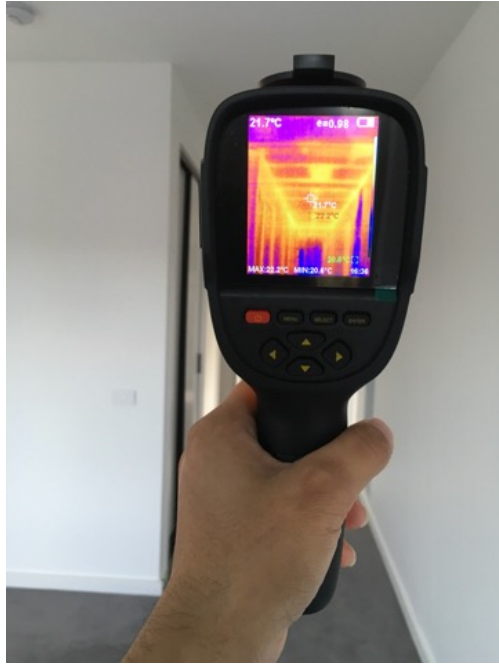
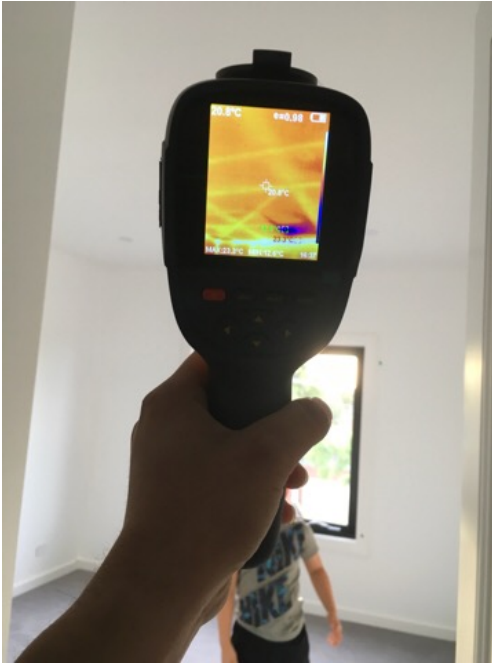
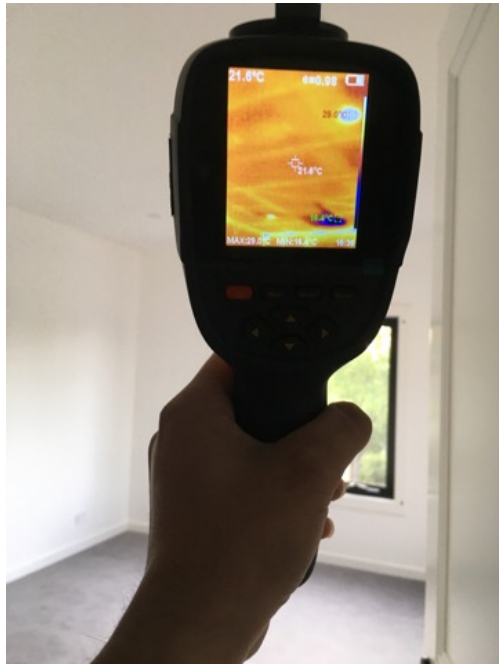
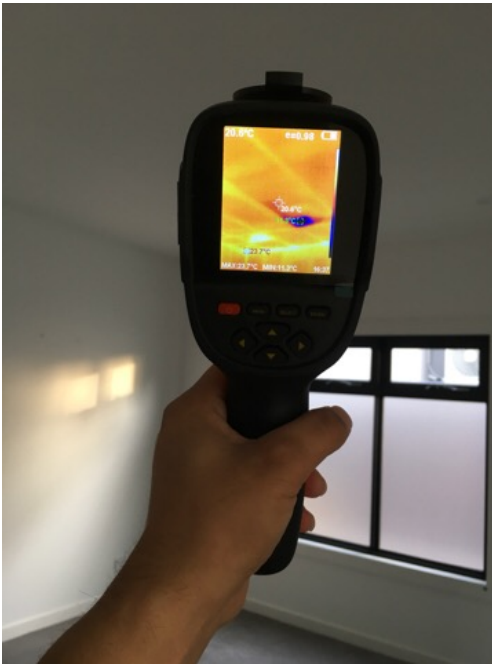
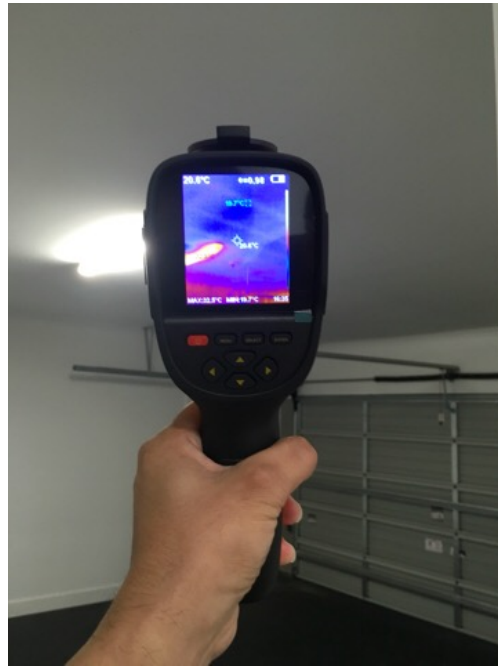
Any Sighting of Rain or Water Leakage Problem

No Sighting of Rain or Water Leakage
