Building Inspection Report

Fangs Building Inspections

lot 555, 12 Ninevah Avenue, Clyde North, VIC

Inspection Date: 12 Dec 2019

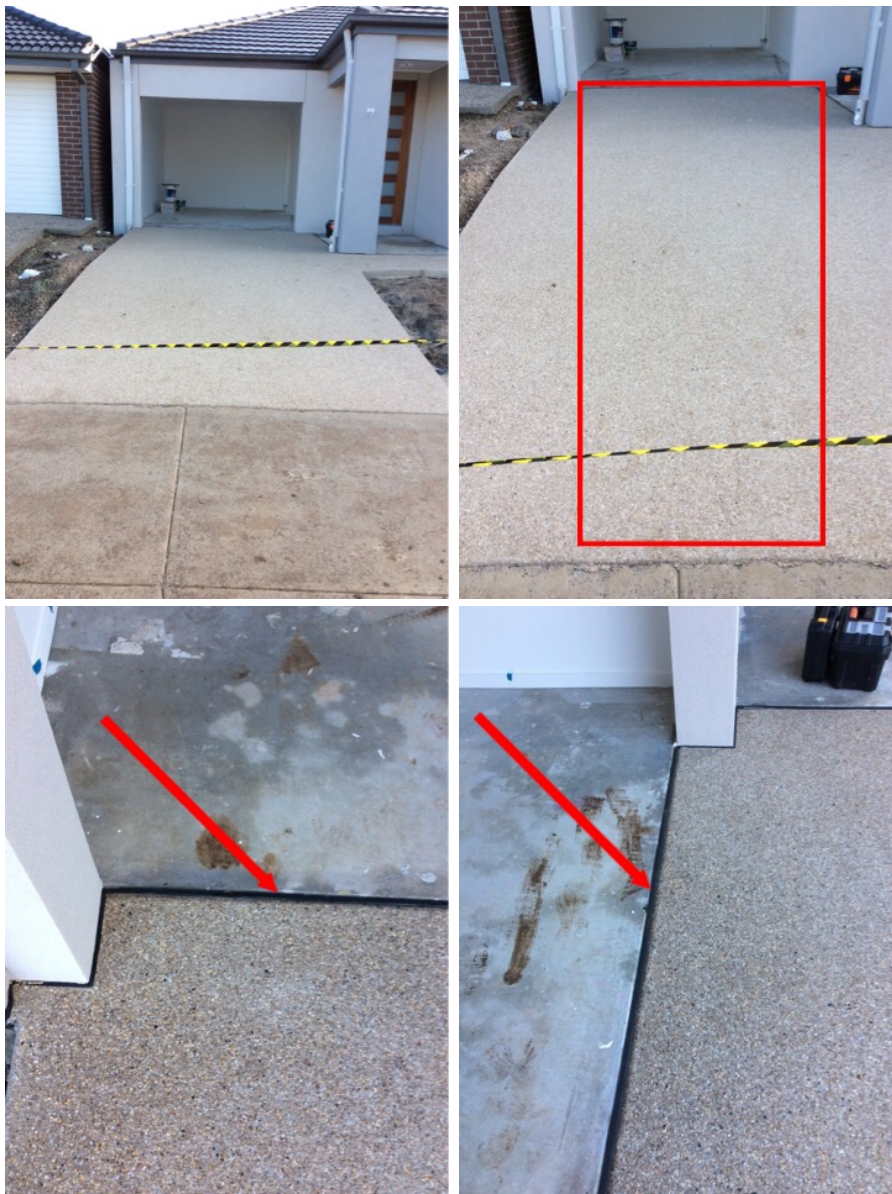
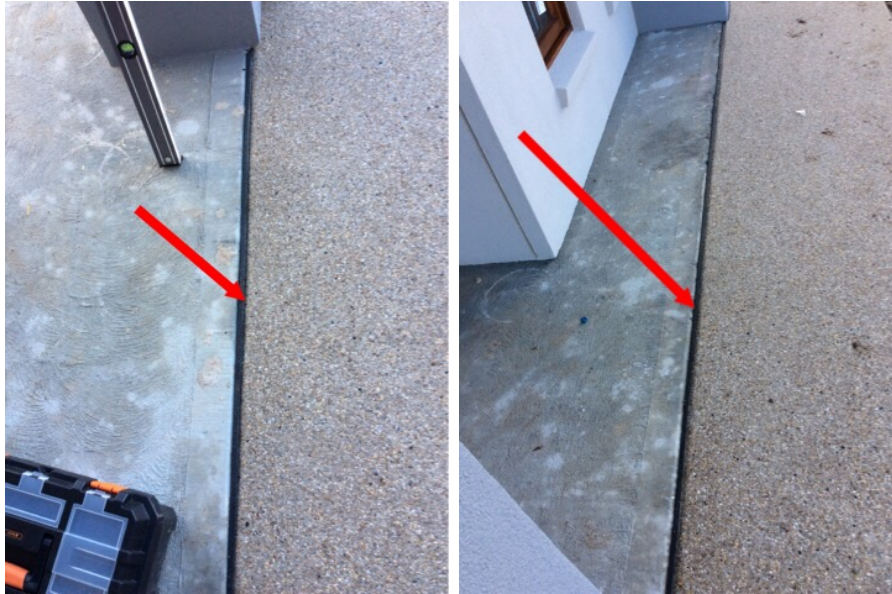
Driveway Condition

All of the AJ's must be stripped, cleaned of all non-compressive material and then presented for inspection and only then sealed.

Please refer to the BCA for further details of expansion joints

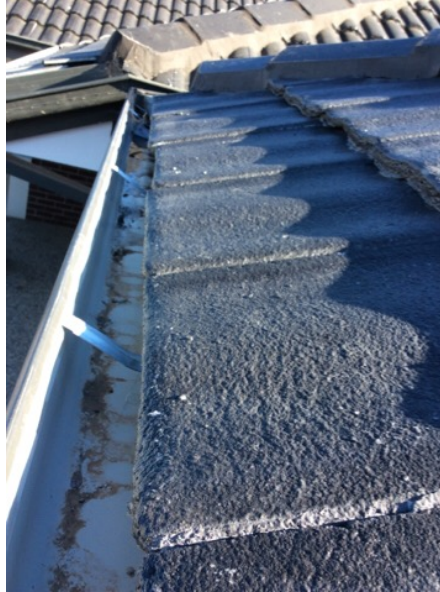
Down Pipes

The down pipe/s wall clips is detached or missing. Recommendations: Although minor and easily rectifiable, we recommend a licensed roof plumber be engaged for repairs

Downpipes should be finished in a protective coating to preserve integrity and minimise the likelihood of corrosion.

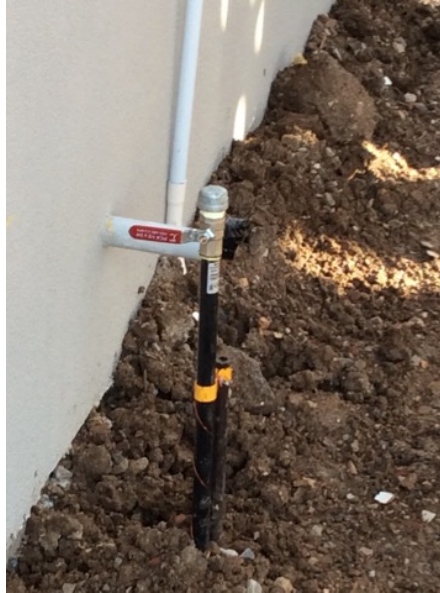
Water Meter

Ground clearance of 150mm is not achieved as per BCA vol 3 of 2019

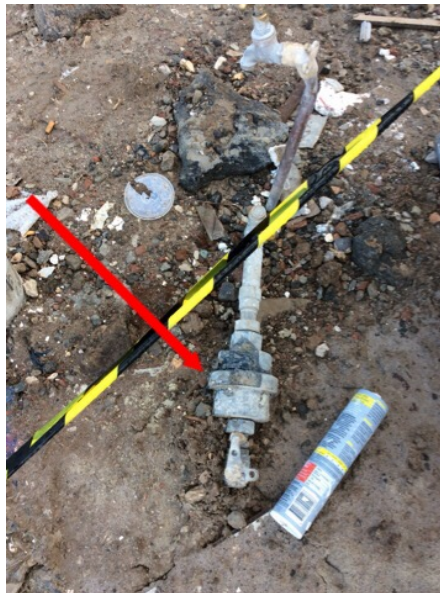
Durable Notice

Termite control durable notice missing, confirm with builder that termite treatment has been carried out.

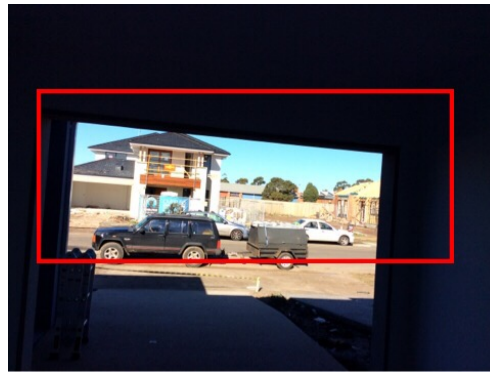
Internal Wall Findings

Minor dents, chips and scratches noted, touch up will satisfy.

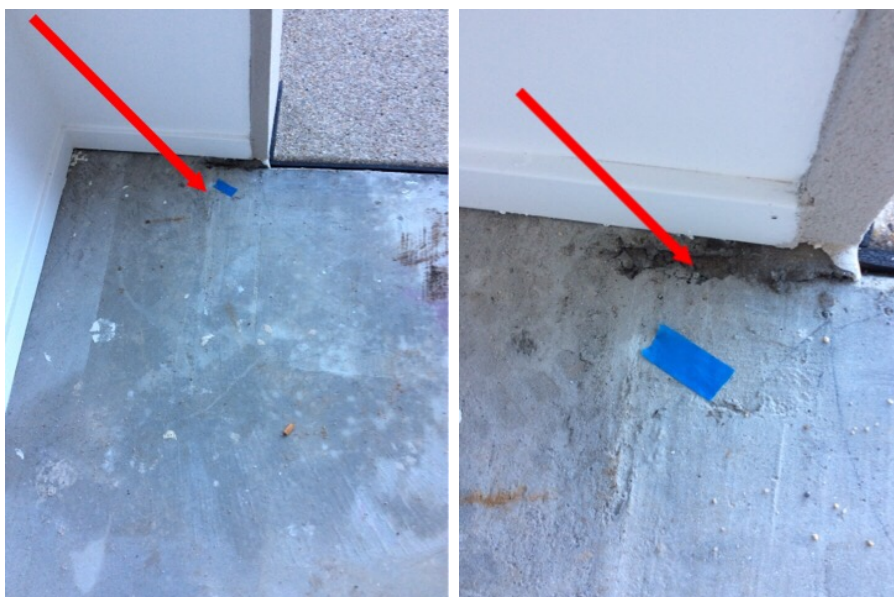
Floor Findings

Floor is uneven and not smooth. Requires rework

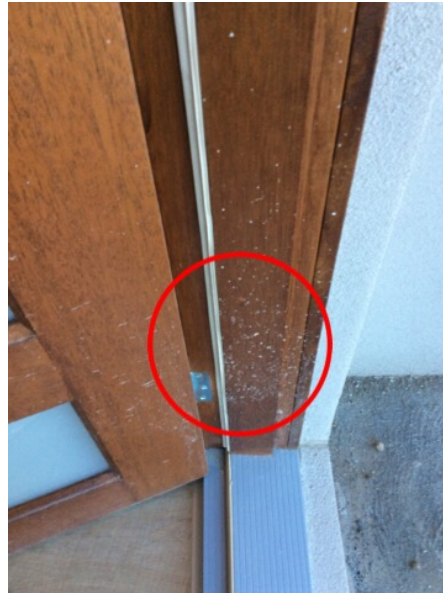
Door

Minor dents, chips and scratches noted - touch up will satisfy
Uneven / out of square door causing binding, adjustment required.

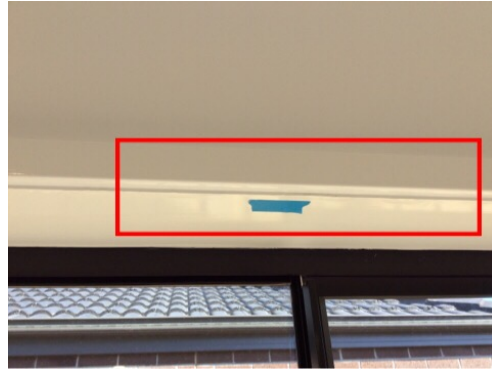
Windows

Minor dents, chips and scratches noted, touch up will satisfy.

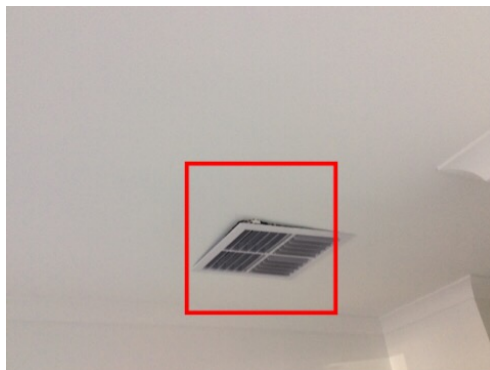
Ceiling

Ducted heating / cooling out cover has separated from the ceiling and requires re-attachment

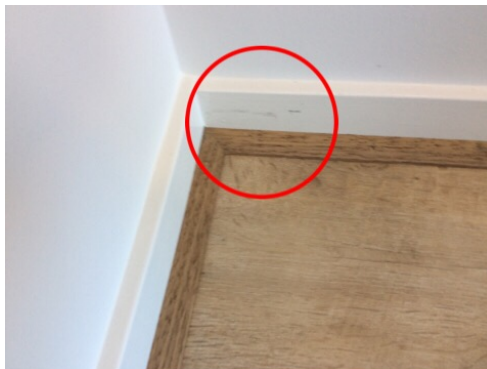
Walls

Minor dents, chips and scratches noted, touch up will satisfy.
Over painting to the referred area, touch up will satisfy.

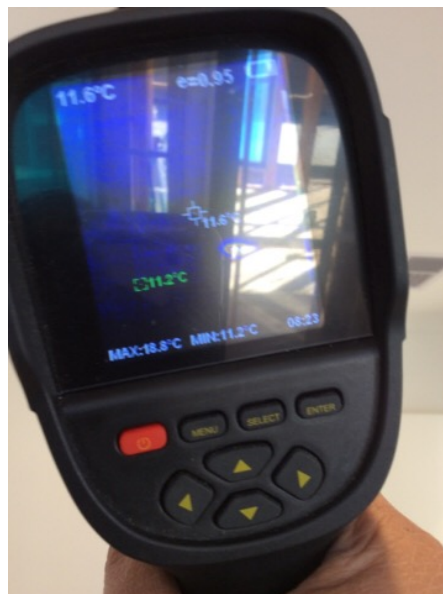
Door stopper doesn't fit for the purpose

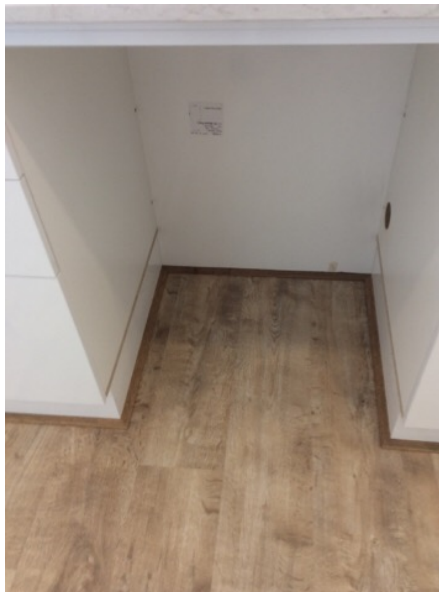
Electric Outlets

Electrical outlet(s) not Installed Properly

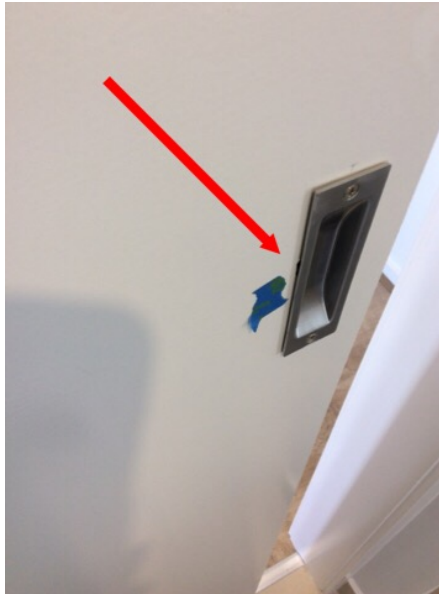
Door

Minor dents, chips and scratches noted - touch up will satisfy

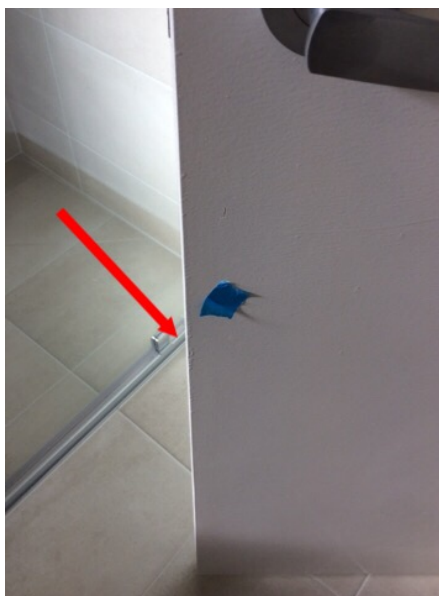
Walls

Minor dents, chips and scratches noted, touch up will satisfy.

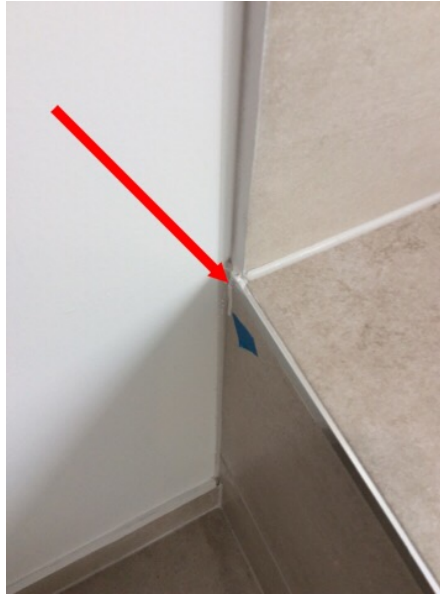
Shower

The shower is serviceable at the time of inspection.

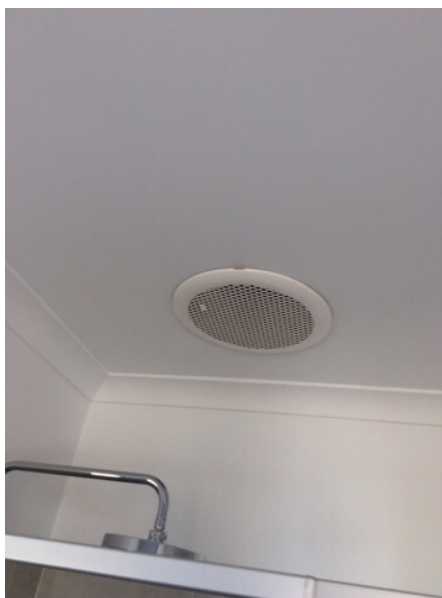
Ventilation

An exhaust fan is present and operable in the bathroom - Regular cleaning advised.

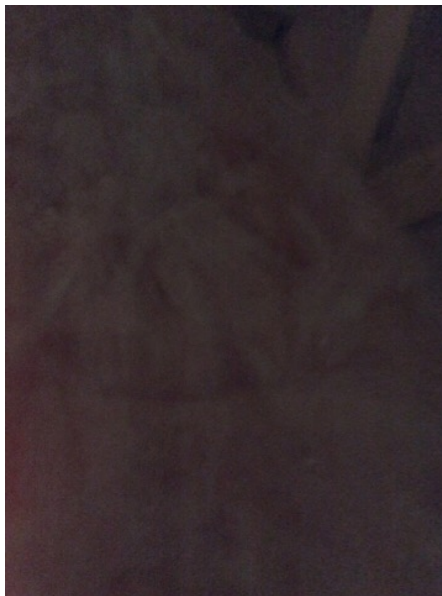
Insulation

The roof space is insulated with fibreglass batts.
