# Building Inspection Report

FANGS BUILDING INSPECTIONS

## Inspection Address John St, Bayswater, VIC

Inspection Date:        31 May 2019

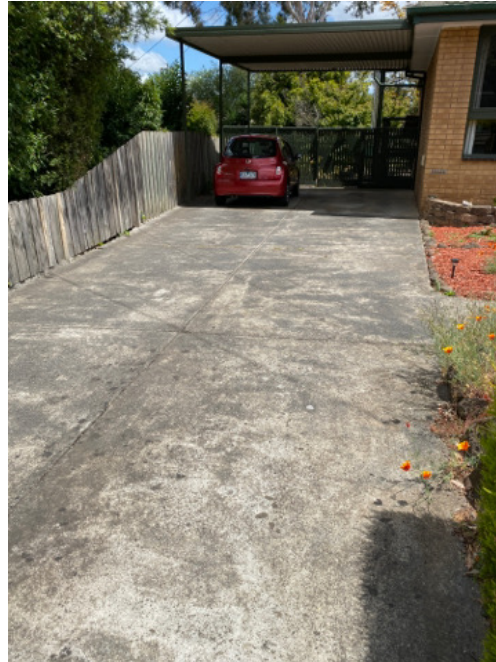
#### **Driveway Condition**

On visual inspection, the general condition of the driveway is in a serviceable condition.

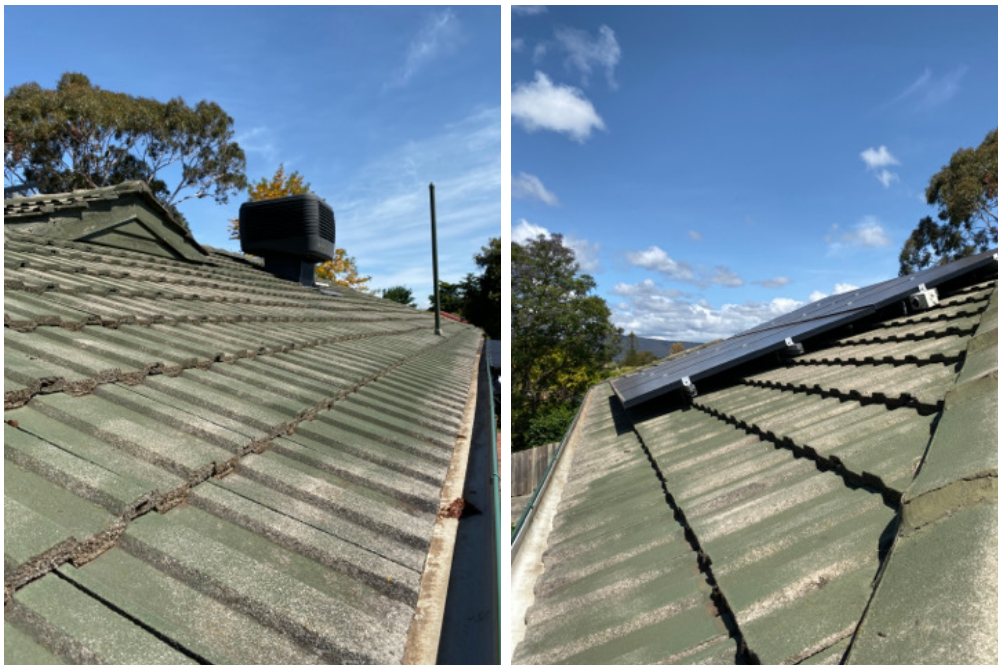
### Roof Clad Condition

Mortar cracks visible. We recommend having these repaired by a licensed roofer as they contribute to water ingress. Whilst common on properties of this age we recommend repair it may result in water ingress into the roof cavity

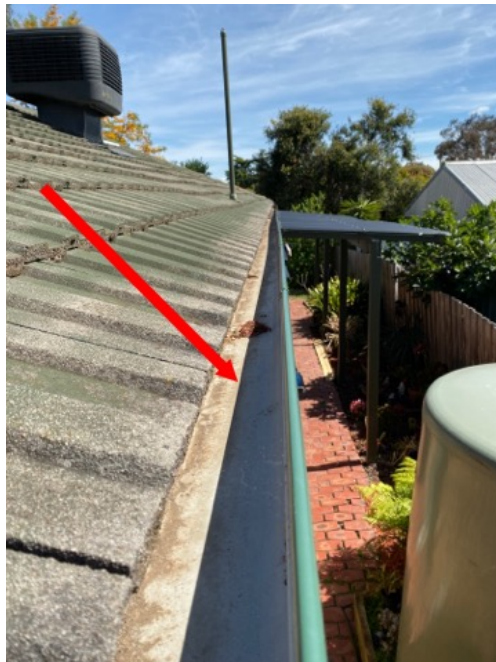
### **Gutter Findings**

All visible guttering appears serviceable condition with no apparent defects at the time of inspection. Note: Periodic maintenance checks should be carried out for rust penetrations and leaks.

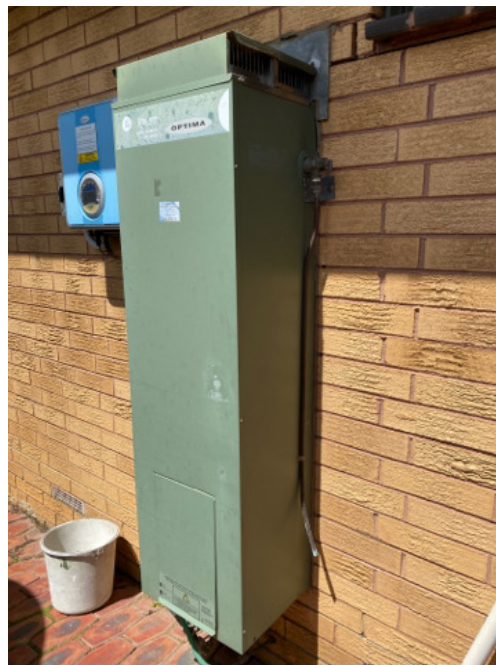
The hot water system appears to be in a serviceable condition. No specific tests other than running the hot water from a tap was carried out. No determination has been made as to the suitability or adequacy of the hot water system in relation to capacity or otherwise.

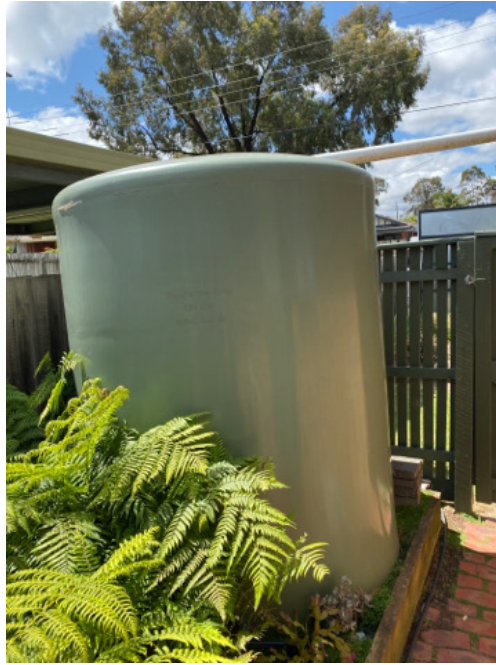
### **Water Tank Condition**

On Visual Inspection the water tank appears serviceable, but should be checked by a qualified plumber.

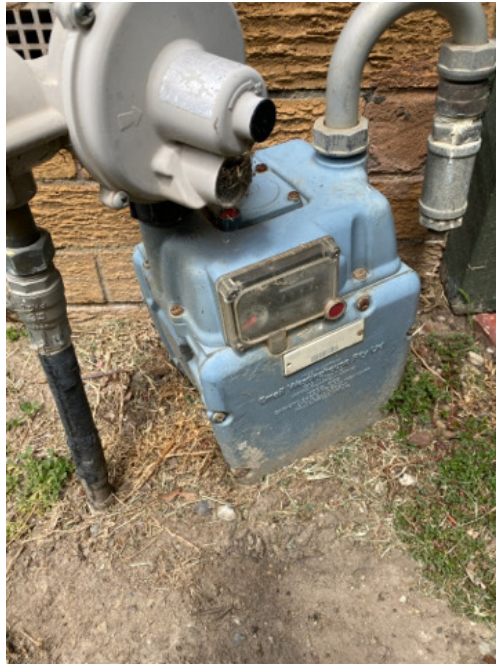
#### Gas Meter

Gas meter is serviceable at the time of inspection.

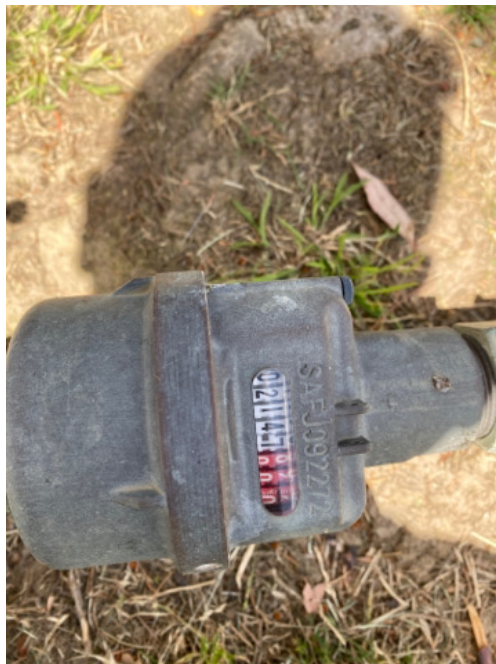
#### Water Meter

The water meter is serviceable at the time of inspection.

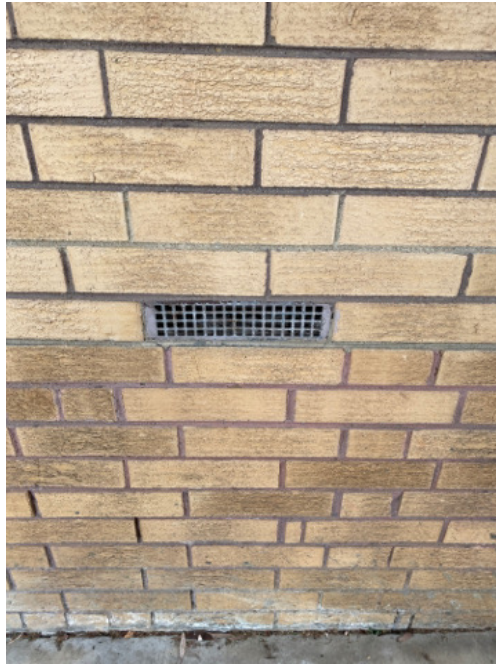
## Weep Holes and Ventilation

The weep holes are unobstructed .

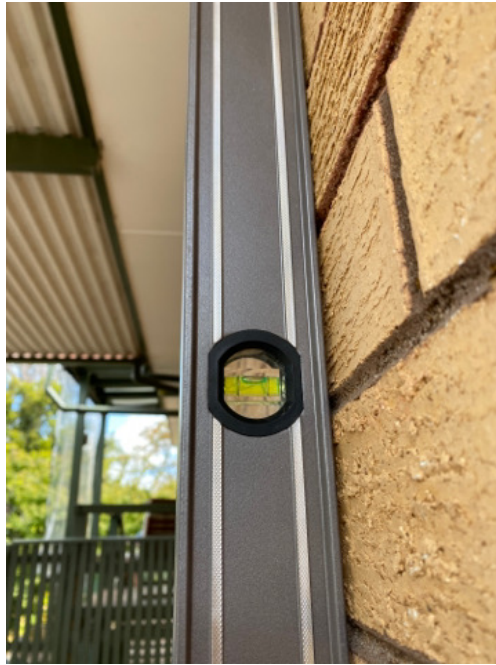
**Wall Plumbness (Deviation <15mm Minor / <25mm Medium / >= 25mm Major)**

The exterior wall is straight with no deviation detected

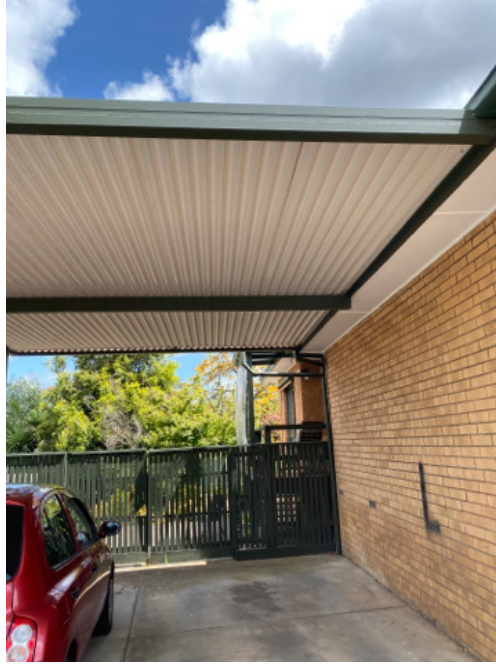
#### Overall Condition

The overall condition of the carport is serviceable for the age.

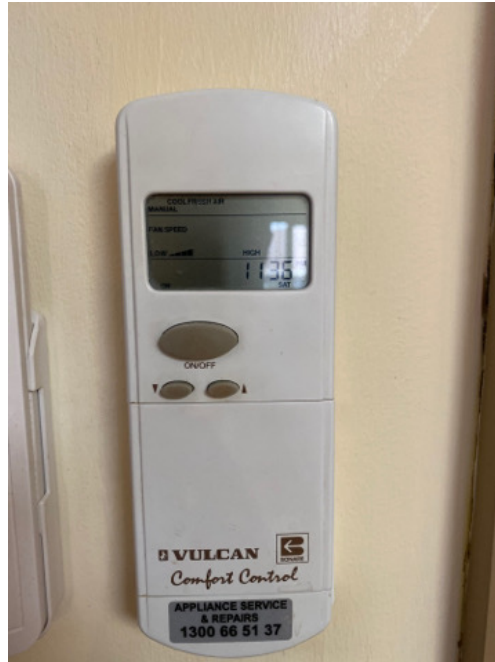
#### Central Cooling Unit Findings

The central cooling system is serviceable

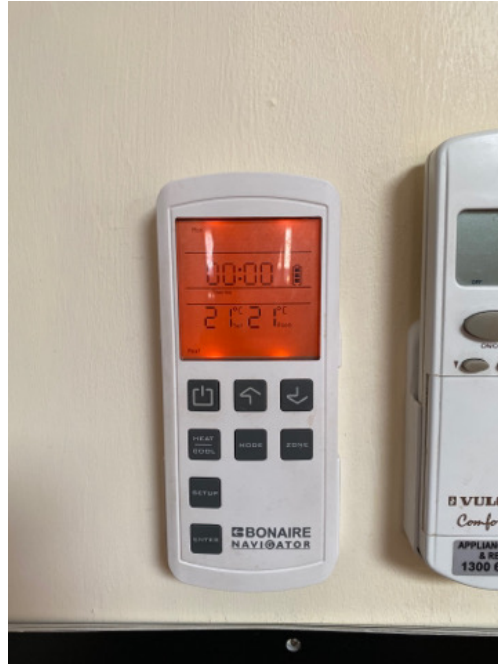
### Ducted Heating System Findings

Ducted heating unit serviceable

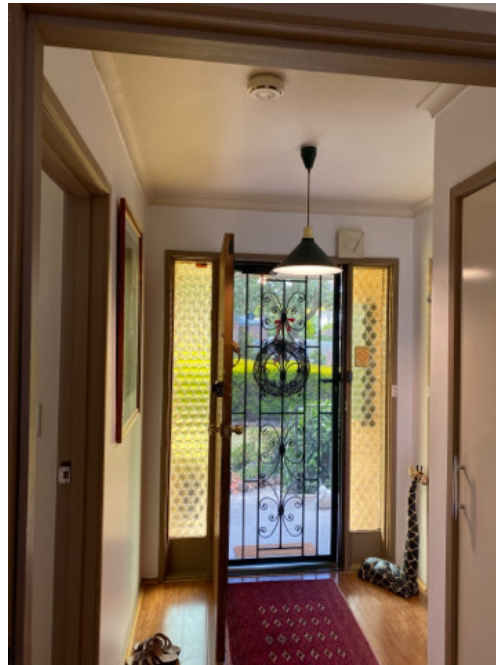
### Overall Condition

From the visible and accessible areas, the entry/Hallways appears to be in a serviceable condition for the age of the property with no notable structural defects sighted.

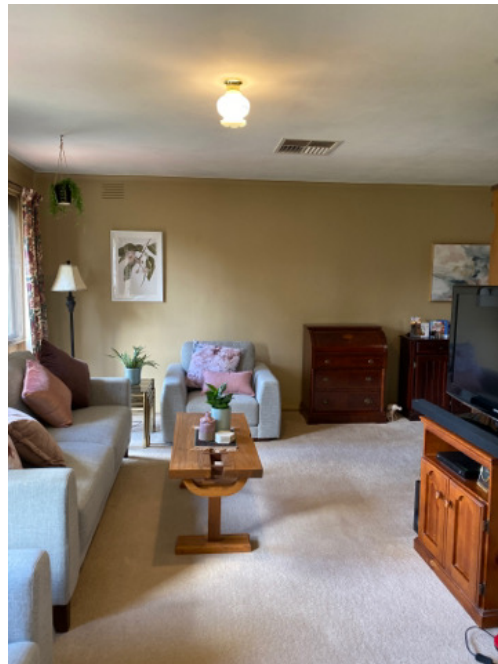
### **Overall Condition**

From the visible and accessible areas, the entry/Hallways appears to be in a serviceable condition for the age of the property with no notable structural defects sighted.

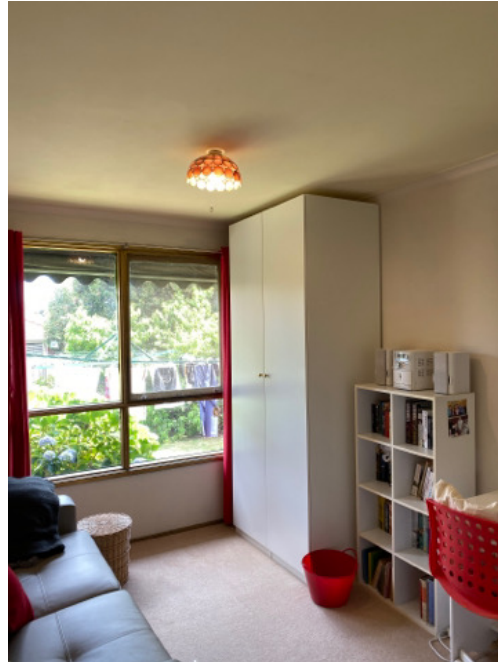
### Overall Condition

From the visible and accessible areas, the entry/Hallways appears to be in a serviceable condition for the age of the property with no notable structural defects sighted.

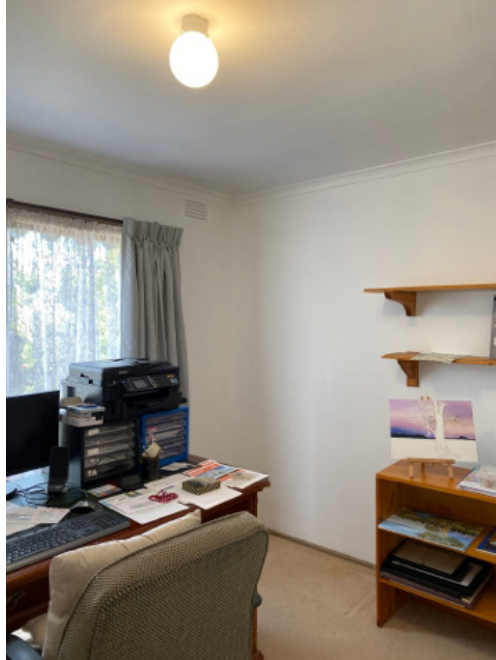
### Overall Condition

From the visible and accessible areas, the entry/Hallways appears to be in a serviceable condition for the age of the property with no notable structural defects sighted.

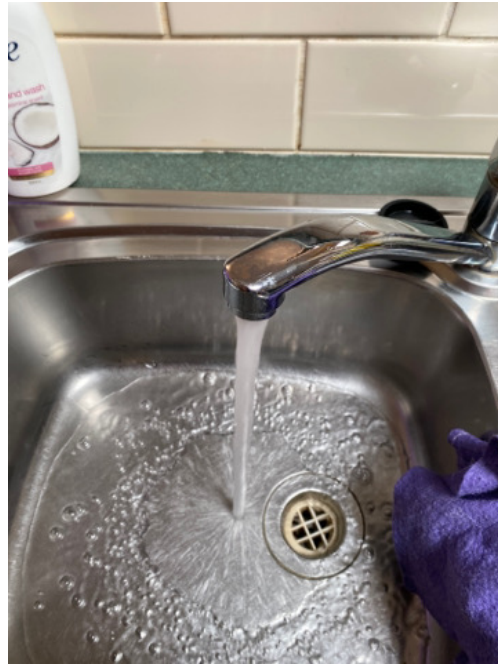
#### Sink and Taps

This area appears to be serviceable condition.

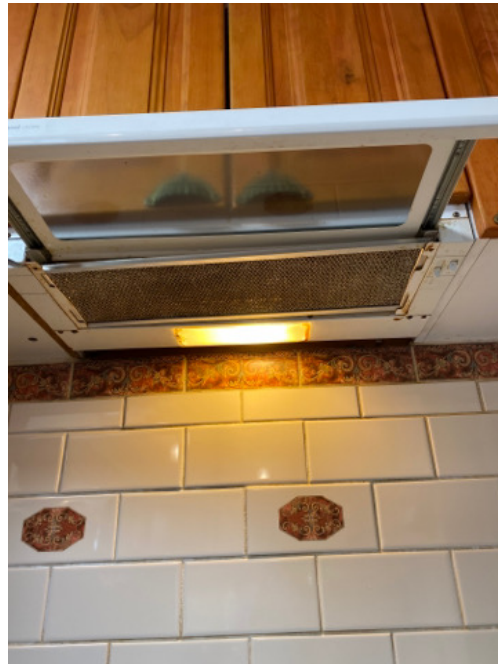
#### Rangehood

The rangehood is serviceable at the time of inspection

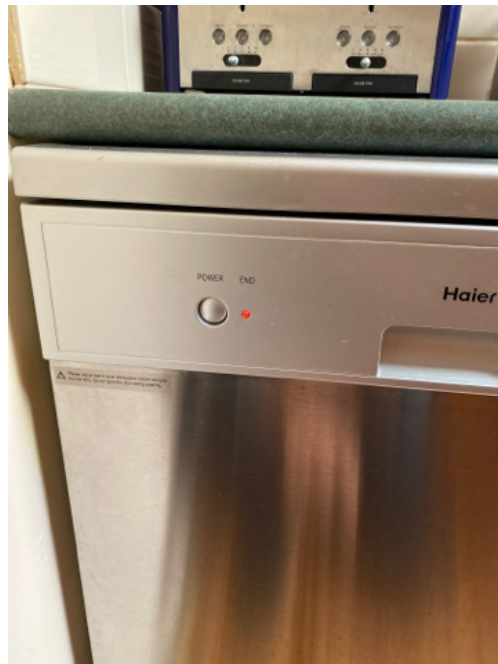
## Dishwasher

The dishwasher is serviceable at the time of inspection

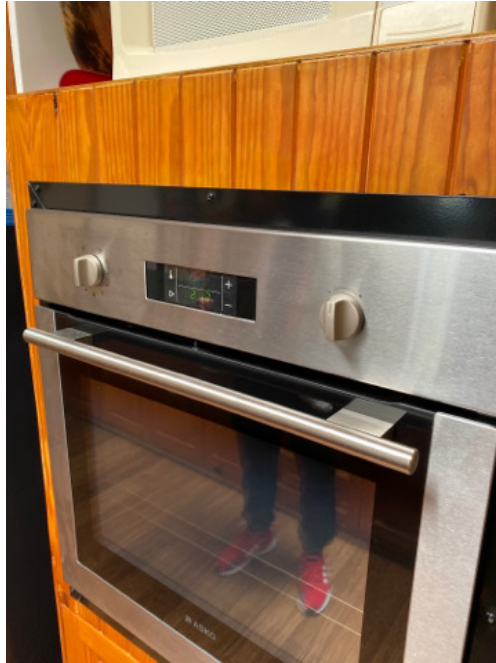
## Oven

The oven is serviceable at the time of inspection

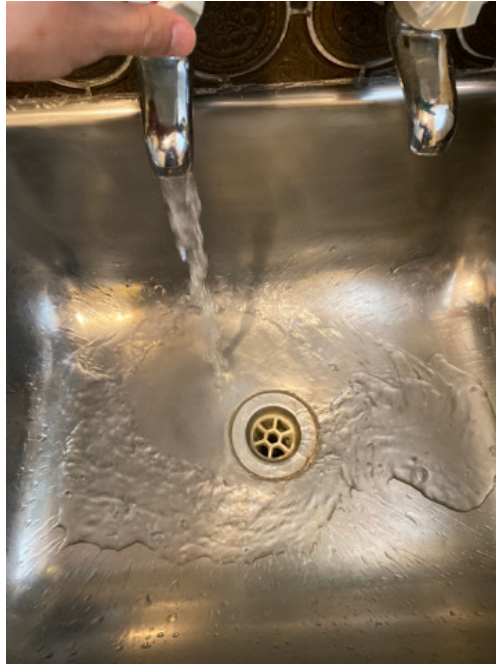
### **Sink and Taps**

This area appears to be serviceable condition.

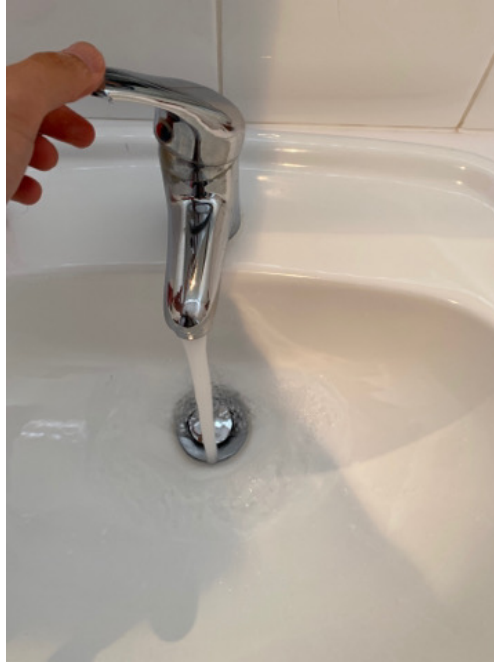
#### Sink and Taps

This area appears to be serviceable condition.

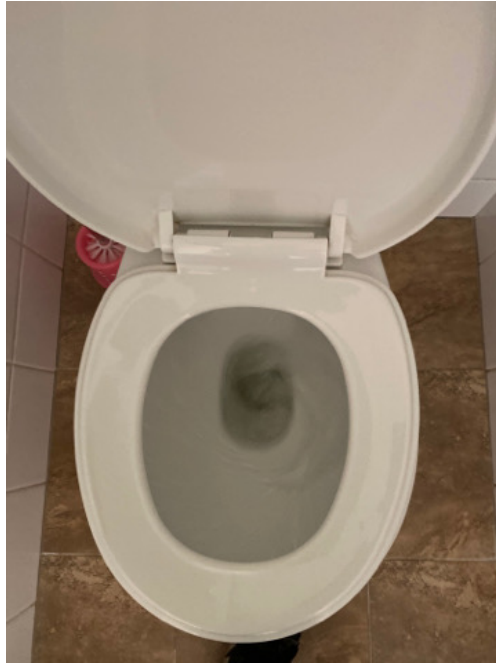
## Toilet

The toilet is in a serviceable condition.

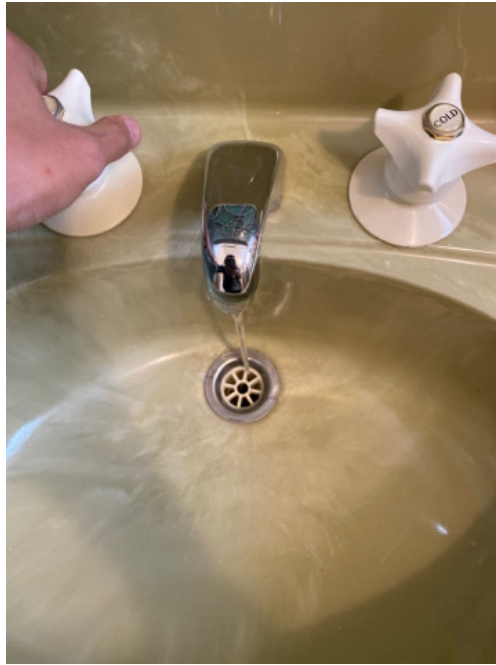
## Sink and Taps

This area appears to be serviceable condition.

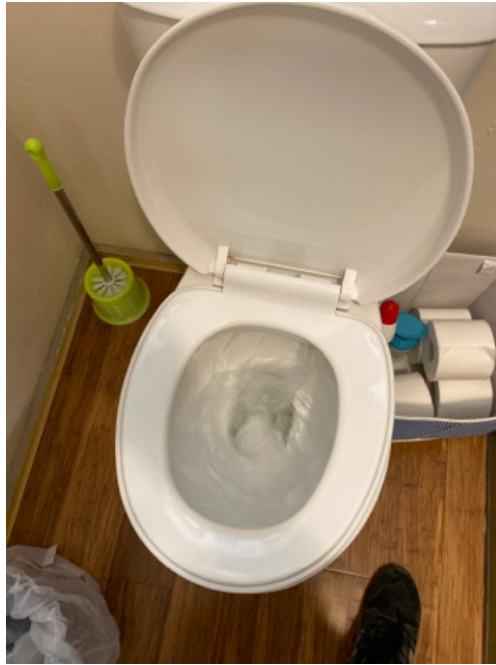
## Toilet

The toilet is in a serviceable condition.

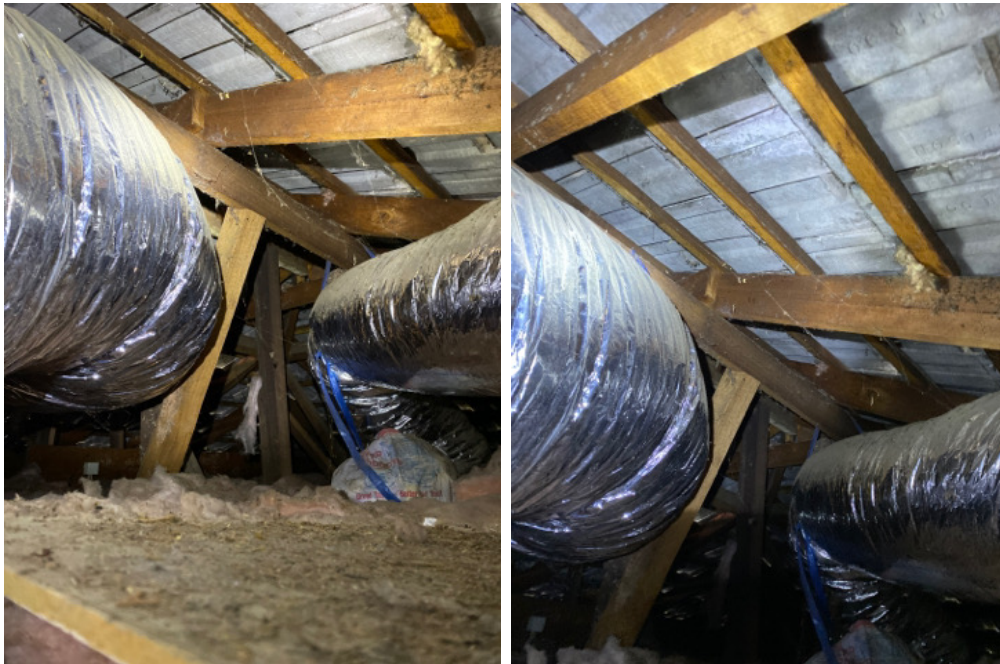
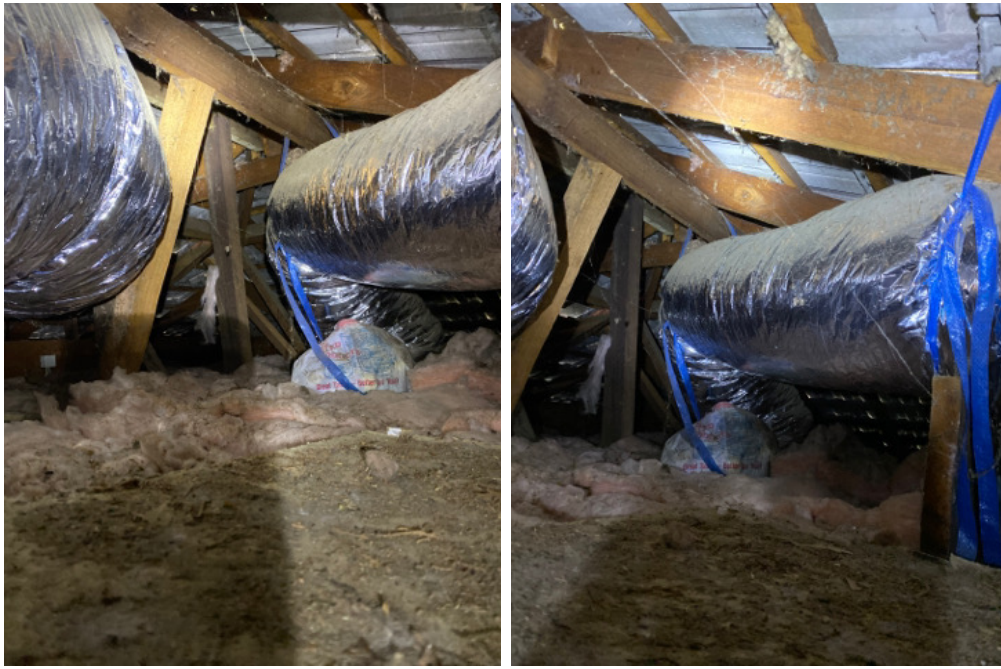
### **Overall Condition**

Visible sections of the roof void is in a serviceable condition for age of this dwelling.

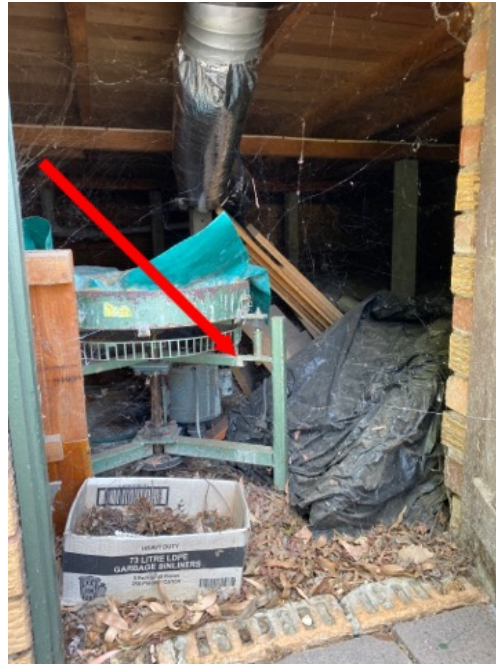
### Restricted Areas

Stored items restricted visual inspection.

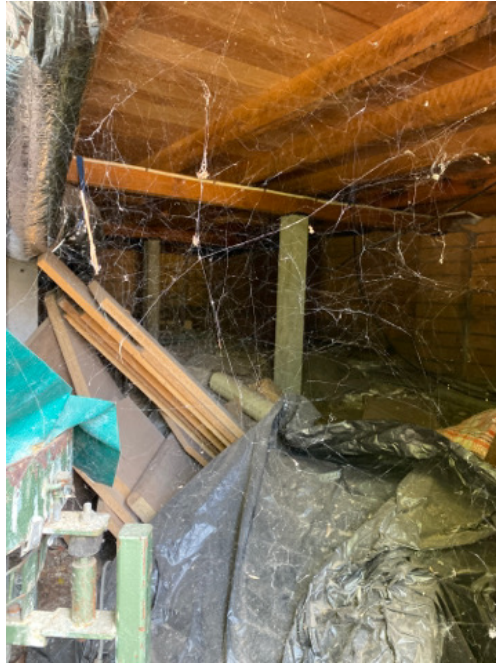
### **General Condition**

Of areas accessible and visible, the subfloor and components appeared to be in a serviceable condition.
